BETHEL HOSPITAL, NORWICH
GAZETTEER
ISSUE 3
NOVEMBER 2016

This Gazetteer has been written to accompany the Conservation Management Plan (CMP) for Bethel Hospital. It is a room by room assessment of most of the site with the occupied flats generally having a single entry. The Gazetteer is intended as a reference guide to allow the status of a particular structure or interior to be checked if a change or conservation works are proposed. A location plan and photographs are included for each entry.

The Gazetteer has been prepared by the authors of this document based on a site visit to each area in late January and early February 2016.

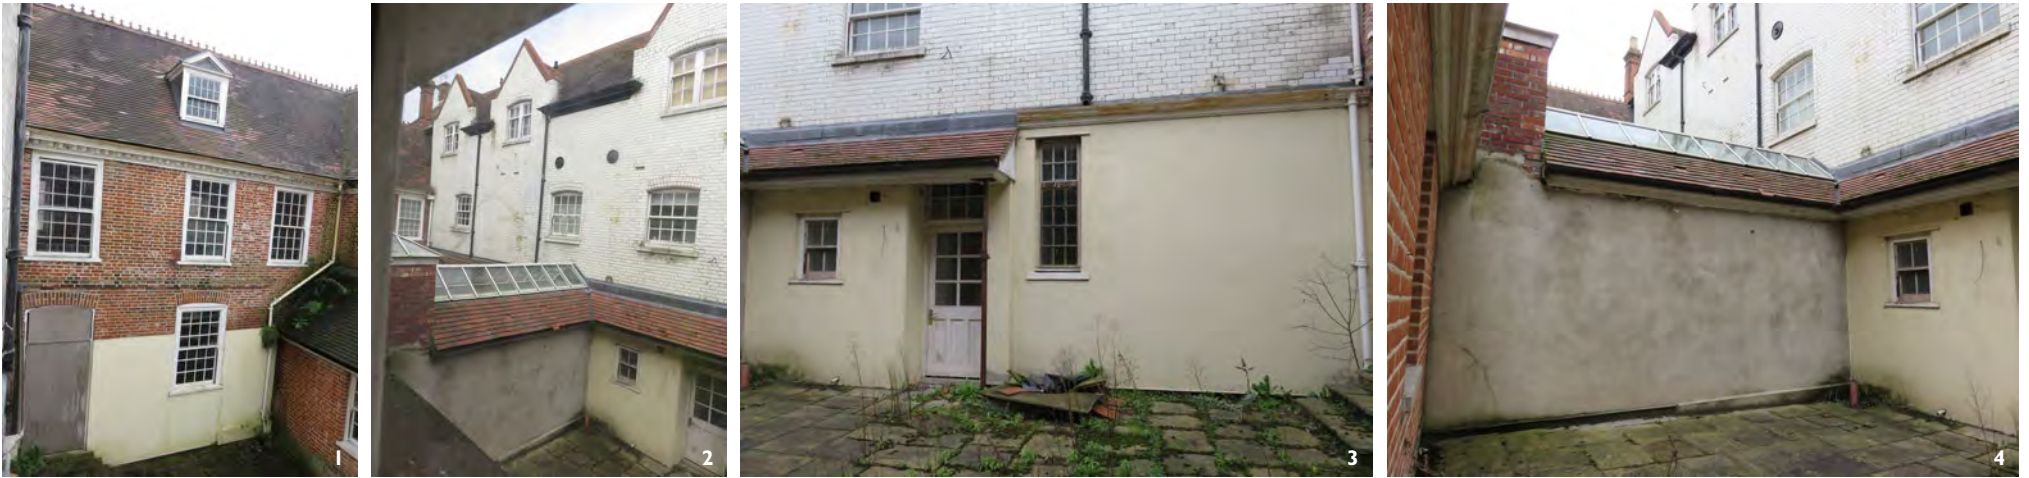
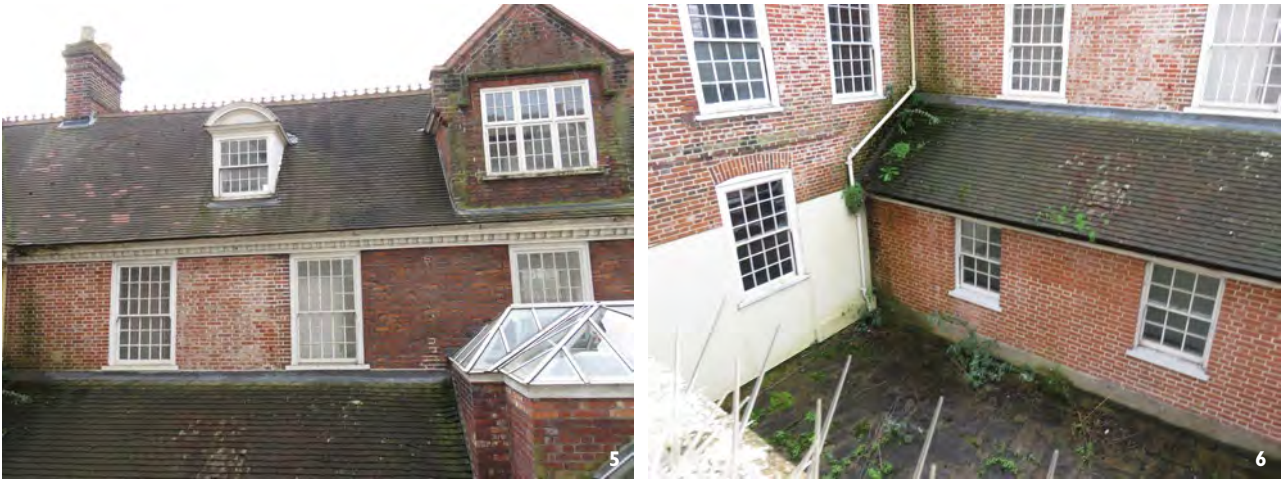
- 1 East elevation
- 2 View of the courtyard from the Central Range
- 3 North elevation
- 4 West wall
- 5 Upper part of the south elevation
- 6 Lower part of the south elevation
- 7 Slipped and missing tiles to west elevation

Generally in adequate condition. The glazed bricks to the north elevation are stained and cracked/broken in places. The window sills on the north elevation are also stained and green, with dark staining around the gutters and at the east end where the north elevation meets the east roof. The gutter between the red and glazed bricks is badly rusted and it appears some glazed bricks have been replaced just above the gutter in the north-east corner. The render is in poor condition at the base of the wall – paint is peeling and the render is green. The door and windows also look in poor condition.

The south elevation is in pretty good condition at ground floor level with the exception of moss and vegetation growth to the lean-to roof. At first floor level, the brickwork looks fair but has been repointed in a cement mortar in areas and some bricks look missing or badly spalled. The dentilled cornice, roof tiles and dormer window are showing areas of moss growth although there are no missing tiles.

The west elevation is in fairly poor condition. The render has not been painted and now has areas which have gone green. There are areas of green brickwork under the corridor rooflight and one missing and one slipped tile.

The east elevation looks to be in satisfactory condition, although the door is boarded up. The brickwork looks fine as do the windows. The roof, cornice and dormer all look in fairly good condition.

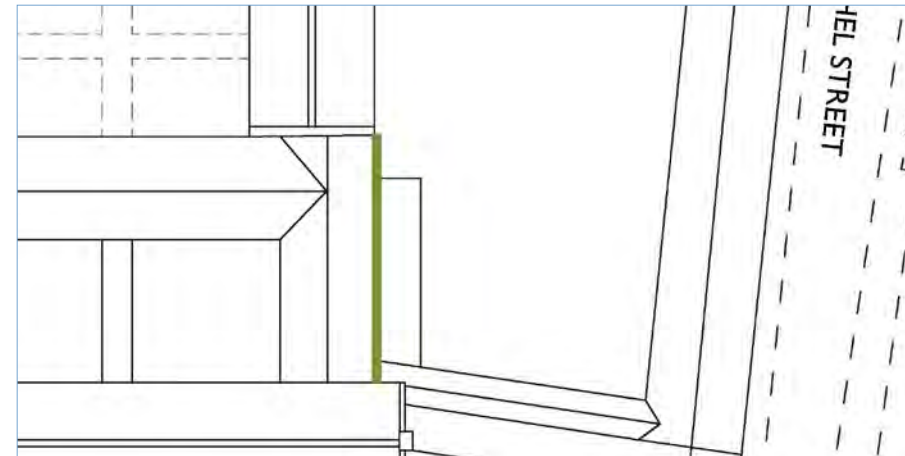
Generally good condition. Some green moss/lichen growth to the lean-to roof and to the chimney. Windows adjacent to chimney in slightly worse condition with staining to the sills. Rainwater pipe by chimney looks in poor condition with area of decay at first floor level. There has been a significant amount of repointing and some of the bricks are stained black but otherwise brickwork appears in good condition.

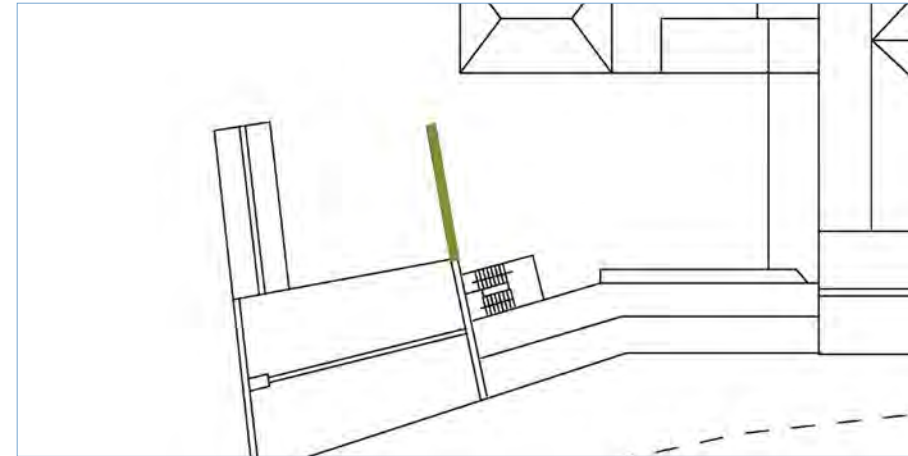
From the west, the brickwork is green with a considerable amount of spalled bricks and areas of repair in cement mortar. Some render still remains at base, but most has been removed or fallen off.

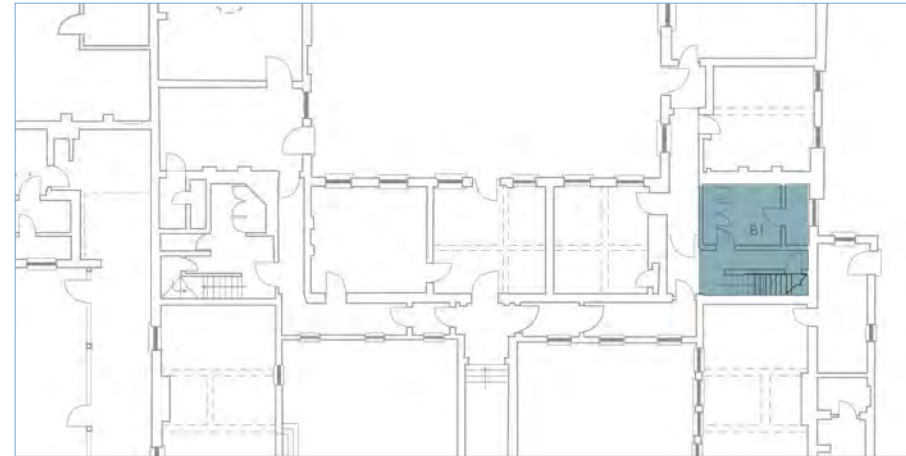
In reasonable condition, with patchy cement render repairs around the room.

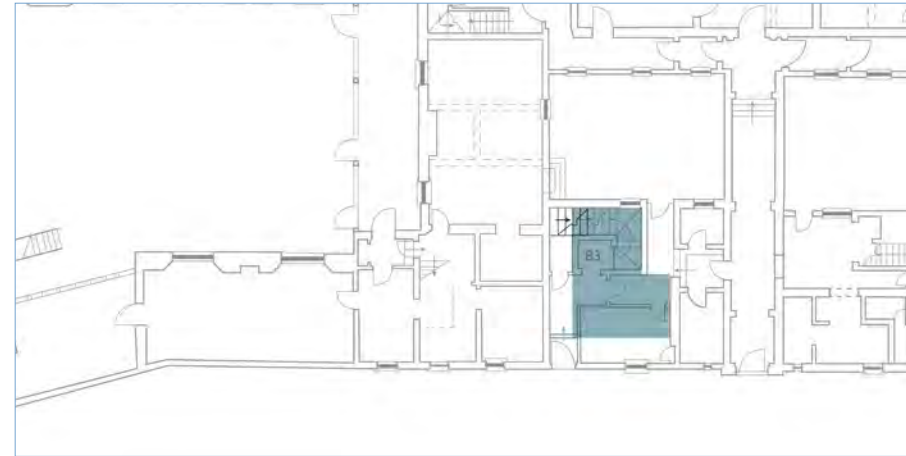
Extremely damp due to water ingress through window, urgent works required.

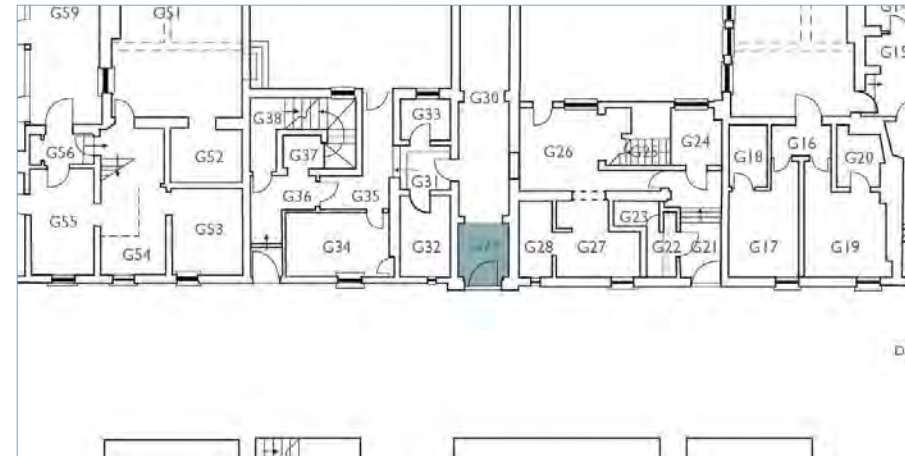
Adequate condition. Some staining to timber door and woodwork. Damage to plaster to walls and vaulted ceiling for services. Letter box on west side of door is rusted.

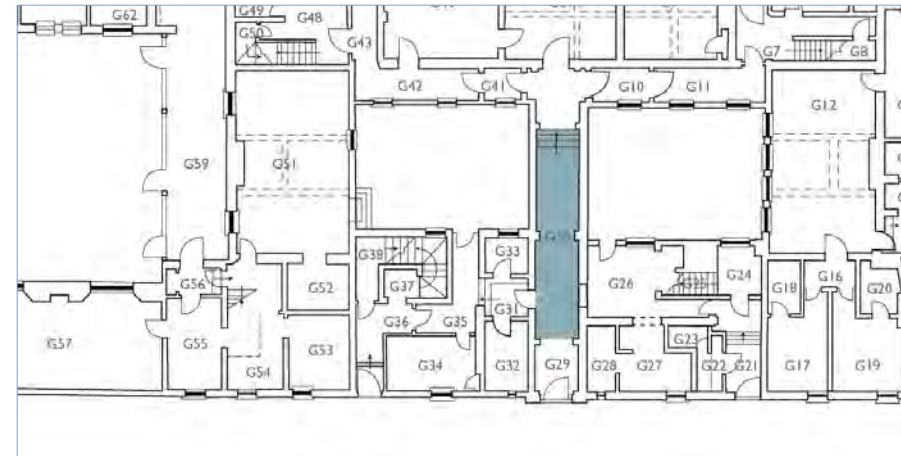
art complete. There is no plaster finish to ceiling or walls. Cement mortar and some modern bricks and blocks used in repairs to walls. No timber panelling to walls. Marble floor and steps looks in reasonable condition. Damage to base of door surround and adjacent columns to door into G39.

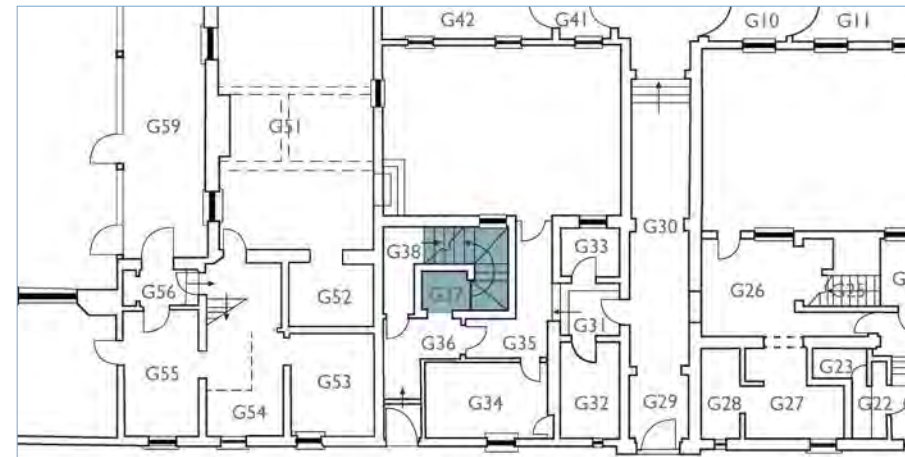
Considerable cracking to stair treads and around newel post around winder steps due to water ingress through basement window.

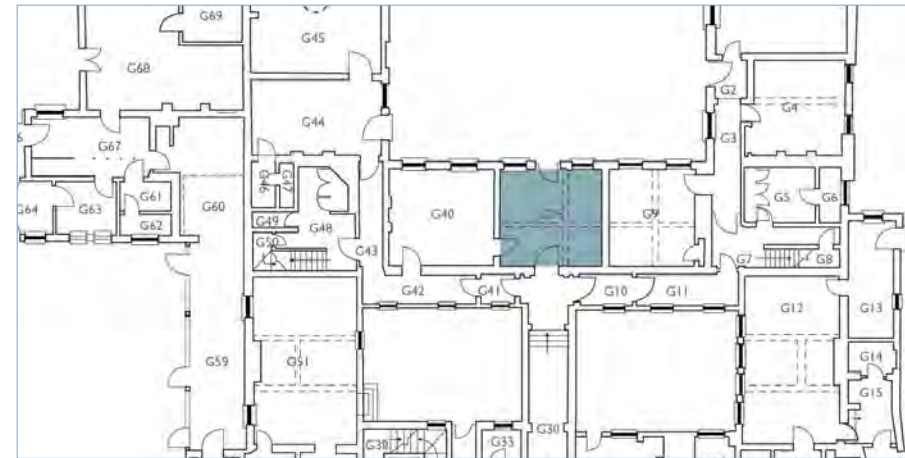
Good although external door and windows only in adequate condition. Glazing panels to door boarded up and windows poorly fitting and one broken pane of glass. Glass broken to door into G30.

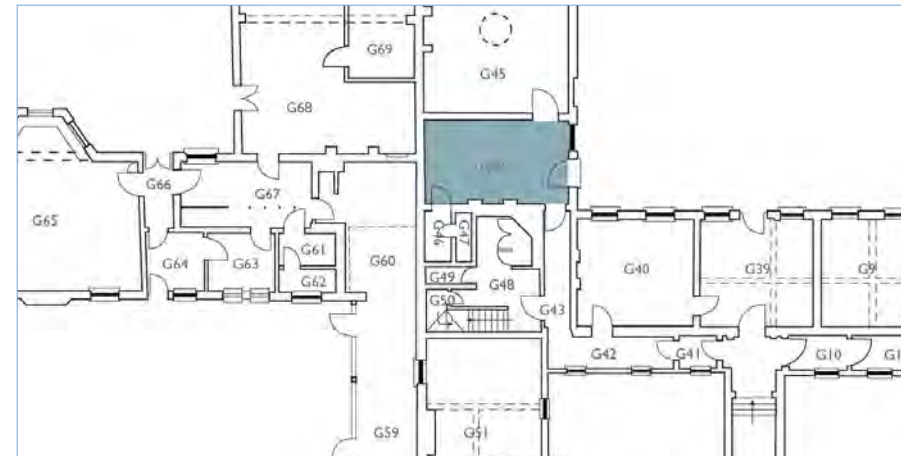
Incomplete plaster work to walls and reveals of doorway to G60. Areas of damp to ceiling in north-west corner of the room adjacent to the timber beam relating to a blocked swan neck in the external downpipe.

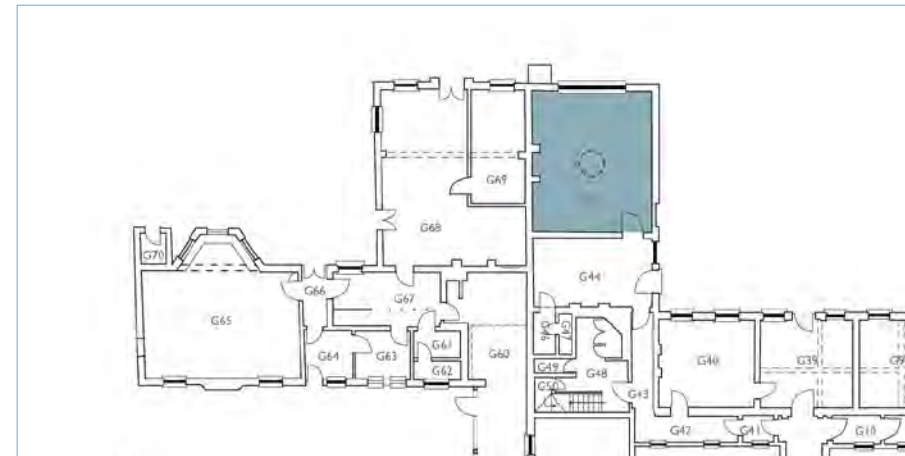
Poor. Structural cracking to south wall and south end of east and west walls. No plaster to south wall or south ends of east and west walls. Considerable cracking and damp damage to plaster at south end of west wall above dado. Cracking to cornice, ceiling and ceiling rose. Damp stains to ceiling throughout. Timber panelling below dado cracked. Window in poor condition. Floorboards and fireplace surround and grate in good condition.

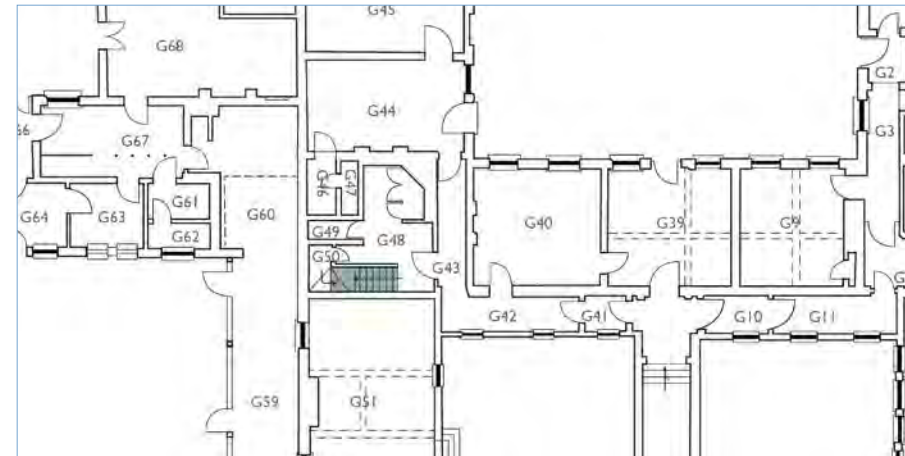
Good with the exception of an area of mould and decay due to water penetration, to the east wall adjacent to the window on the half landing.

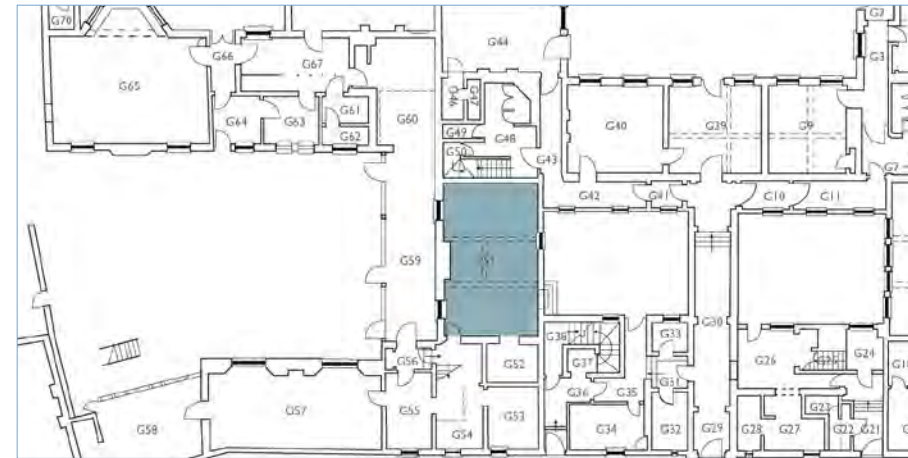
Poor. There is no plaster to walls. There is no ceiling plaster or laths. Previous doorways are blocked up with concrete blocks. Brickwork has been badly repaired and repointed with cement mortar. Bricks are missing or broken, particularly to window reveals and sills and around fireplace. New Catnic lintels over window and doorway in west wall. Door way is boarded up. The timber lintel over the northernmost window in the east wall is rotten. Windows are in a poor condition with broken sash cords and rotten frames and no window sills.

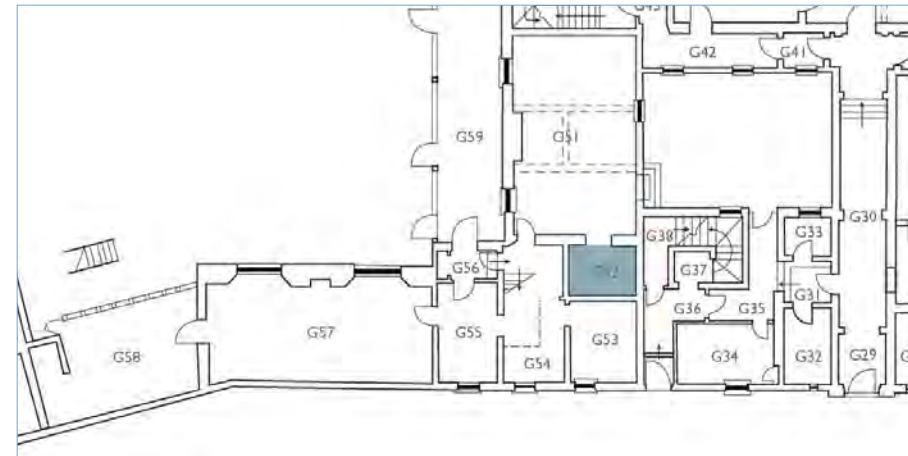
No access available for inspection. No floor. Poor condition as viewed from room G51. There are no finishes to wall. There is no ceiling plaster or laths. Repairs to brickwork in concrete block and cement mortar.

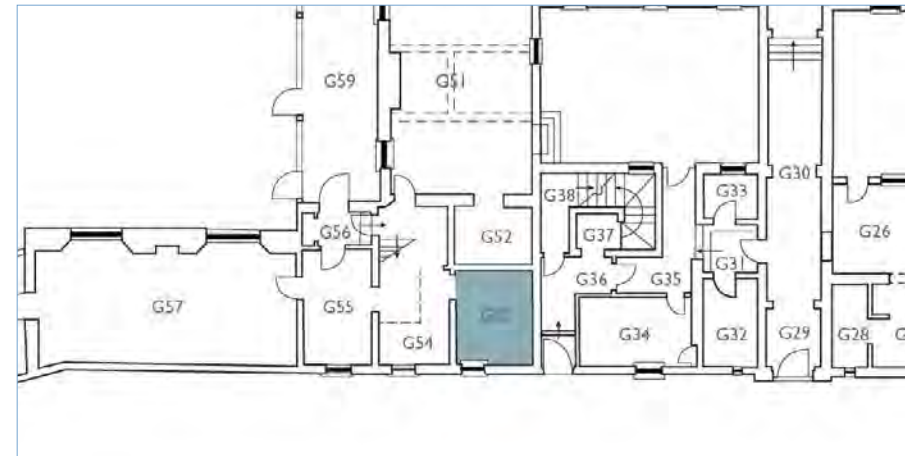
Poor condition. There is no plaster to the walls. There is no ceiling plaster or laths. Openings are blocked up with concrete blocks. Brickwork has been repaired with cement mortar. Bricks are broken or missing, particularly to reveals of window. There is a large crack with missing bricks in east wall.

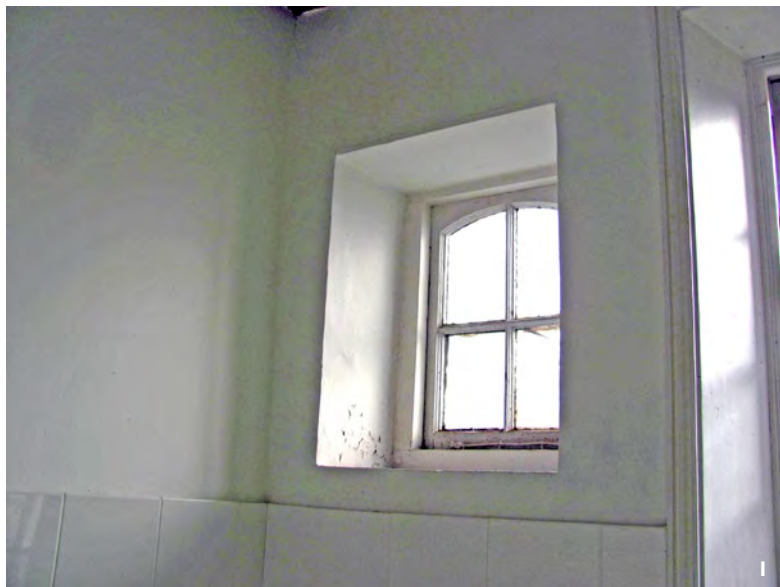
- 1 Peeling paint to casement window reveal
- 2 Missing glass pane in sash window
- 3 Quirk
- 4 Door
