Norfolk Partnership Laboratory

**Desk Study and Risk Assessment,
Deal Ground and Former May Gurney Site,
Trowse, Norwich,
Norfolk,
104182
April 2023**

Client:
Serruys Property Co Ltd
SPC House
Norwich Road
Lenwade
Norwich
NR9 5SN

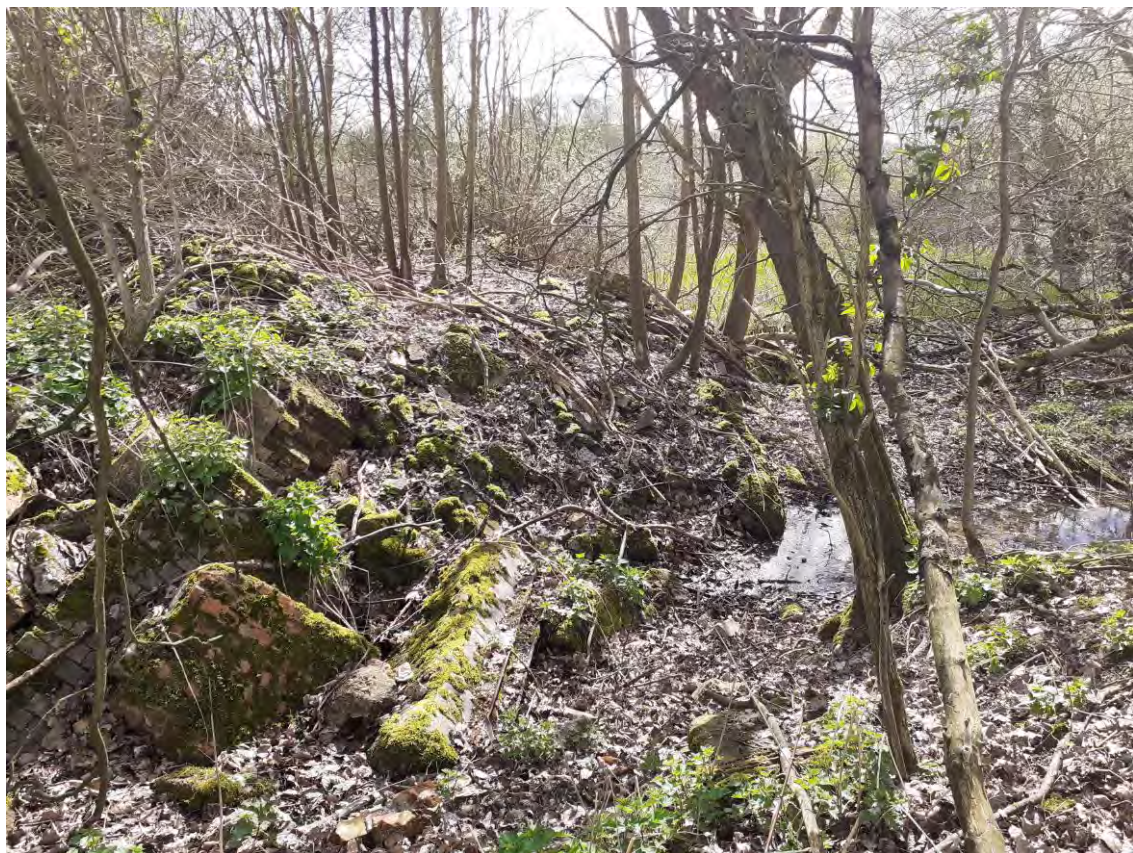
Photograph 6 : Made Ground on land between the access road and the fenland.

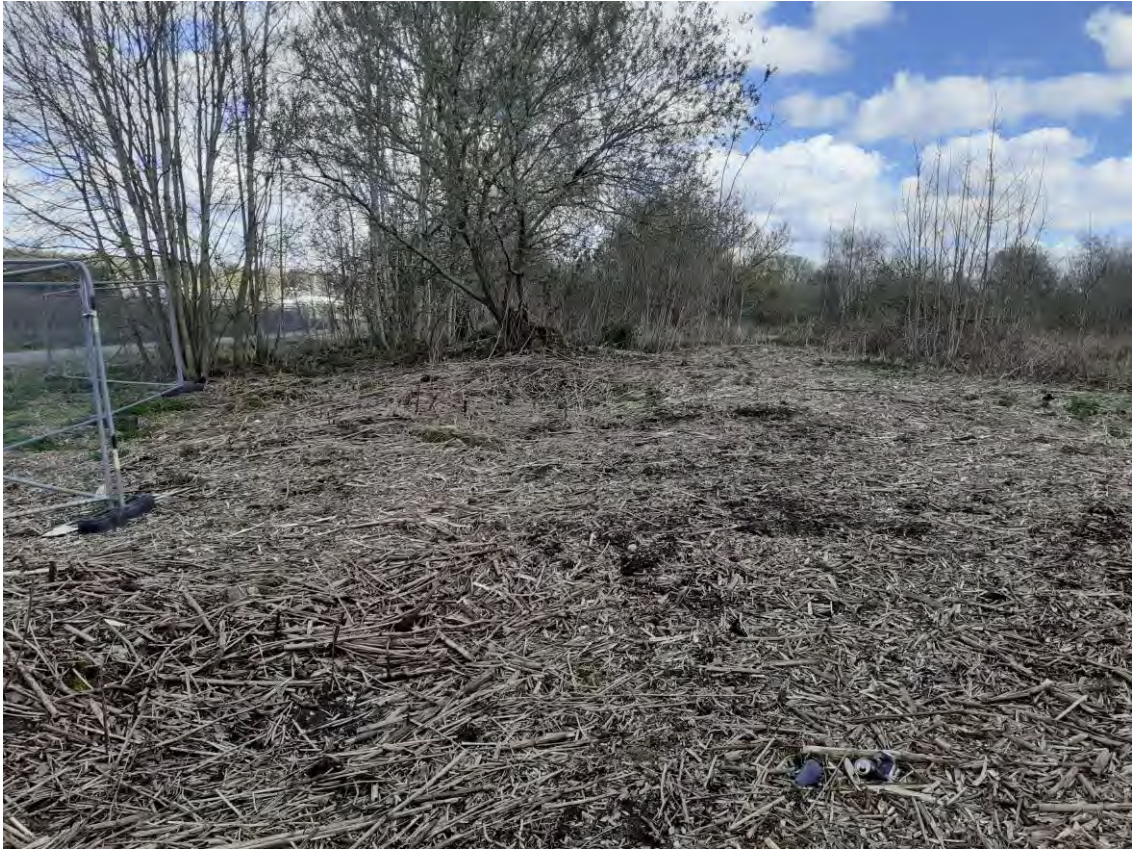
Photograph 7 : Treated area of Japanese Knotweed.

An area of Japanese Knotweed is present on the site. It is recommended that an action plan to eradicate this invasive weed is put in place prior to the current years seeding.

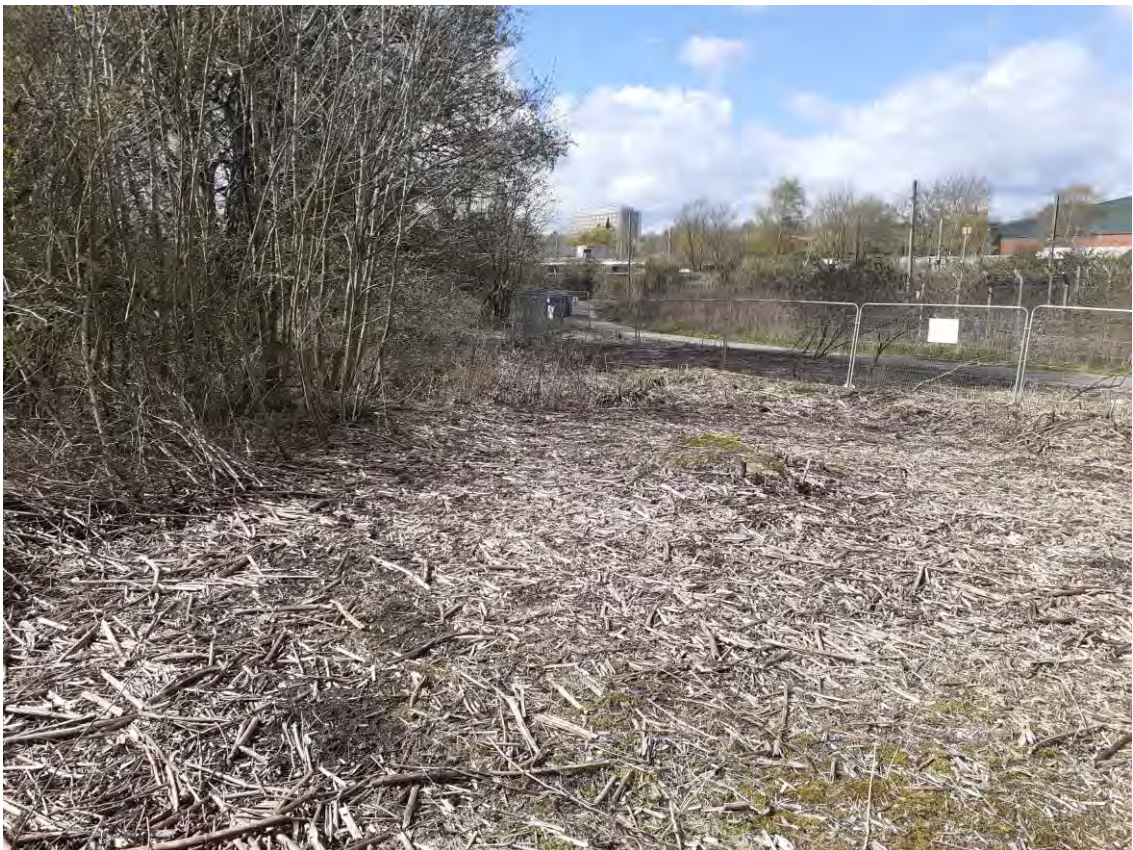
Photograph 8 : Treated area of Japanese Knotweed.

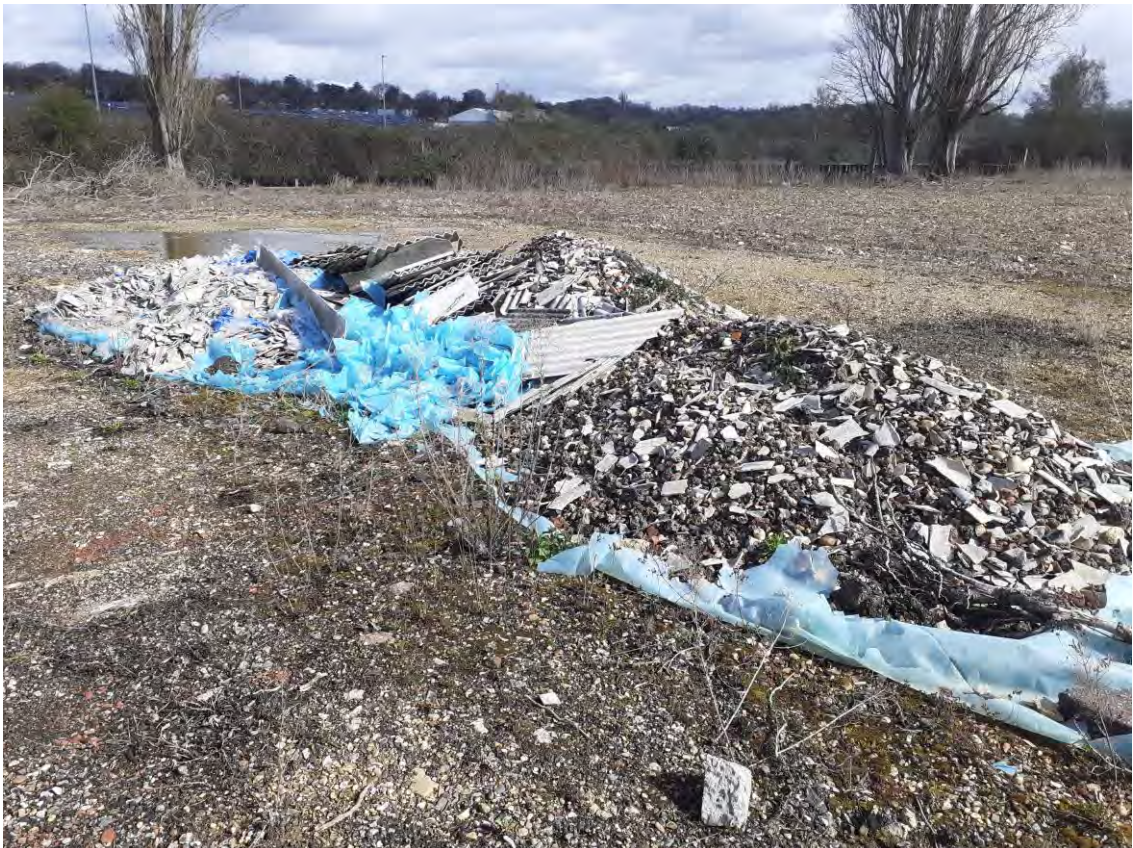
Photograph 10: North western portion of the site with cement board sheets and fragments.

It is recommended that all potential asbestos containing material (ACM) should be removed by a suitably licensed contractor and disposed of to a suitably licensed facility. Consignment notes for any removed asbestos and documentation stating that all asbestos has been disposed of from the site should be submitted to Norwich City Council. Post removal and remediation it is recommended further surface soil samples are retrieved and tested for the presence of Asbestos.

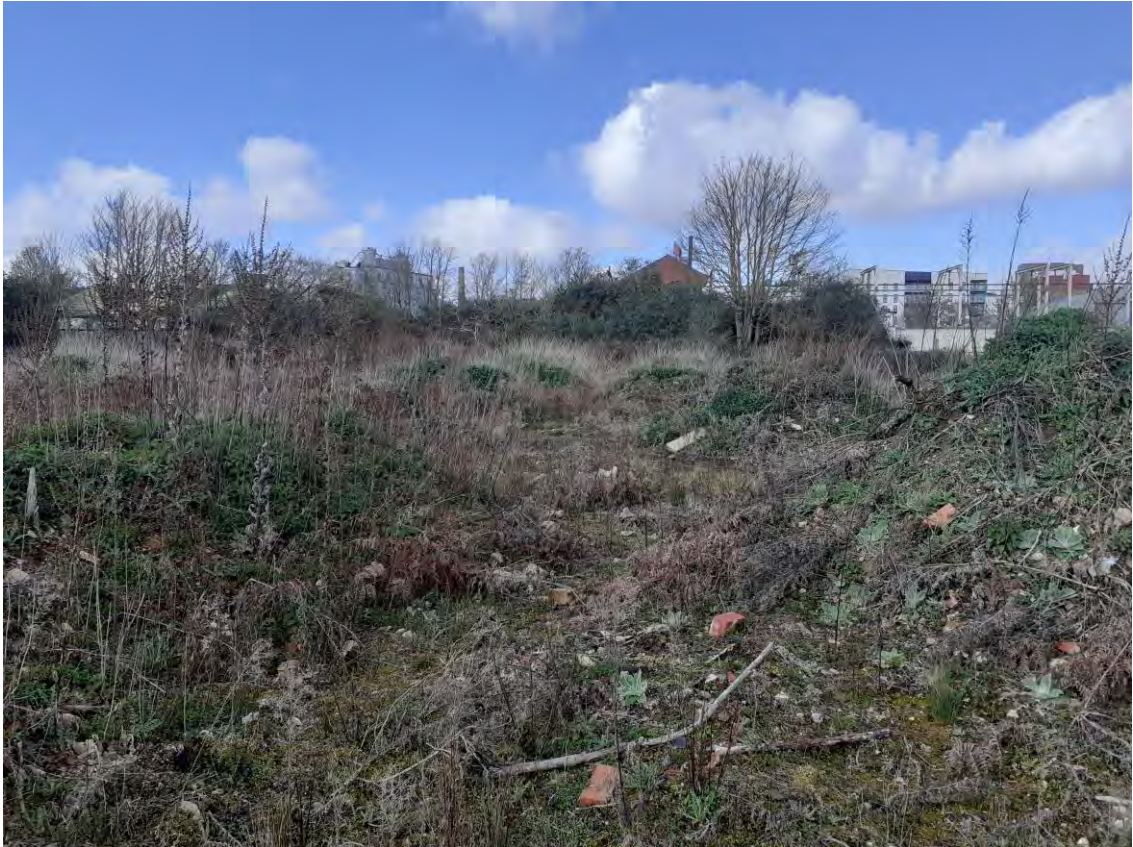
Photograph 11: Spoil heaps on the north west portion of the site.

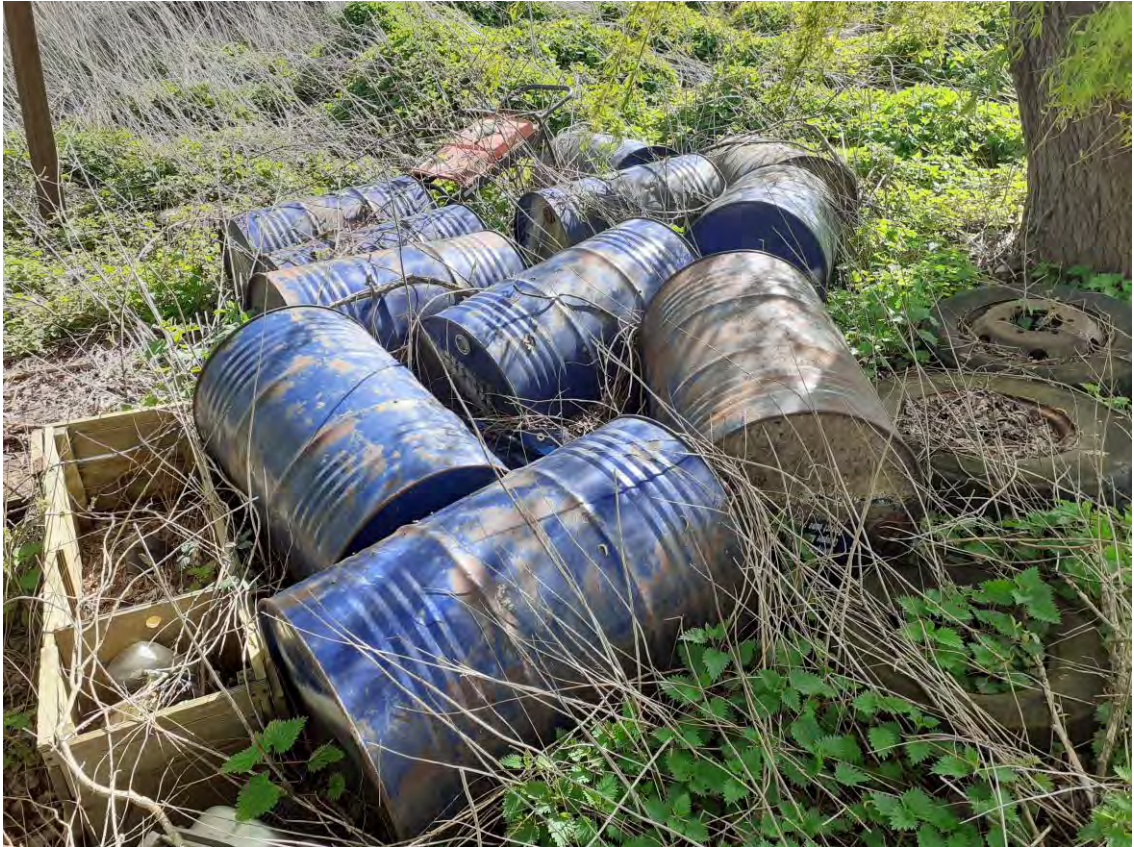
A small number of unidentified blue 45 gallon drums, tyres and an engine part were present adjacent to the river towards the north eastern corner of the site. This could have been a abandoned raft due to its proximity to the river.

Photograph 13 : Unidentified barrels, and tyres

These are thought to represent a High Risk (considered probable about 50% chance) to some receptors via a surface soil linkage and a Medium Risk (considered possible but unusual) to some receptors via a subsurface soil linkage. Once removed it is recommended the surface and subsurface soils in this area are appropriately tested for any residual contents and remediated accordingly.

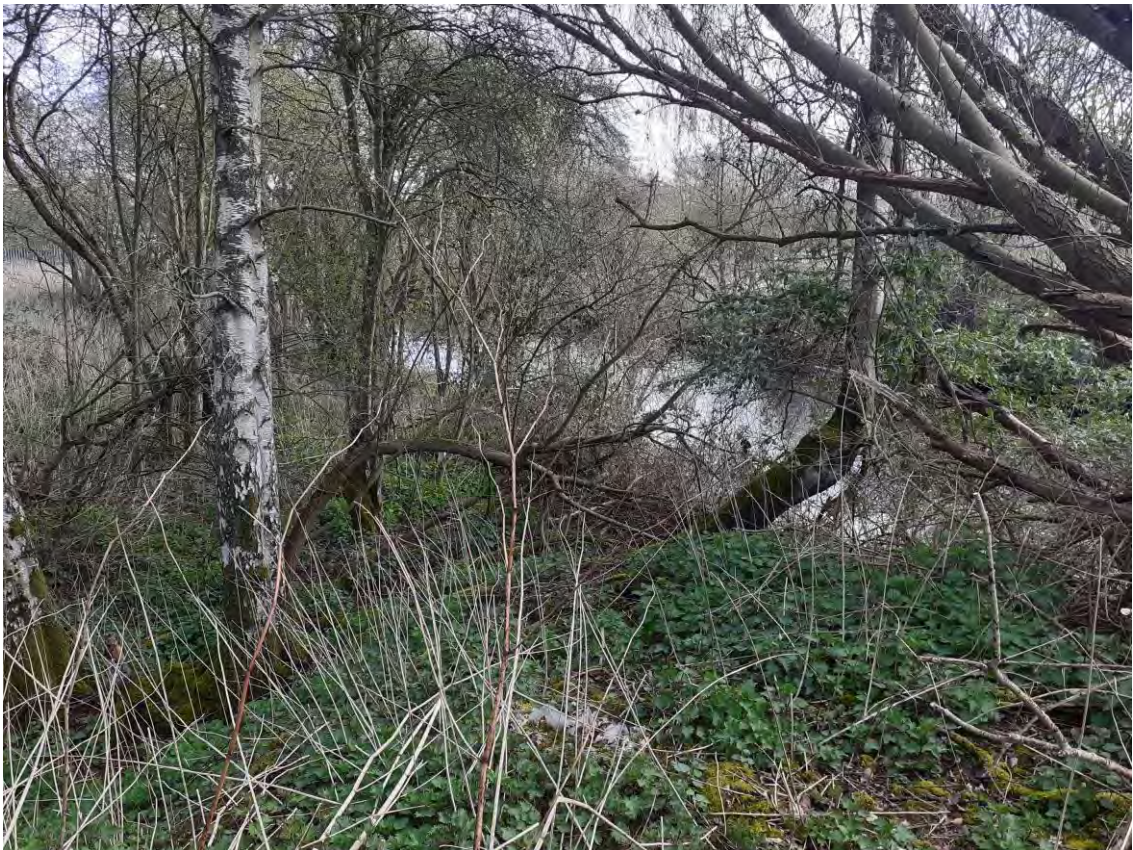
Photograph 16 : Potential made ground strip close to the River Yare.

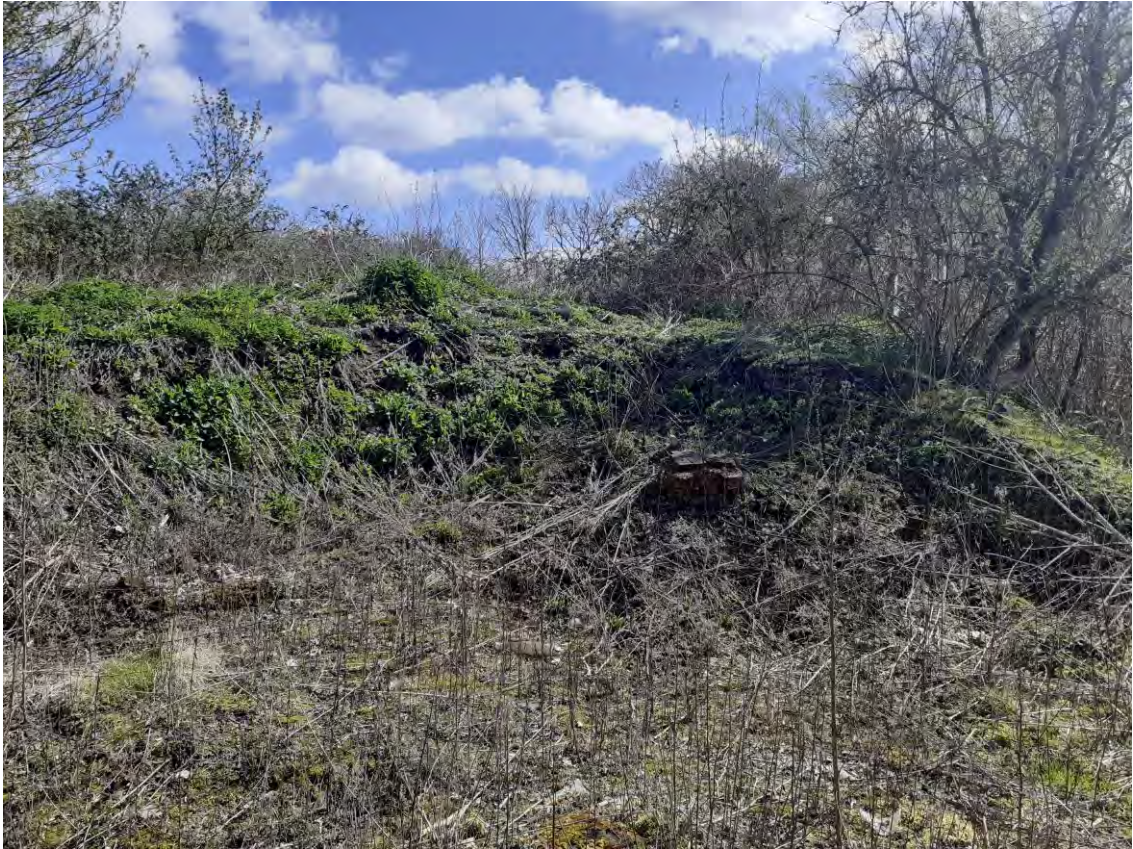
Photograph 17 : Potential made ground strip close to the River Yare.

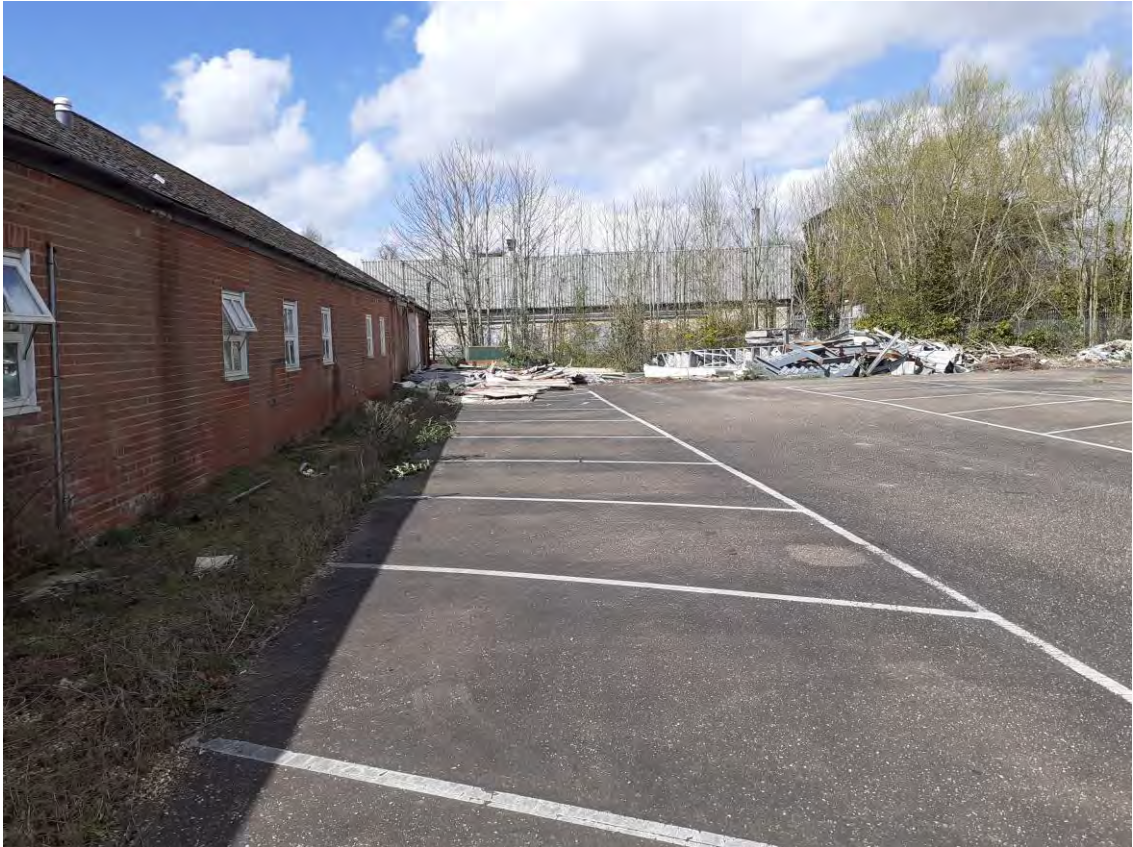
Photograph 20: Heating oil tank and scrap to the north of the buildings in the south west corner.

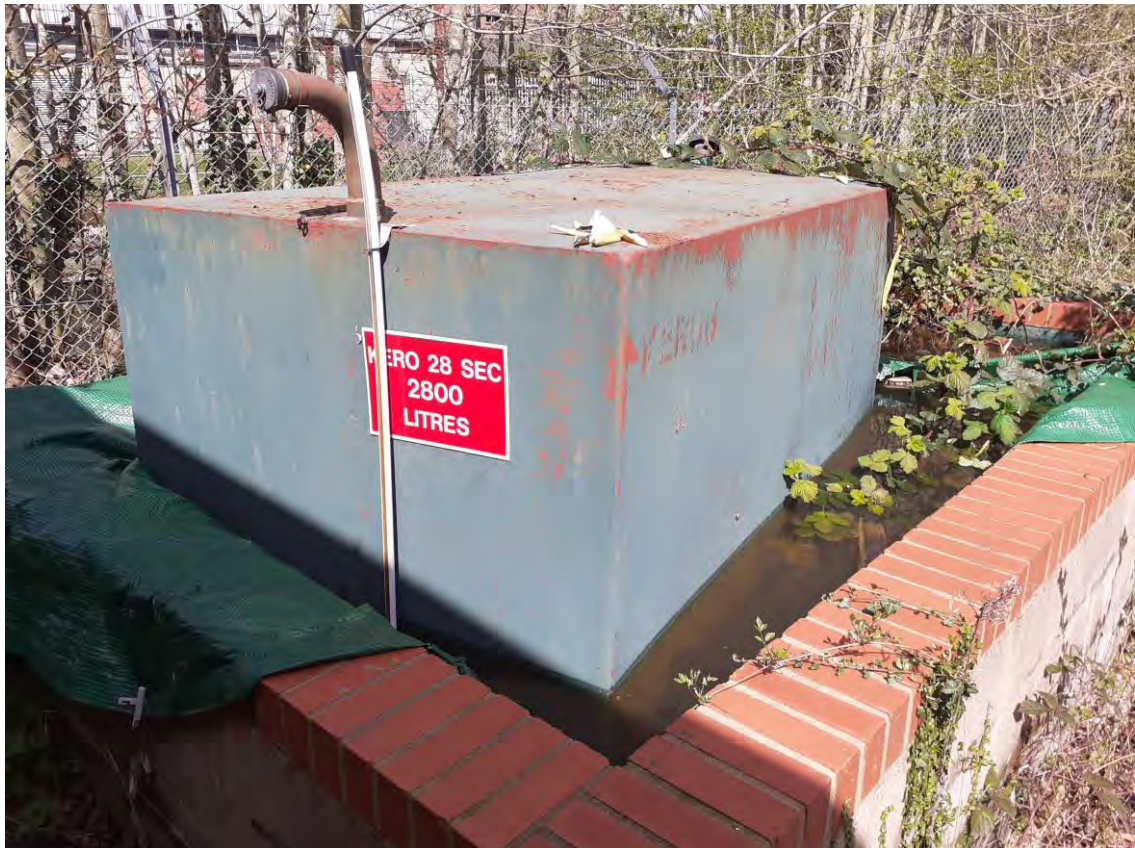
Photograph 21: Heating oil tank with bund full of water.

An empty heating oil tank was present to the rear of the office building located in a brick bund (photograph 21). No leaks were evident from the bund as it was retaining rain water.

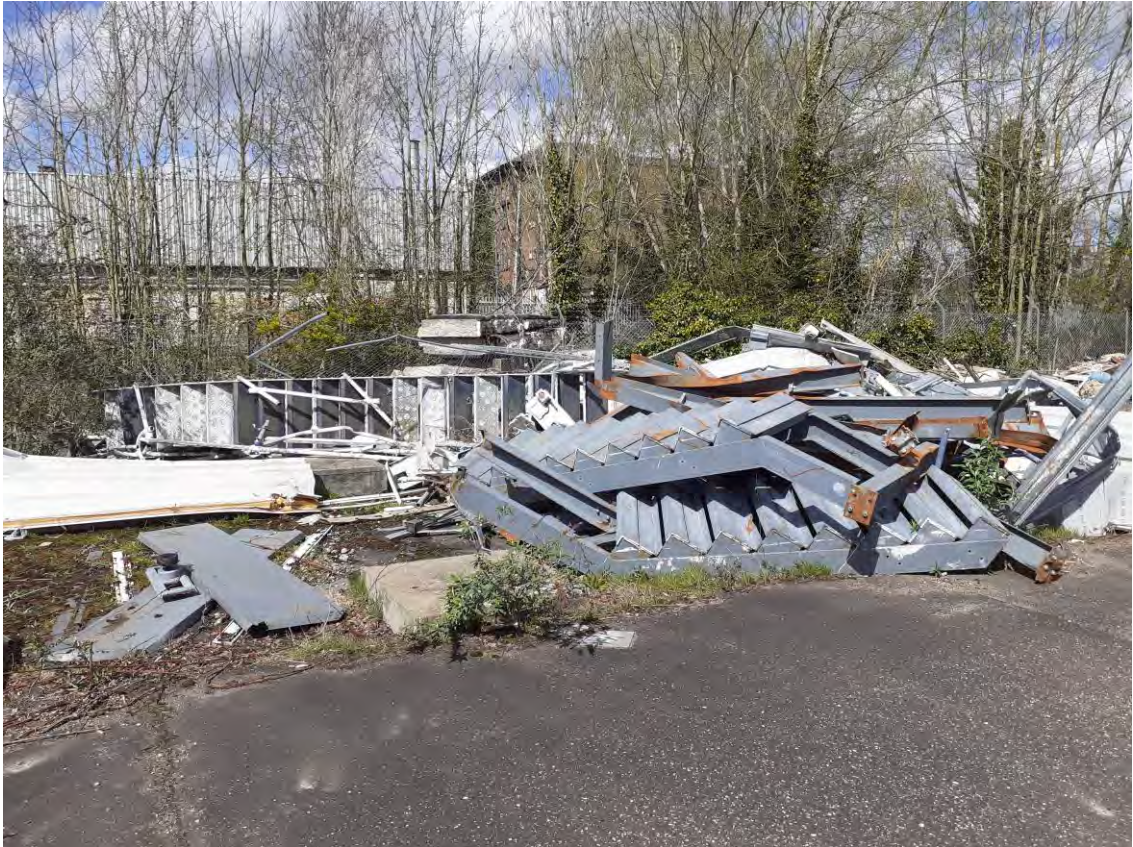
Photograph 22: Scrap metal close to the western boundary.

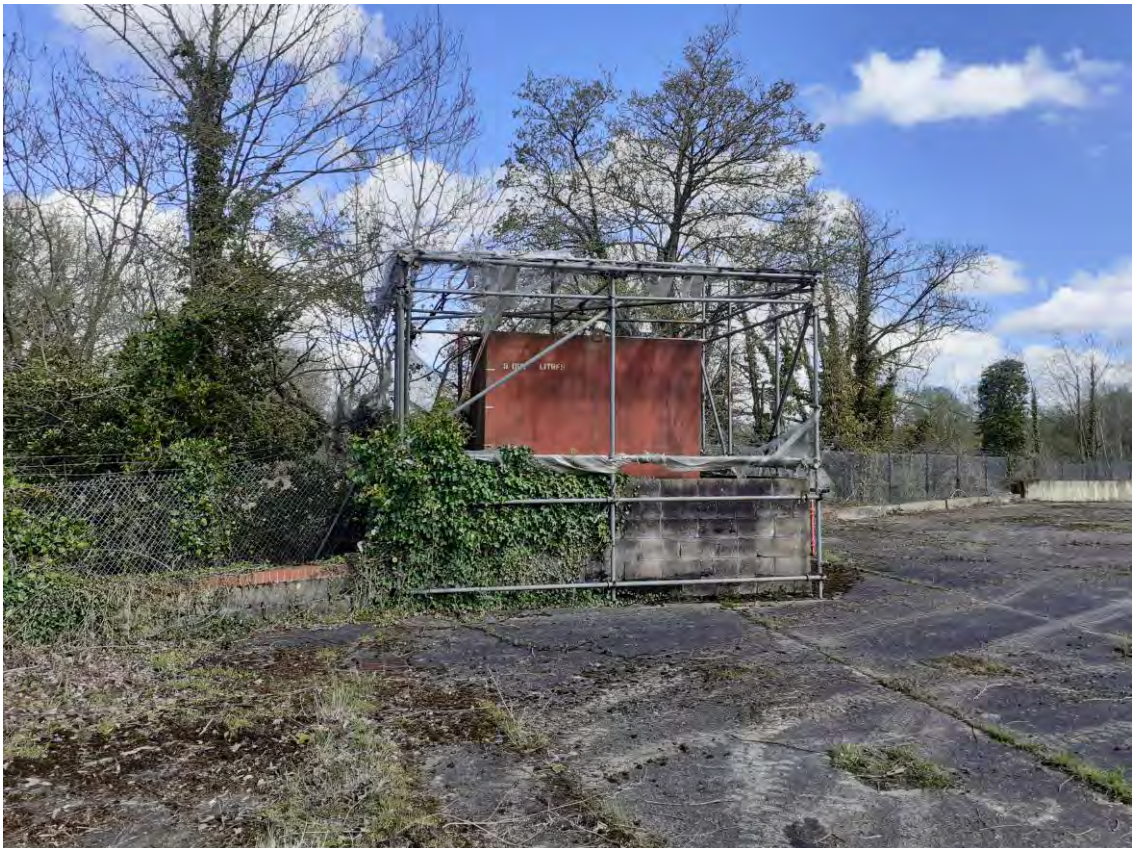
Photograph 27: 9000 litre bunded fuel tank

Two large diesel tanks are present close to the northern site boundary on the west side of the site (photographs 27 and 28). Both tanks appeared in good condition and are located within brick bunds with intact bases. No evidence of staining was seen around the tanks.

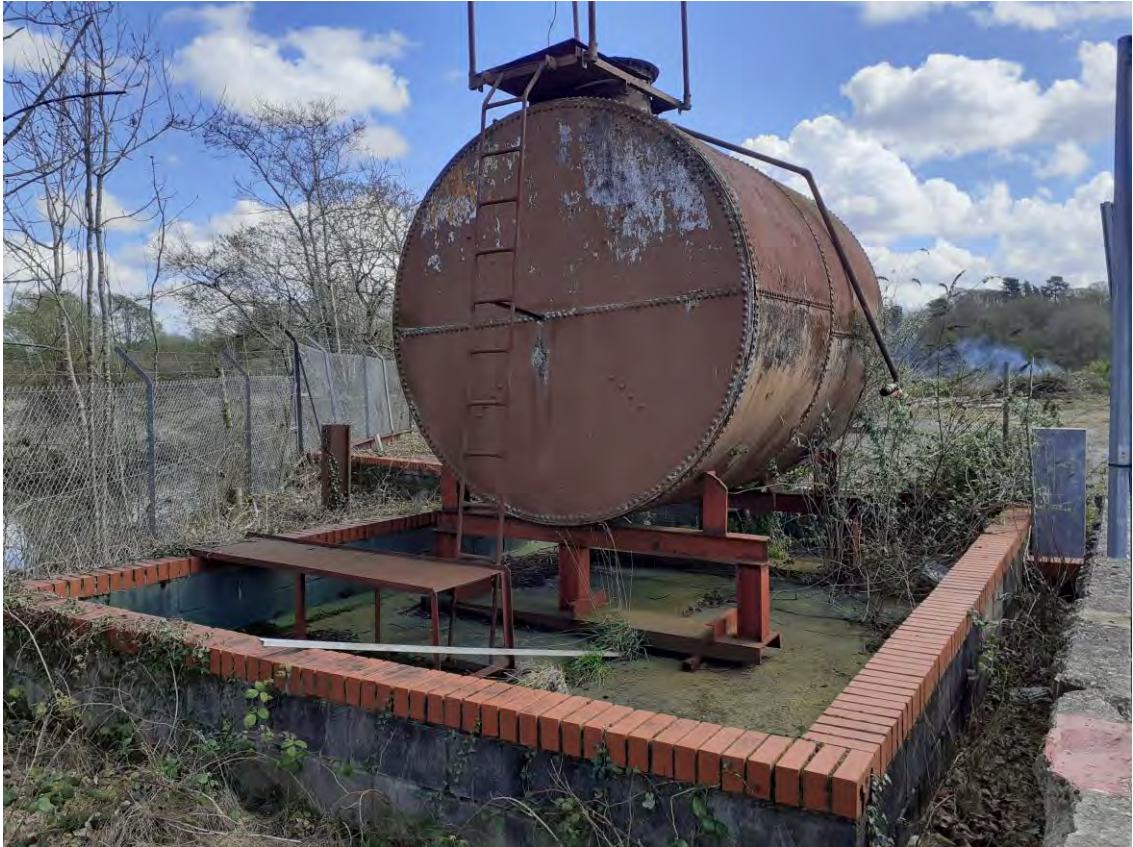
Photograph 28: 10000 litre bunded fuel tank close to northern boundary
