# Anglia Square, Norwich

## Archaeological Impact Assessment

# ARCHAEOLOGICAL IMPACT ASSESSMENT

JAC27722  
Anglia Square,  
Norwich  
Version 02  
(Revision 2022)

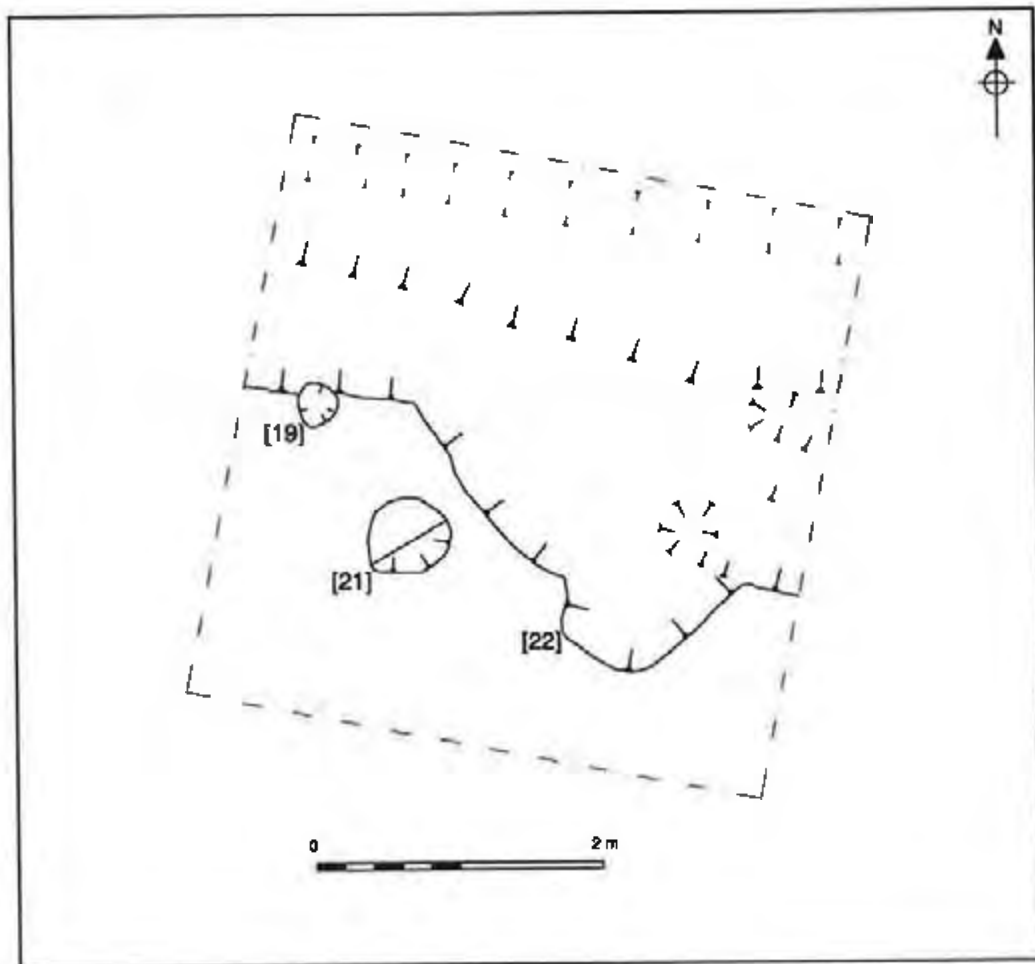
Undisturbed orange-coloured sands [08] were found at the relatively shallow depth of 1.1–1.7m across Trench 1.

Figure 2. Plan of Trench 1. Scale 1:50

The earliest features identified were a series of east-west aligned furrows, [22], which were cut into the sands on the north side of the trench. They were cut in a stepped pattern (Plate 1), each furrow being slightly deeper than the last, and, judging by their size and form, were probably spade-dug. This suggests the area around Trench 1 was used as a garden. Two further features cut into the natural, [19] and [21], small pits 0.3m and 0.6m in diameter and 0.2m deep, were probably contemporary with this horticultural activity and represent deeper planting of taller plants or trees. The fills of these features were very similar to that of the furrows – a rich and soft dark brown, garden soil type deposit ([05],) which was almost a metre deep in places and filled not only the furrows ([22]) but also overlay the rest of the trench. This deposit contained a range of pottery dated to the 16th century as well as residual sherds dated to the Late Saxon and early medieval periods. The depth of [05] suggests systematic manuring and perhaps the importation of topsoil/garden soil from elsewhere. A small patch of crushed mortar, [06], was seen at the base of the garden soil [05]. An uneven and patchy layer of soft brown silt and orange sand, [07], occurred in places between deposit [05] and the 'natural' sands [08]. This layer had the characteristics of subsoil and showed evidence of root disturbance, further confirming the horticultural nature of the lower deposits recorded in Trench 1.

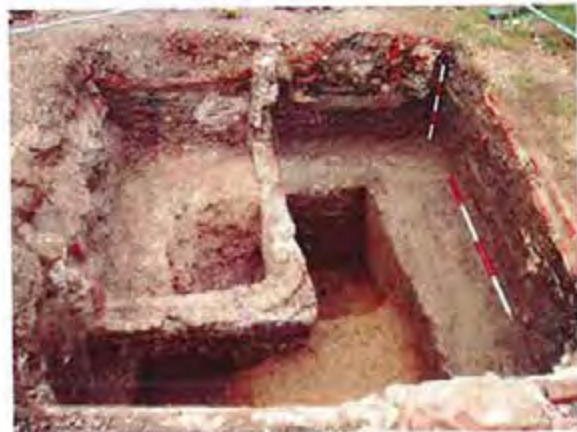
Three walls of a cellar of unusual form and appearance were exposed within Trench 2. It is likely that this structure was built in the second half of the 19th century. The northern and southern walls and the very base of the eastern wall were all neatly constructed from reused red brick, flint and limestone (and given the context number [252]). The north-western corner was interesting in that it had a curved interior face (Plate 3). This

curve was also apparent on the exterior of the wall directly beneath its junction with the ceiling, [248], which was vaulted and composed entirely of soft 'Norfolk Red' type bricks, in common use in the Victorian era. The floor, [272], was also of red brick. The eastern wall, [235], which was mostly of flint, was more roughly constructed than the rest, employing a lot more mortar and only occasional brick. Its inner surface was rendered to blend in with the others, but the difference in its construction, along with the mismatched foundation (which was

Plate 3 Looking south at curved wall [252] of Victorian cellar in Trench 2

part of [248]), suggests that it was built after completion of the vaulted ceiling, perhaps initially being left open with only temporary props on top of the foundations, to allow access for work on the ceiling.

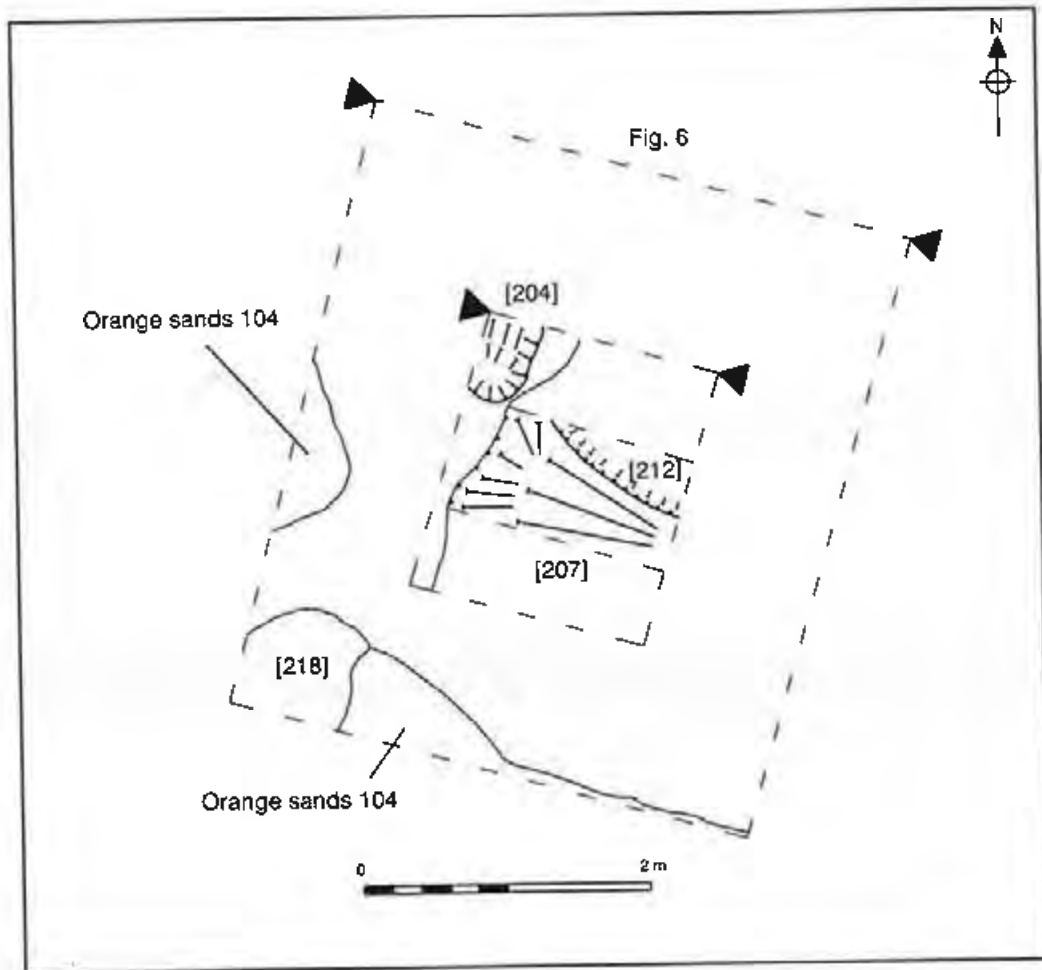
The edges of these features were later clipped by another quarry pit – [204] – less deep than the first two and filled with silt rather than domestic waste. Above this were several mounded layers of silt and garden soils, containing patches of crushed mortar and building rubble. The appearance of part of this sequence of deposits suggests that these were deliberately dumped, having been brought in from elsewhere. Two elements within this sequence of deposits ([119] and [227],) contained pottery dated to the 15th to 16th centuries.

The nature of the deposits which sealed the early post-medieval quarry pits suggests that the area of Trench 3 was used as a yard or garden throughout the post-medieval period. The 1885 Ordnance Survey 1:500 plan clearly shows the area around Trench 3 and to the north of it as a garden. All of the earlier cartographic sources (see Hutcheson and Penn 2007 and Frostick 2002) indicate

Figure 5. Plan of Trench 3. Scale 1:50

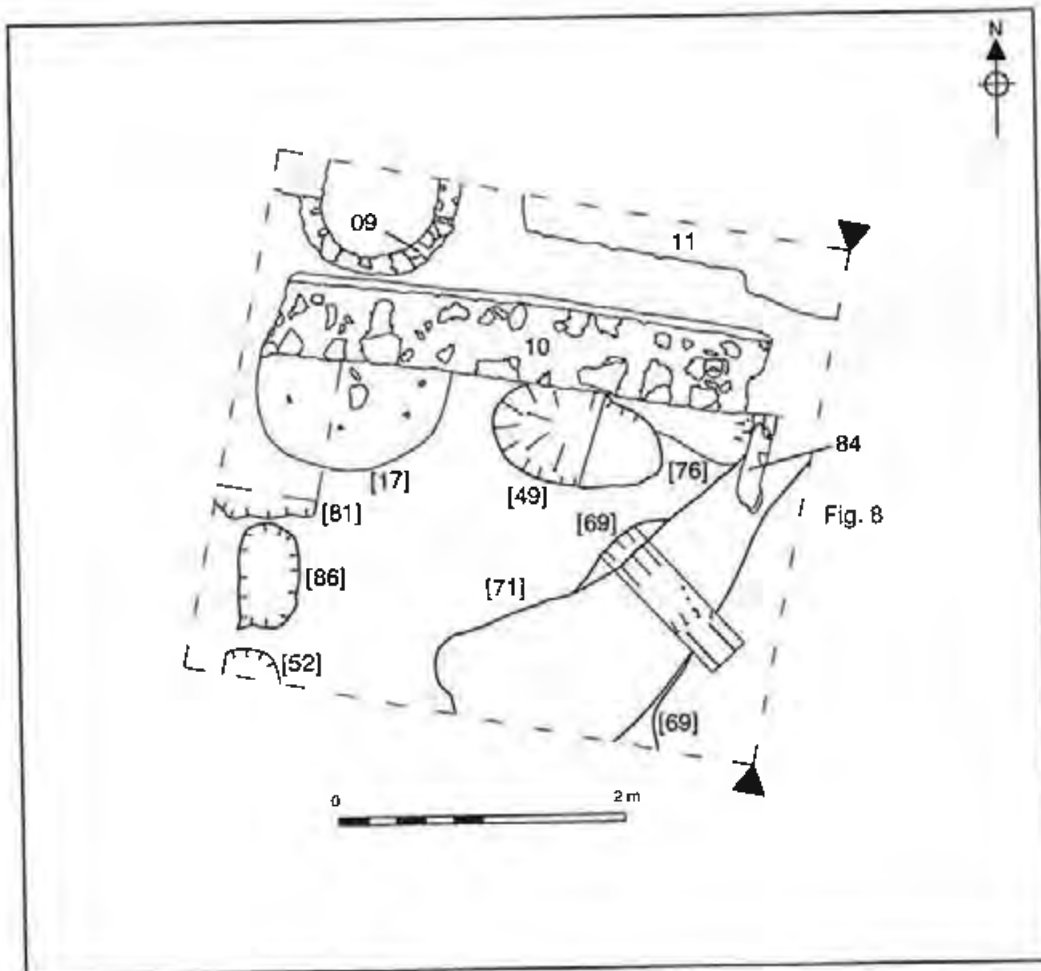
Towards the south-west corner of the trench, the subsoil like layers were cut by a sequence of pits, the earliest of which, [52], was overlain by another: [86]. One of the fills of pit [86], context [88], contained pottery dated to the 11th to 13th centuries. Pit [86] was in turn cut by another pit, [81]=[53]. This feature yielded pottery from three of its fills that was dated to the 12th to 13th centuries. A single, more isolated pit, [49], was located towards the centre of the trench. The upper fill of this pit, context [50], contained pottery dated to the 11th to 14th centuries.

Possibly contemporary with the latest of these pits was a fragmentary, banded clay floor surface (recorded with context numbers [192], [193], [194], [195], [196], [197], [198] [199] and [200], not illustrated). The upper surface of the floor was burnt, suggesting the presence of a hearth. As there were no contemporary walls or structural features immediately adjacent to this hearth, it may have been a central fireplace, within a domestic building fronting onto St. George's Street – but no structural evidence of the building was recorded. Given the probable date of the hearth, the building may well have been of timber and left relatively scant remains that were obliterated or masked by later walls and other features.

Figure 7. Plan of Trench 4. Scale 1:50

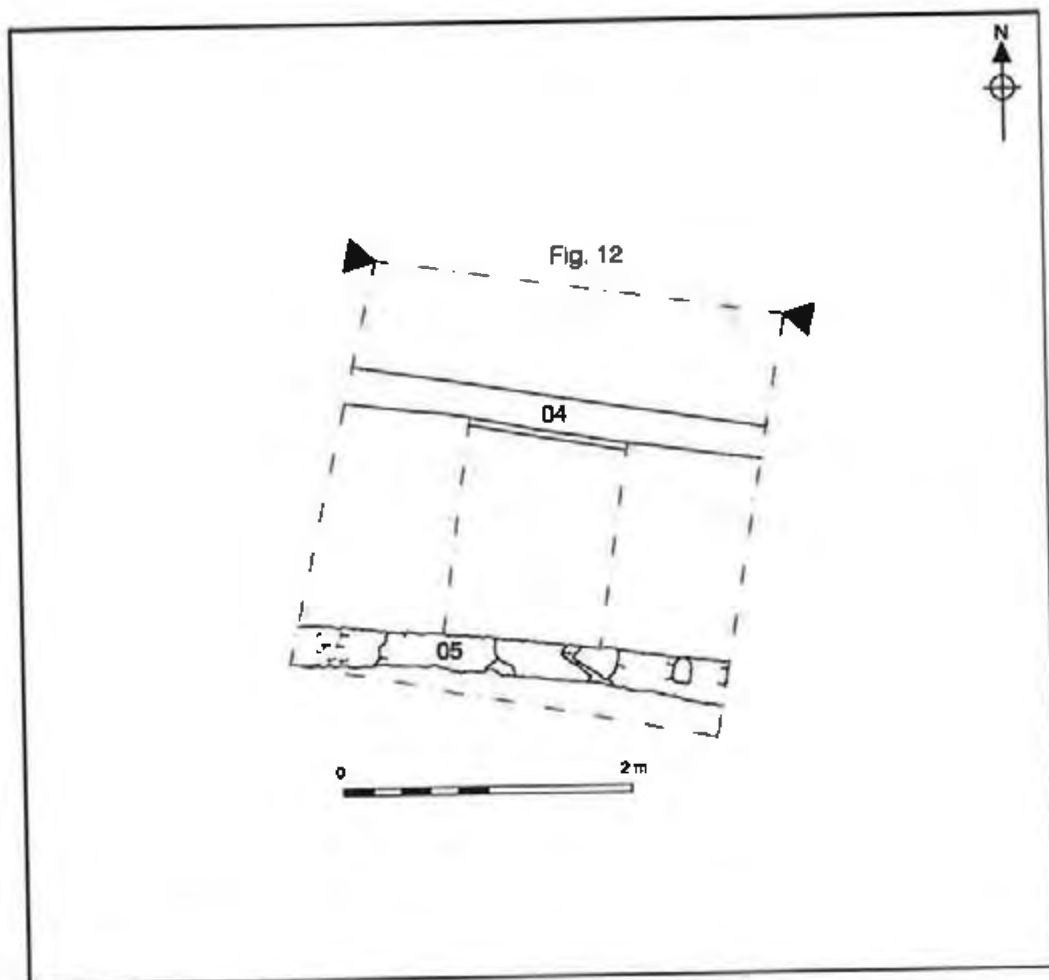
The uppermost of the sandy ditch fills, [38]=[27], was cut by [77]: a small, shallow ditch following the same line of orientation as the Late Saxon defence. This feature contained fills similar to those of the Saxon ditch, with an initial layer of mid-brown sandy silt ([75]) in its base, topped by an upper fill of light brown sandy silt ([26]). It was possibly a boundary or roadside ditch of medieval date. Very little of this

Figure 13. Plan of Trench 6 Phase 3. Scale 1:50

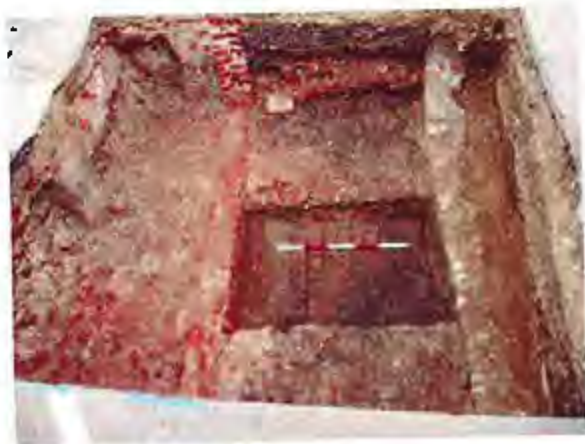
A flint and mortar-walled cellar (cut [43], wall [05]) of probable post-medieval date had heavily truncated almost all of the above deposits, down to the layer below [38]=[27]. The cellar had a floor of flattish, red bricks, edged by square tiles of a yellow fabric on the north side, where it was cut by a later wall (Plate 6). The floor [03] was situated 40-70mm below the base of the post-medieval wall [05] (the variation is due to the wall having an uneven base,) and was probably a replacement floor of 19th century date, set at a lower level than the original. Both wall [05] and floor [03] were coated in a thin layer of coal dust. Although coal was probably imported into Norwich during the medieval and post-medieval periods, its use is unlikely to have become ubiquitous until the arrival of the railways in the mid 19th century

As mentioned above, floor surface [03] was truncated on its northern side by an east-west-running wall of red brick: [04]. This was the southern wall of a cellar of Victorian or Edwardian date, floored with yellow bricks laid in a regular pattern. This later cellar was filled in with brick rubble [11], probably from demolition of the building to which it belonged. The post-Medieval cellar also contained some heavy brick and flint rubble ([17,]) but was mainly filled with layers of silt mixed with small

Plate 6 Looking east at the post-medieval and Victorian cellars in Trench 6

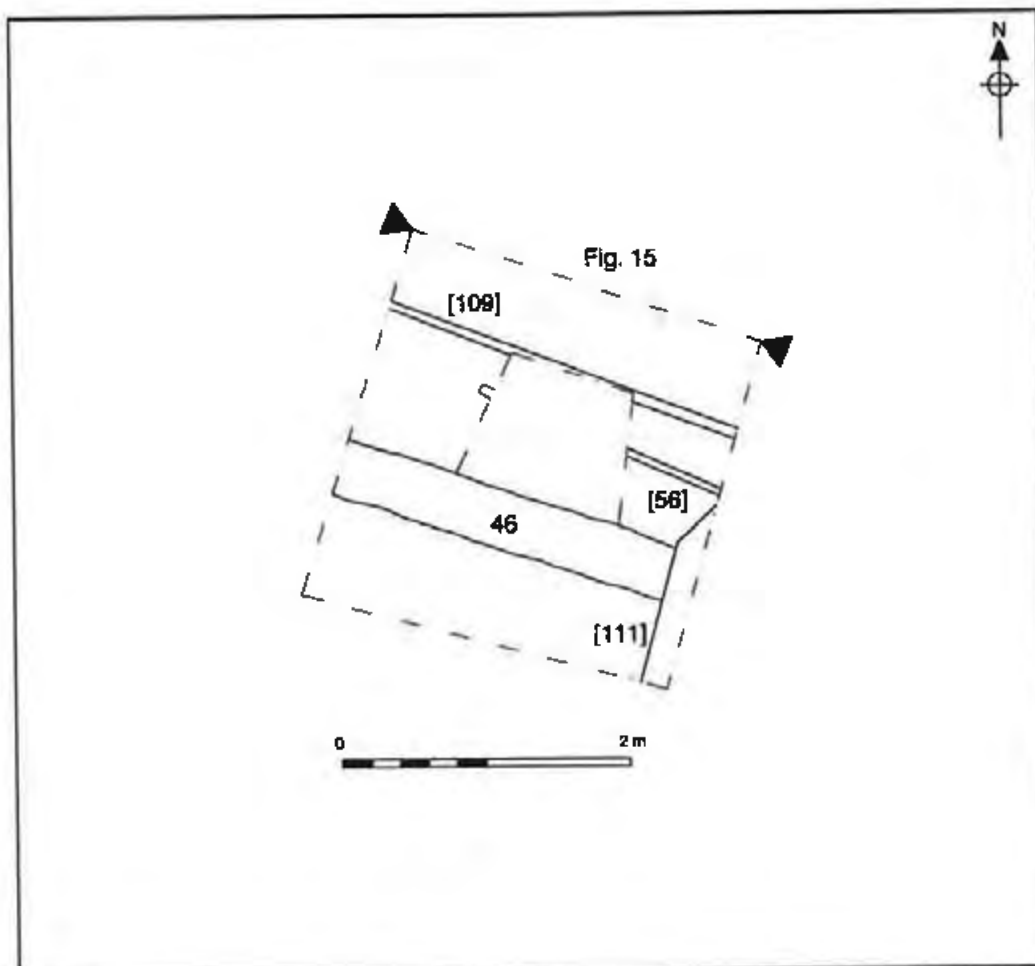
Demolition rubble, [89], on the outer side of wall [46], was interpreted as dating from a Victorian phase of demolition and rebuilding. Wall [46] was capped in at least one place by a distinctly Victorian rebuild or repair, [82], made

Figure 16. Plan of Trench 7 Phase 3. Scale 1:50

of soft red bricks; layer [89] may relate to this phase of repair. The inside of the building demarcated by wall [46] was filled with modern brick rubble, [81], from more recent demolition of a Victorian building, probably in c. 1966 to 1967. A deliberate make-up layer ([80],) had been laid on top of the rubble and an asphalt surface ([79]) on top of that. At some stage, the asphalt and the remains of the Victorian building beneath were partially removed and new make-up and asphalt layers were laid down. A temporary gravel surface ([90],) succeeded this phase, and a modern (imported,) sandy topsoil ([83],) was later laid on top of that.

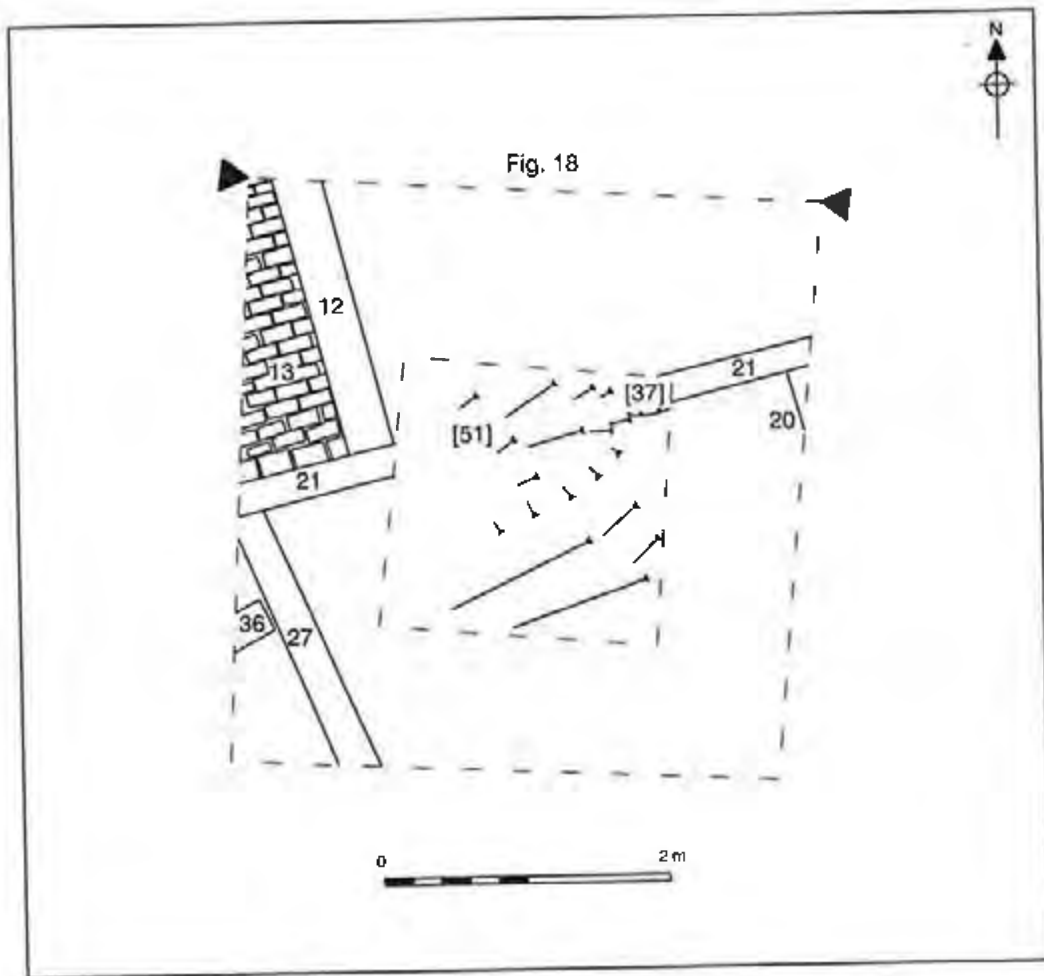
Figure 17. Plan of Trench 12. Scale 1:50

the general level of the upper horizon of geologically-derived deposits. What are probably backfilled quarry pits, similar to those found in Trench 12, were recorded in Window Samples 5, 7 and 9. The depth of these quarry pits varied from 2.2m to 3.6m below the modern ground surface.

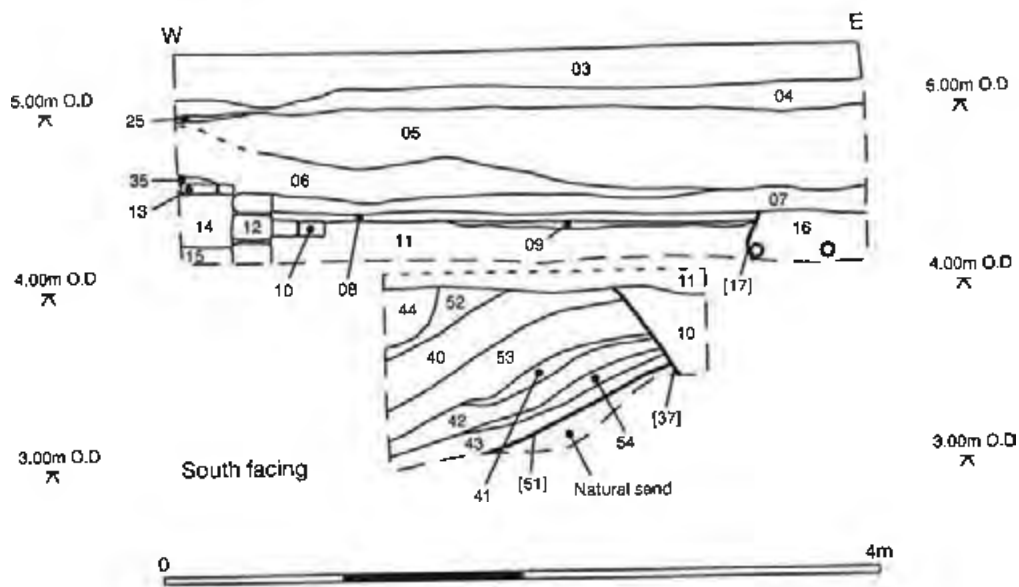
Figure 18. Trench 12, sections. Scale 1:40

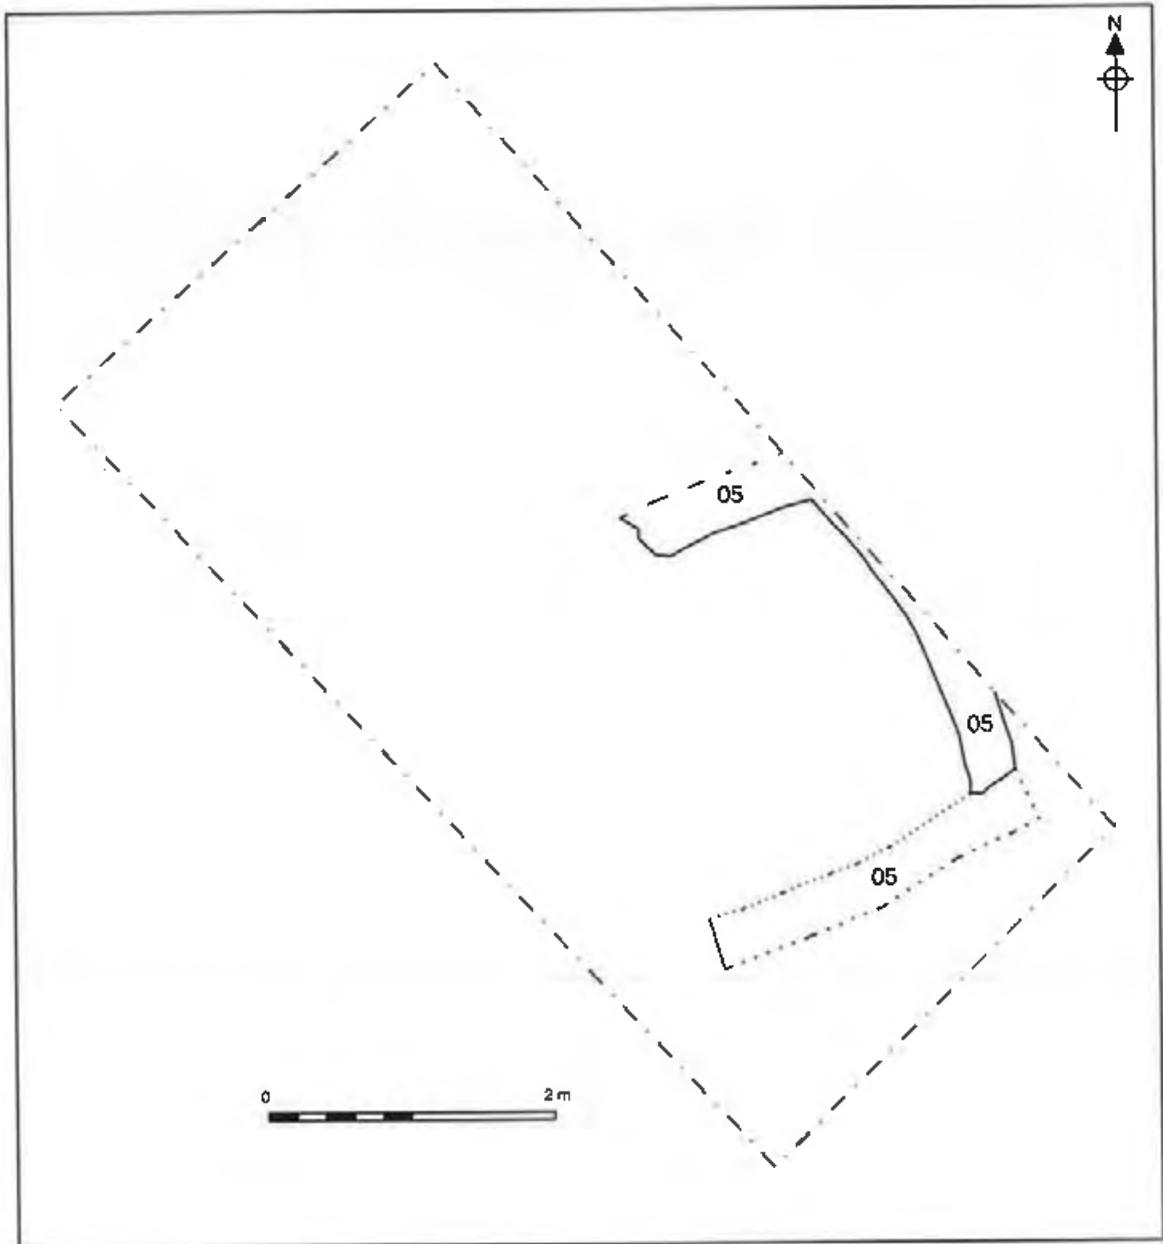
Figure 19. Plan of Trench 13. Scale 1:50

[04],) which contained many large fragments of concrete and steel pipe (Plate 12) as well as other debris such as brick rubble and reinforcing rods; this material was overlain by about 0.4m of yellowish sand and gravel hoggin, topped by a thick, if somewhat fragmentary, asphalt surface. The lowest elements of deposits [03] and [04] smelt strongly of diesel and were undoubtedly heavily contaminated with hydro-carbons. The concrete structures had at some stage almost certainly contained fuel tanks of some sort.
