APPENDIX 1.1: LOCATION OF SPECIFIED INFORMATION IN THE ES

Specified Information in Part 1 of the EIA Regulations		Location within ES
4(2)	The EIA must identify, describe and assess in an appropriate manner, in light of each individual case, the direct and indirect significant effects of the proposed development on the following factors—	
4(2)(a)	Population and human health	Population assessment provided within Chapter 4: Socio-Economics
4(2)(b)	biodiversity, with particular attention to species and habitats protected under Directive 92/43/EEC and Directive 2009/147/EC .	Chapter 6: Ecology
4(2)(c)	land, soil, water, air and climate.	Climate has been scoped out of the EIA with agreement from NCC (Appendix 1.4 Scoping Opinion). Assessment of air quality is included as Chapter 8. Assessment of Flooding, Drainage and Water Environment has been scoped out of the EIA with agreement from NCC. Assessment of land (ground conditions) has been scoped out of the EIA with agreement from NCC.

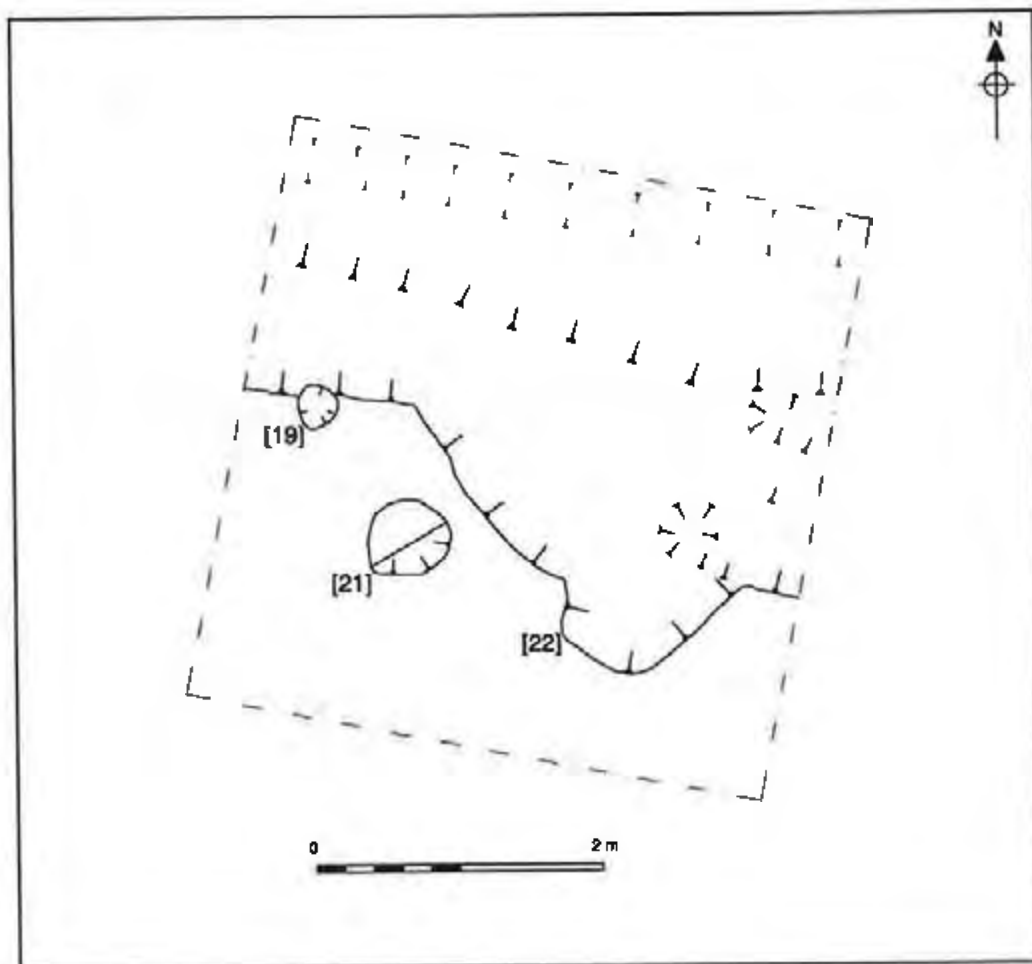
Figure 2. Plan of Trench 1. Scale 1:50

The earliest features identified were a series of east-west aligned furrows, [22], which were cut into the sands on the north side of the trench. They were cut in a stepped pattern (Plate 1), each furrow being slightly deeper than the last, and, judging by their size and form, were probably spade-dug. This suggests the area around Trench 1 was used as a garden. Two further features cut into the natural, [19] and [21], small pits 0.3m and 0.6m in diameter and 0.2m deep, were probably contemporary with this horticultural activity and represent deeper planting of taller plants or trees. The fills of these features were very similar to that of the furrows – a rich and soft dark brown, garden soil type deposit ([05],) which was almost a metre deep in places and filled not only the furrows ([22]) but also overlay the rest of the trench. This deposit contained a range of pottery dated to the 16th century as well as residual sherds dated to the Late Saxon and early medieval periods. The depth of [05] suggests systematic manuring and perhaps the importation of topsoil/garden soil from elsewhere. A small patch of crushed mortar, [06], was seen at the base of the garden soil [05]. An uneven and patchy layer of soft brown silt and orange sand, [07], occurred in places between deposit [05] and the 'natural' sands [08]. This layer had the characteristics of subsoil and showed evidence of root disturbance, further confirming the horticultural nature of the lower deposits recorded in Trench 1.

Undisturbed orange-coloured sands [08] were found at the relatively shallow depth of 1.1–1.7m across Trench 1.

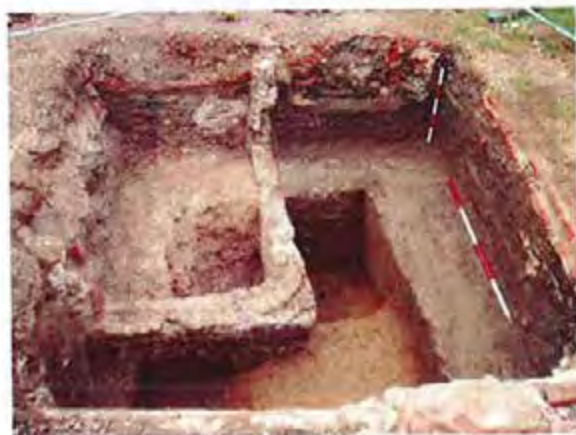
Plate 3 Looking south at curved wall [252] of Victorian cellar in Trench 2

Three walls of a cellar of unusual form and appearance were exposed within Trench 2. It is likely that this structure was built in the second half of the 19th century. The northern and southern walls and the very base of the eastern wall were all neatly constructed from reused red brick, flint and limestone (and given the context number [252]). The north-western corner was interesting in that it had a curved interior face (Plate 3). This

curve was also apparent on the exterior of the wall directly beneath its junction with the ceiling, [248], which was vaulted and composed entirely of soft 'Norfolk Red' type bricks, in common use in the Victorian era. The floor, [272], was also of red brick. The eastern wall, [235], which was mostly of flint, was more roughly constructed than the rest, employing a lot more mortar and only occasional brick. Its inner surface was rendered to blend in with the others, but the difference in its construction, along with the mismatched foundation (which was

part of [248]), suggests that it was built after completion of the vaulted ceiling, perhaps initially being left open with only temporary props on top of the foundations, to allow access for work on the ceiling.

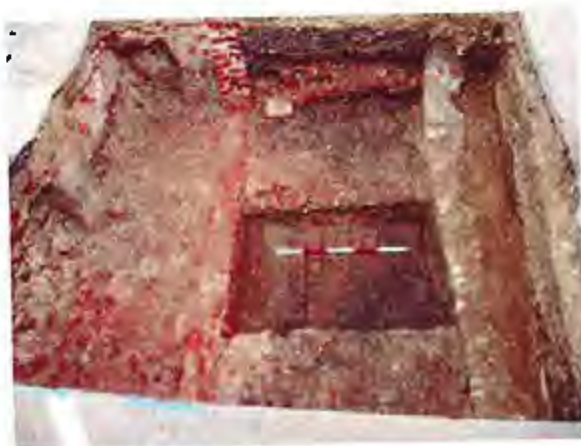
Plate 6 Looking east at the post-medieval and Victorian cellars in Trench 6

A flint and mortar-walled cellar (cut [43], wall [05]) of probable post-medieval date had heavily truncated almost all of the above deposits, down to the layer below [38]=[27]. The cellar had a floor of flattish, red bricks, edged by square tiles of a yellow fabric on the north side, where it was cut by a later wall (Plate 6). The floor [03] was situated 40-70mm below the base of the post-medieval wall [05] (the variation is due to the wall having an uneven base,) and was probably a replacement floor of 19th century date, set at a lower level than the original. Both wall [05] and floor [03] were coated in a thin layer of coal dust. Although coal was probably imported into Norwich during the medieval and post-medieval periods, its use is unlikely to have become ubiquitous until the arrival of the railways in the mid 19th century

As mentioned above, floor surface [03] was truncated on its northern side by an east-west-running wall of red brick: [04]. This was the southern wall of a cellar of Victorian or Edwardian date, floored with yellow bricks laid in a regular pattern. This later cellar was filled in with brick rubble [11], probably from demolition of the building to which it belonged. The post-Medieval cellar also contained some heavy brick and flint rubble ([17],) but was mainly filled with layers of silt mixed with small

amounts of rubble (contexts [01], [02], [12], [13], [14], [17], [18], [28], [29] [30] [31], and 41)). It appears to have been filled in after construction of the Victorian/Edwardian cellar as the fills do not appear to have been cut by the foundation trench for the later cellar wall. Both cellars were almost certainly connected with the Crown and Anchor public house (see below). This and other buildings on the eastern side of St George's Street were demolished in around 1966 or 1967, to make way for Sovereign House. The land immediately west of Sovereign House, between it and the road, was then levelled (with layers [15] and [21],) and covered in asphalt ([16]) so that it could be used as a car park.

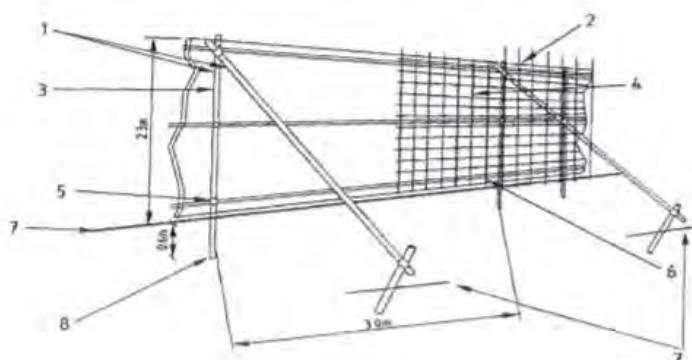
| 1. Standard scaffold poles | 5. Standard clamps |

14.14 An RPZ should be put on all trees where construction will impinge within the crown spread of the canopy. Once erected no storage of any materials inside the area, or any access by site workers permitted within the protected area. The RPZ can be constructed according to BS guidance:
