## Anglia Square, Norwich Contamination Report

# PHASE I DESK STUDY AND PRELIMINARY RISK ASSESSMENT Anglia Square, Norwich, NR3 1DT

CON01-NORW-045

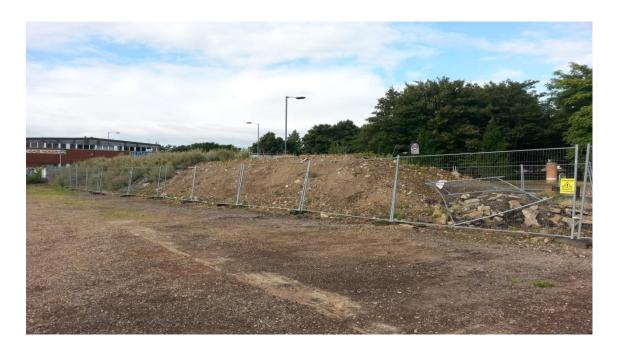
Stockpile in West of the Site

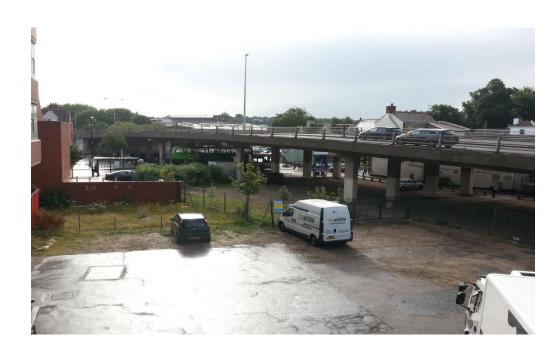
St Crispin's Road Flyover
