Anglia Square, Norwich Contamination Report REV A

PHASE I DESK STUDY AND PRELIMINARY RISK ASSESSMENT Anglia Square, Norwich, NR3 1DT

CON01-NORW-045

Publication Title Phase I Desk Study and Preliminary Risk Assessment

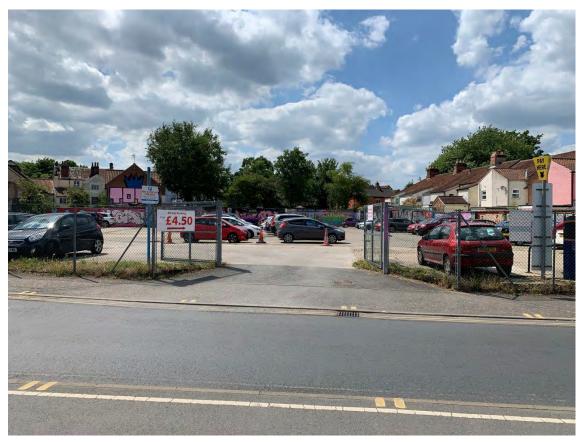
Plate 1

The northwestern and northern car parks (Plates 1 to 3 and 22) are surfaced with concrete slabs which are in poor condition broken in places. No evidence of the former PFS was apparent on the northern car park. An electricity substation was present to the immediate south of the northwestern car park (Plate 3).

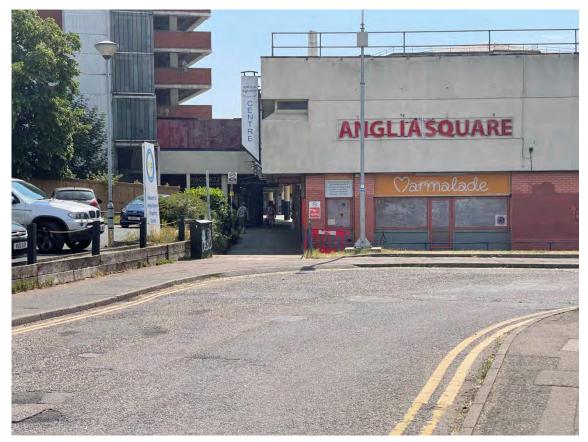
Plate 7

The western part of the main site is predominantly covered in car parking part of which is asphalted (Plate 21). However, the majority is surfaced by hardstanding and poorly maintained concrete slabs (Plates 11 and 17). A heavily vegetated earth bund (which was present in 2016 identified as a waste mound) was present along the western side of the car park (Plates 9 and 10). Botolph Street runs between the car park and Sovereign House (Plates 7, 8 and 12 to 14) with access to delivery bays (Plates 13, 15 and 16).

Access to the Anglia Square Shopping Centre is from Magdalen Street (Plates 26 and 37 to 40) or from the western car park (Plates 5 and 7). Magdalen Street runs to the east of Anglia Square and comprises a number of small retail premises including cafés and a post office (Plates 27, 40 and 41).

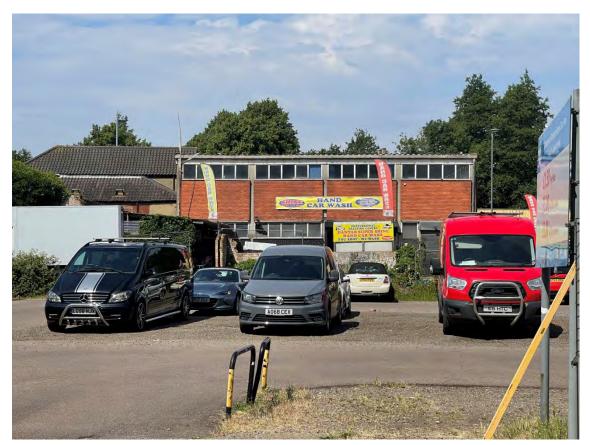
Plate 17

A number of commercial premises are present to the southwest of the site along Pitt Street including a car wash and woodworkers (Plates 17 and 59 to 63). The Surrey Chapel is also present to the southwest with an adjacent electricity substation (Plates 53 to 58).

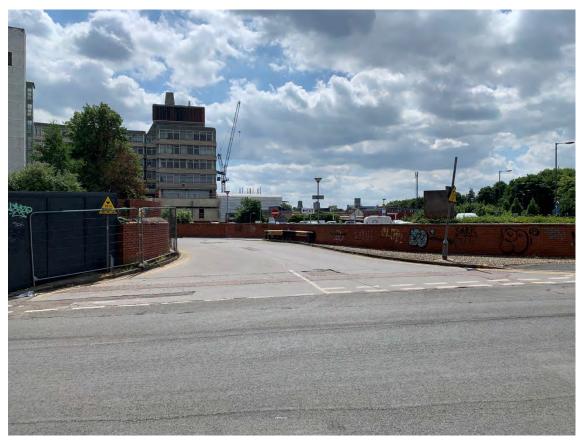
Plate 19

Along Edward Street, to the north, is the access/egress to the derelict multistorey car park (Plate 19) with additional loading bays for Anglia Square further along Edward Street (Plates23 to 25).

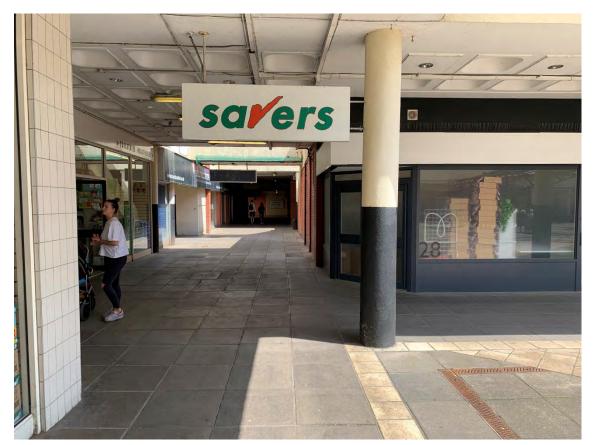
Plate 29

Anglia Square, itself, is dominated by a metal framed glass pergola (Plates 30 to 32) and is surrounded by a range of retail premises including a car dealership (Plates 29 and 32). At first floor level is an access to the multistorey car park (Plate 33), a former cinema (Plate 36) and access to Sovereign House (Plate 35).

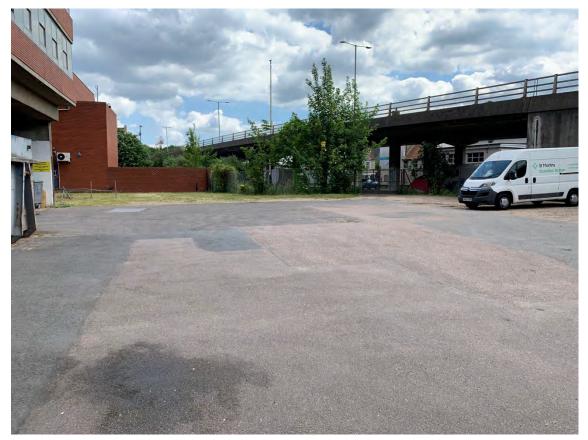
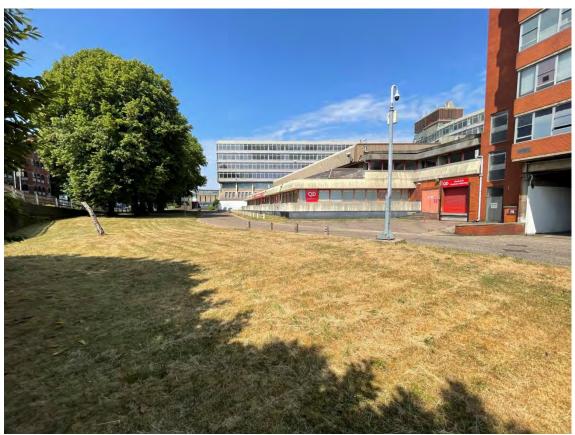
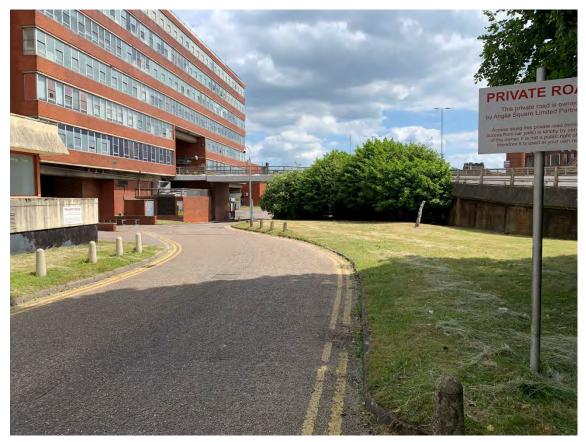
To the south of Anglia Square are further loading bays (Plates 42 to 45) and area of landscaping adjacent to St Crispin's Way (Plates 47 to 49) including a pair of concrete slabs the origins of which are unknown (plate 46).
