Previous View 37: Aylsham Road (additional view)

Appendix 1

RPS Archaeological Report .

Examination of building foundations at Pitt Street, Anglia Square, Norwich

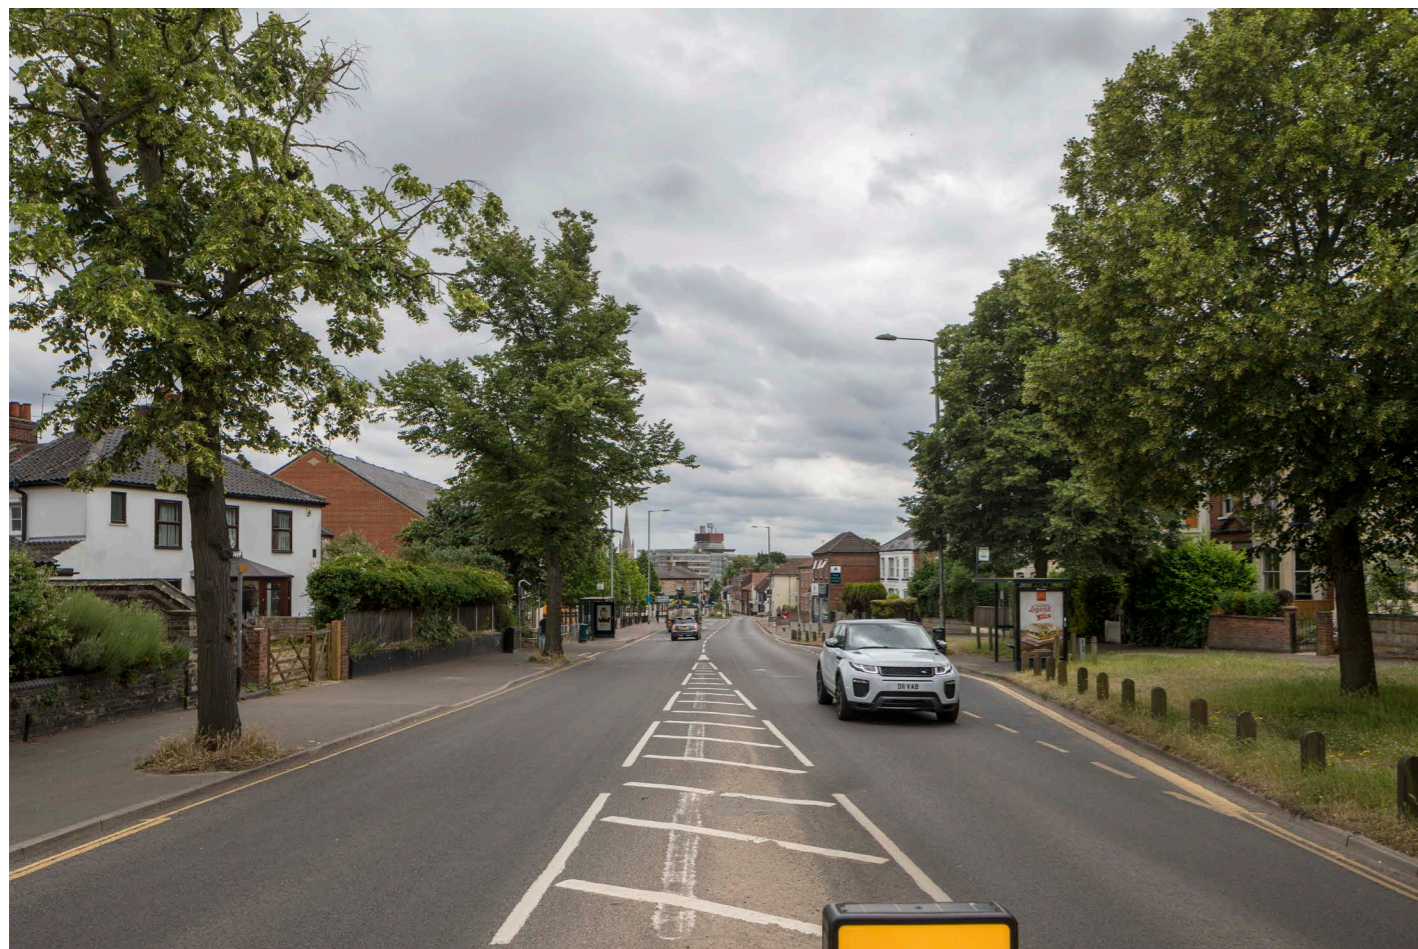
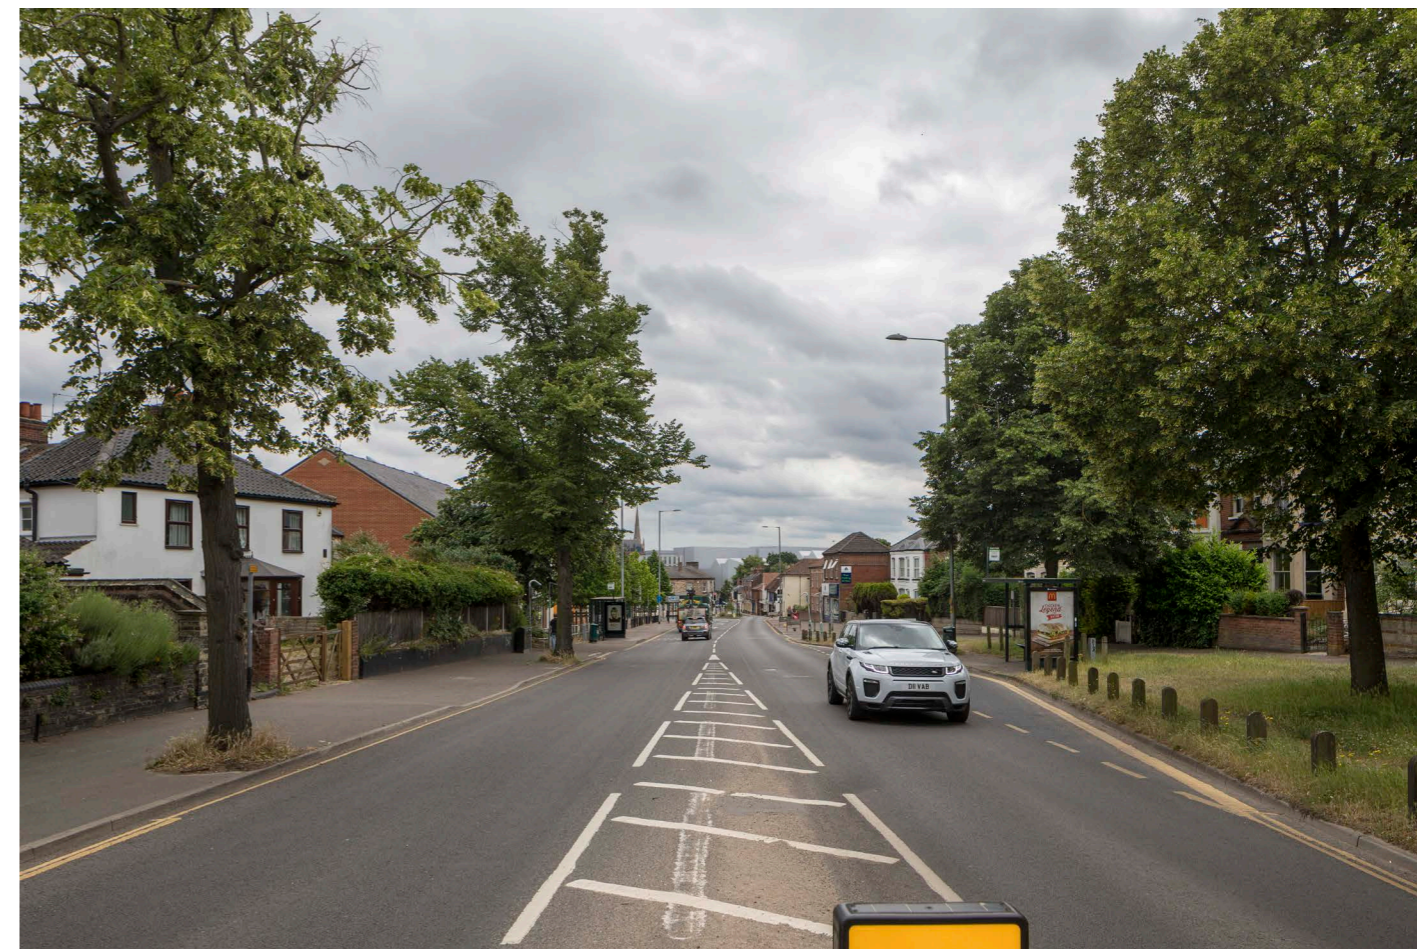
Standing in the middle of the road and on the traffic island looking south along Aylsham Road, some of the existing buildings located on the Site are visible, the most prominent one being Sovereign House, which is the background focus leading from the route along here. Aylsham Road is mostly residential with some small scale commercial businesses dotted along in parts.

The townscape along Aylsham is of a neutral quality, mostly of a functional form but enhanced by the tree planting. The built form along here is not of a particularly high architectural standard. Within the distant background the spire of Norwich Cathedral and Sovereign House are visible, the former being

a highly contributing element associated with Norwich and latter being recognised as a detracting feature within the urban environment. Overall, this view is considered to be of **low sensitivity and low susceptibility**.

Removing Sovereign House, which closes this view at present, the principal effect of the proposed development would be to reduce the visual scale of Anglia Square within this view, and therefore allow an increased focus on the Anglican Cathedral. The development as seen would fall within the existing frame of built form closer to the viewer, thus not appearing as an unduly prominent or dominant

feature. While much of what is visible is in Outline, the visual as currently presented clearly captures the intention to provide a development of quality and interest, such that the viewer is enticed as they move towards Anglia Square from this point.

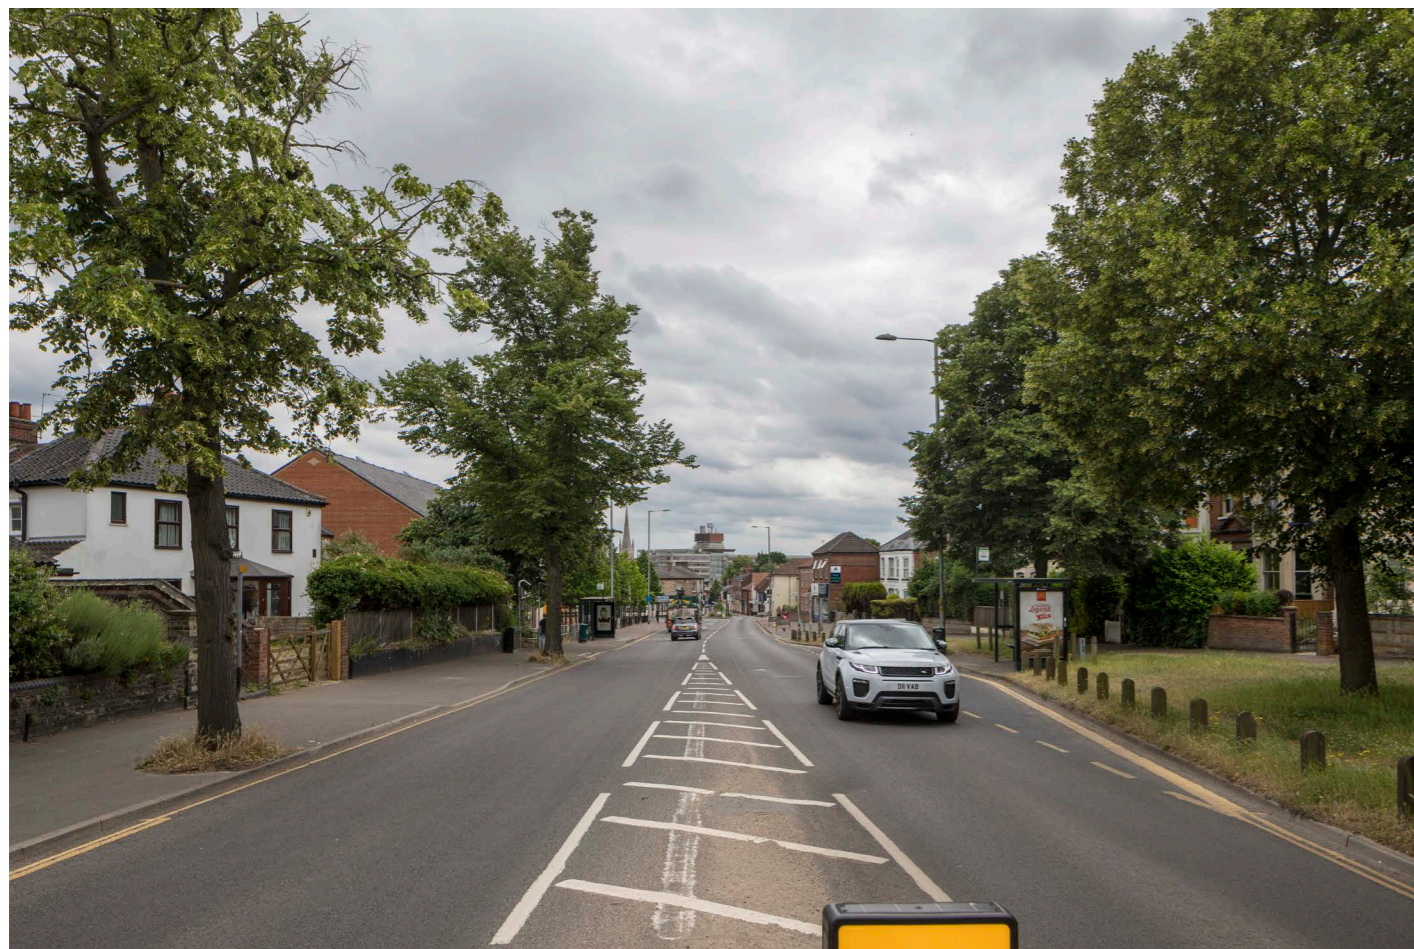
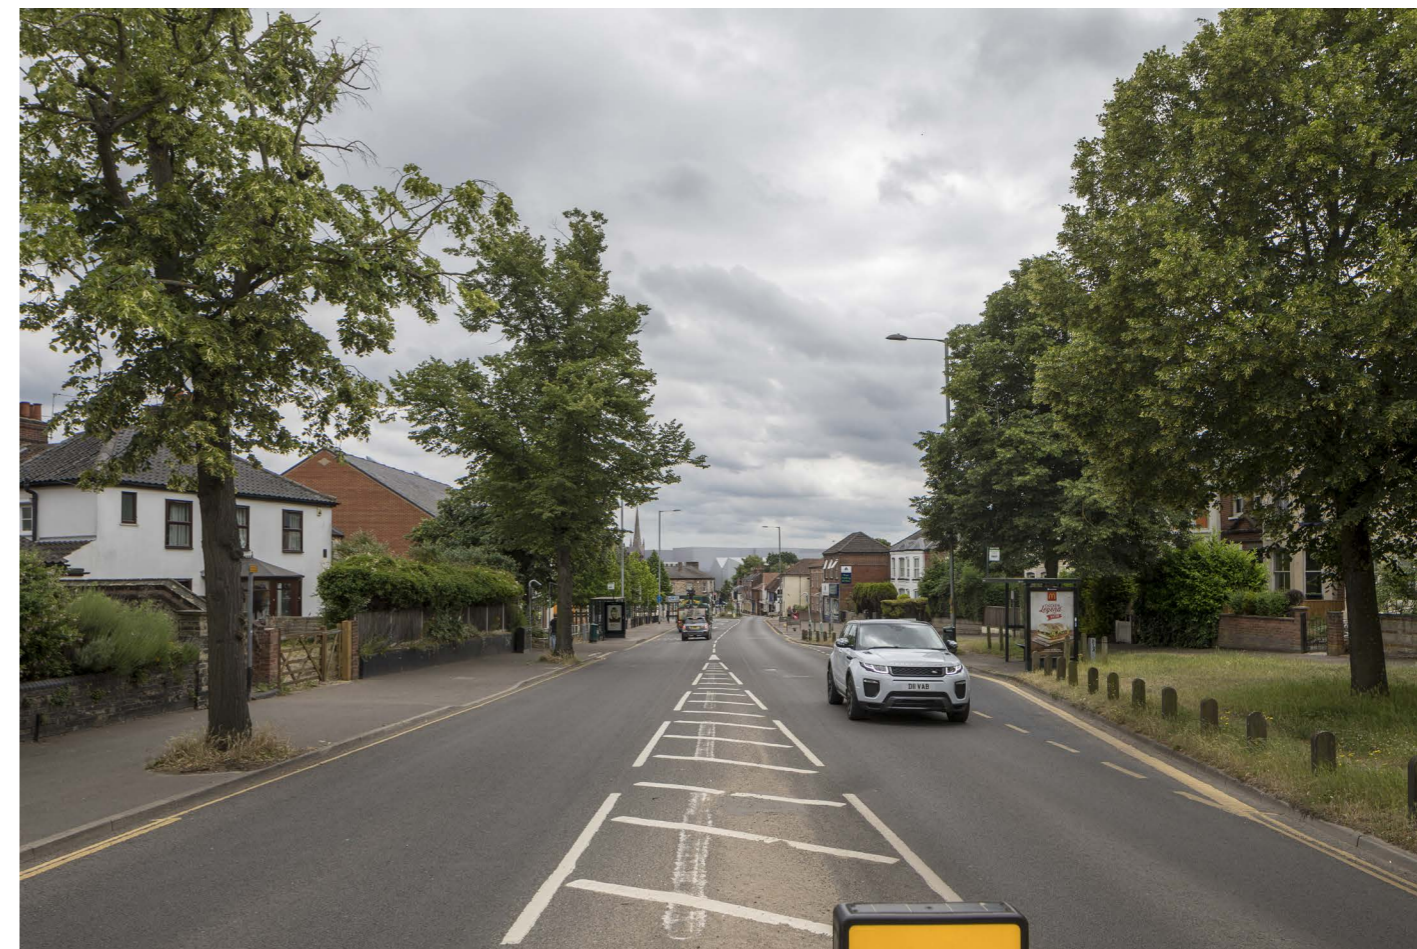
Revised View 37: Aylsham Road (additional view)

The Revised scheme here reduces the scale of Blocks A and D, as seen sitting in front of the Cathedral spire in this view. In our original assessment, we reached the view that this slight obscuration was significantly outweighed by the way in which the scheme as a whole increases the prominence of the spire. It continues to be the case, in our view, that the scheme increases the prominence of the Cathedral spire given the less assertive nature of the architecture of the scheme. It is also the case, however, that the spire itself will become more visible, as a result of the reduction in the height of Blocks A and D, which exposes more of the spire and spirelets. This has the effect of cementing the Minor Beneficial finding of our original assessment.

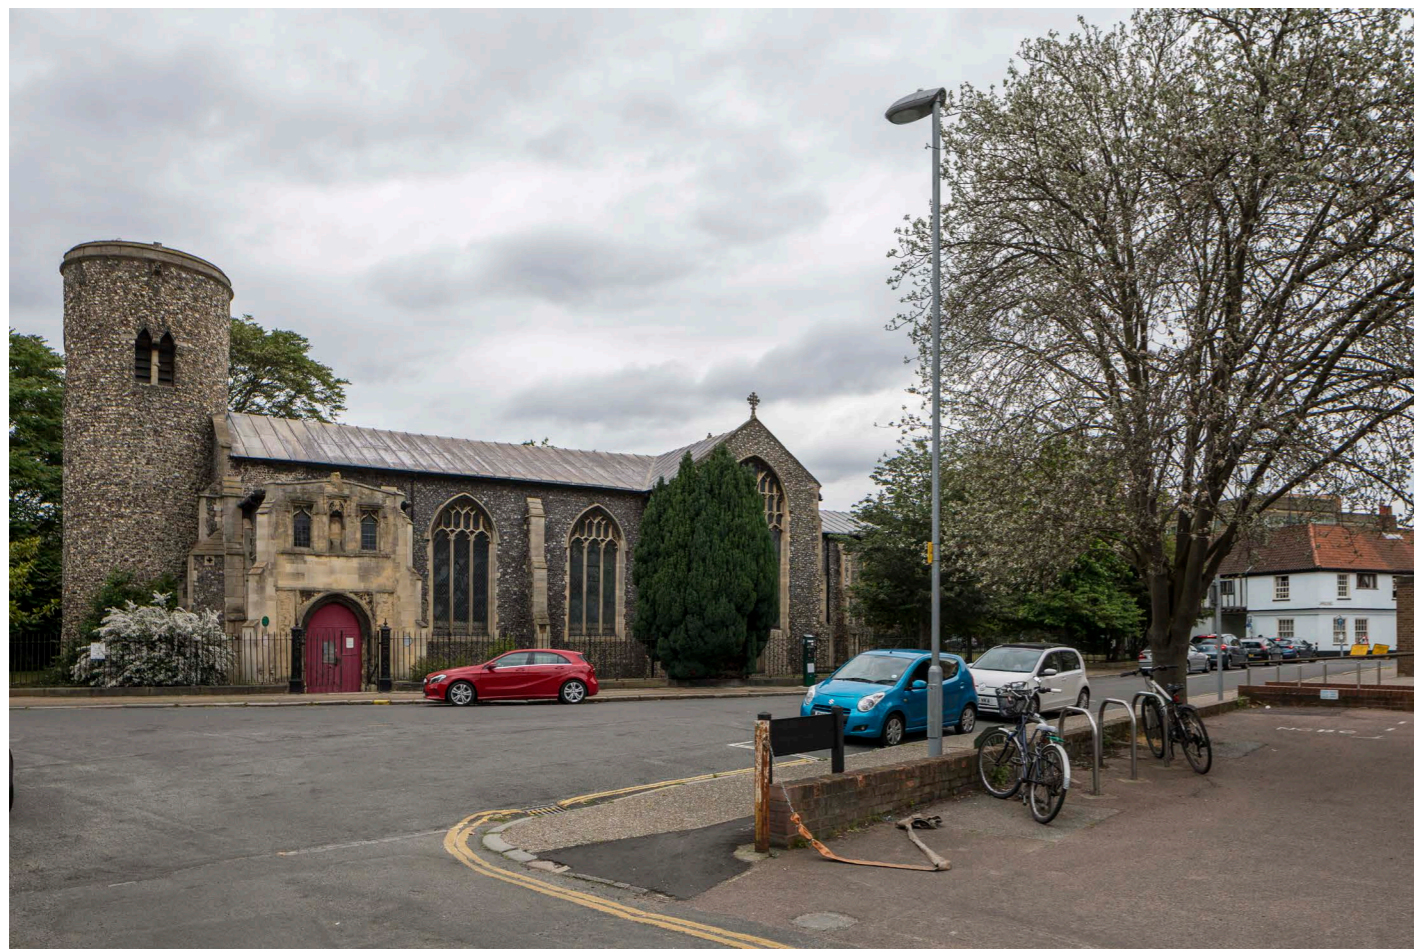
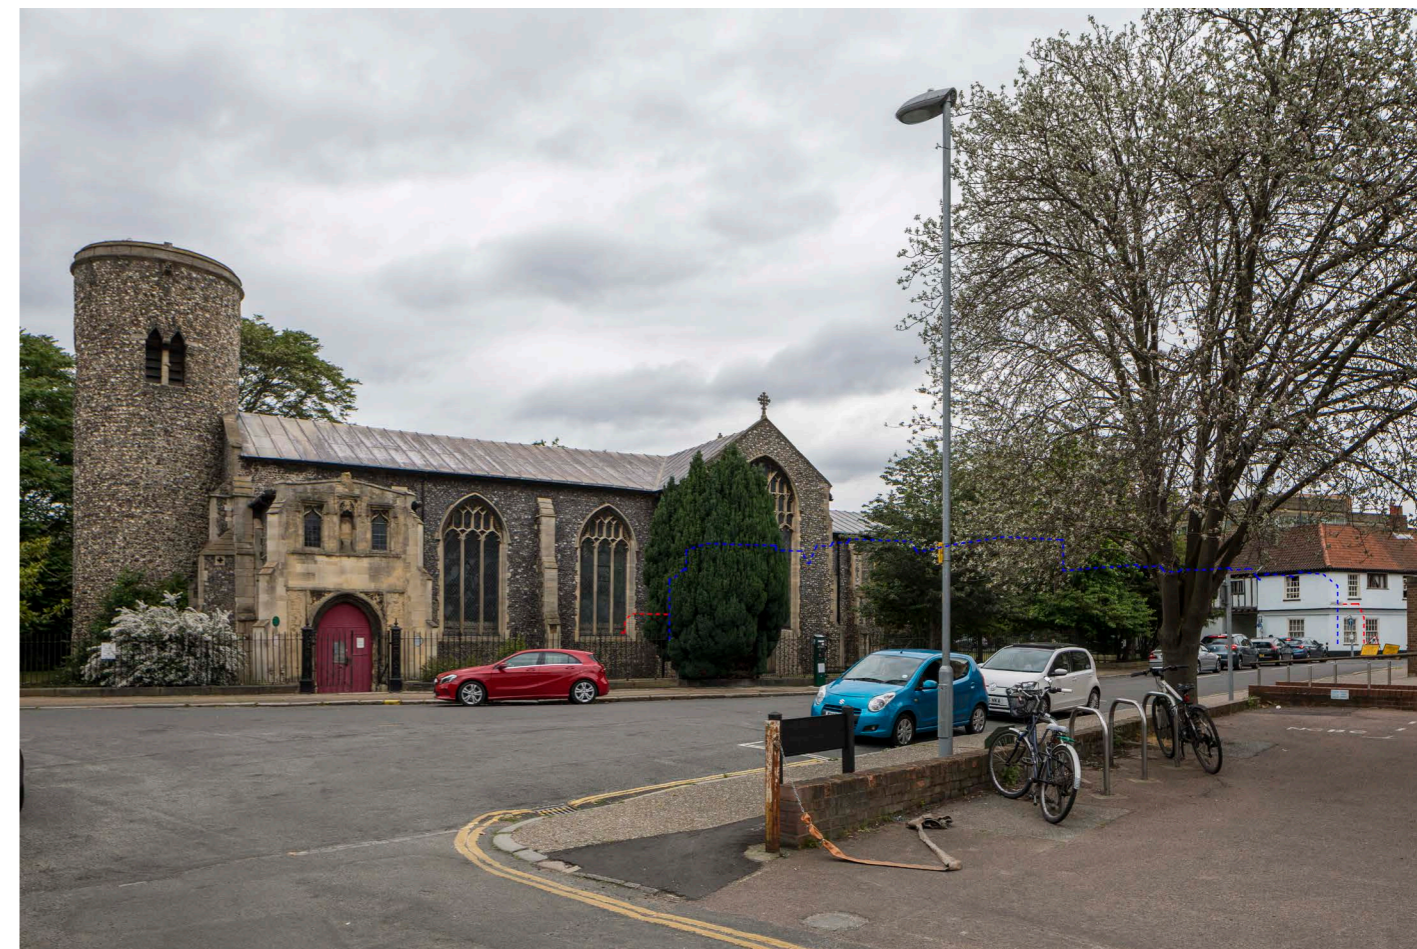
Previous View 38: Rosemary Lane

Standing North along Rosemary Lane, which it merges into St Marys Plain and looking north towards, the main focus of this view is St Mary's Church. Within the immediate foreground is the parking area associated with the Norwich Central Baptist Church, located on the right but not visible within this view, and appearing within the background is the former Wrights Foundry on Duke Street.

The buildings visible within this view are of significant heritage value and have been preserved and maintain to a high level. The public realm is of a functional use but appears to have been established in a haphazard way and is not considered to be of a particular high quality. Overall, this view is judged to be of **medium sensitivity and medium susceptibility**.

The verified wireline illustrates that the scheme would be concealed from view from this location by intervening built form.

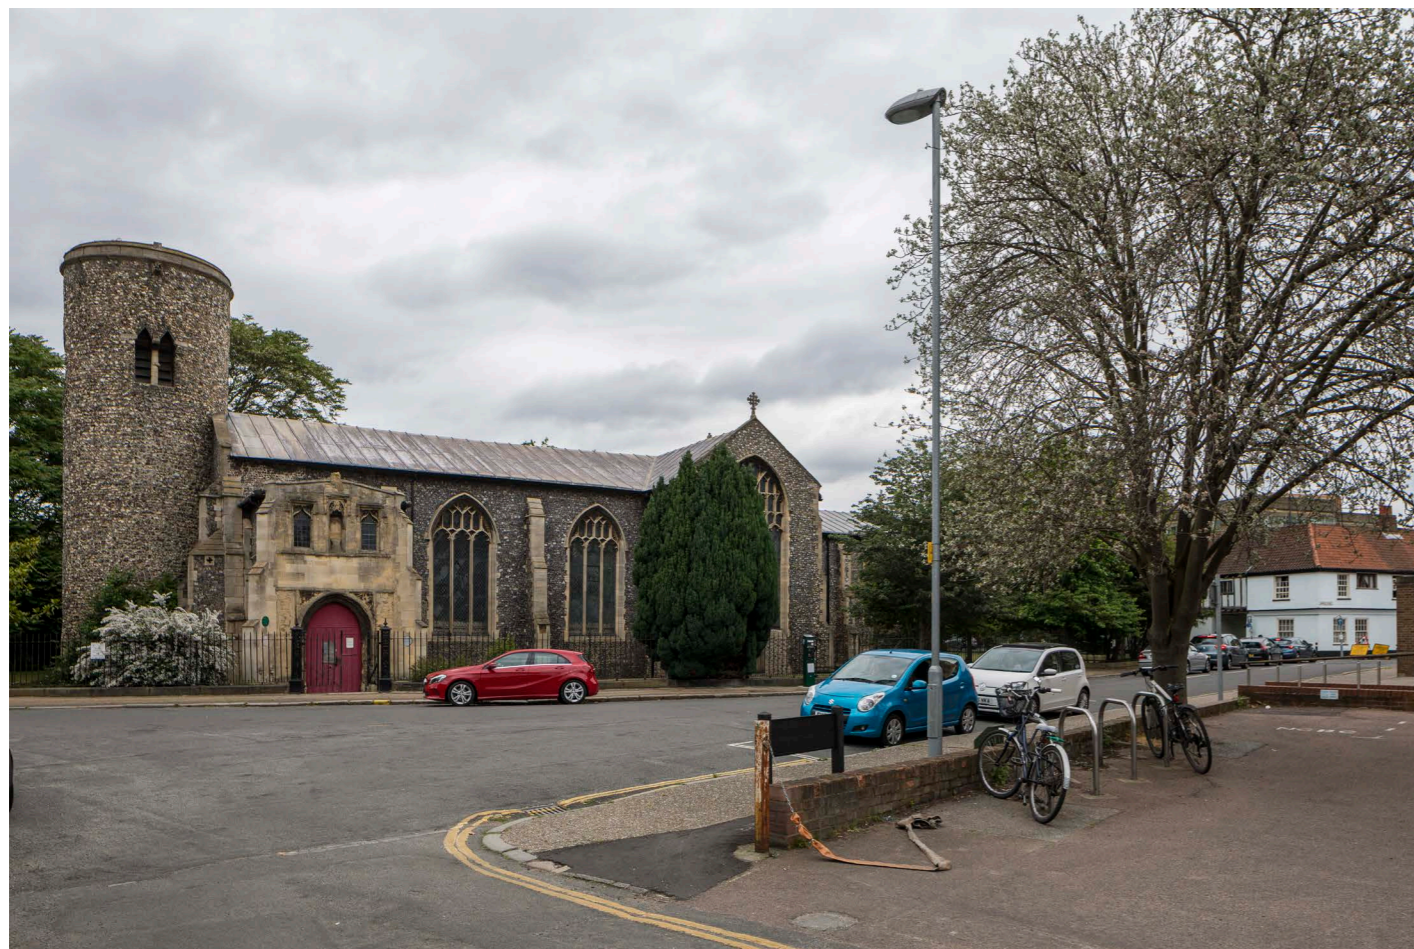
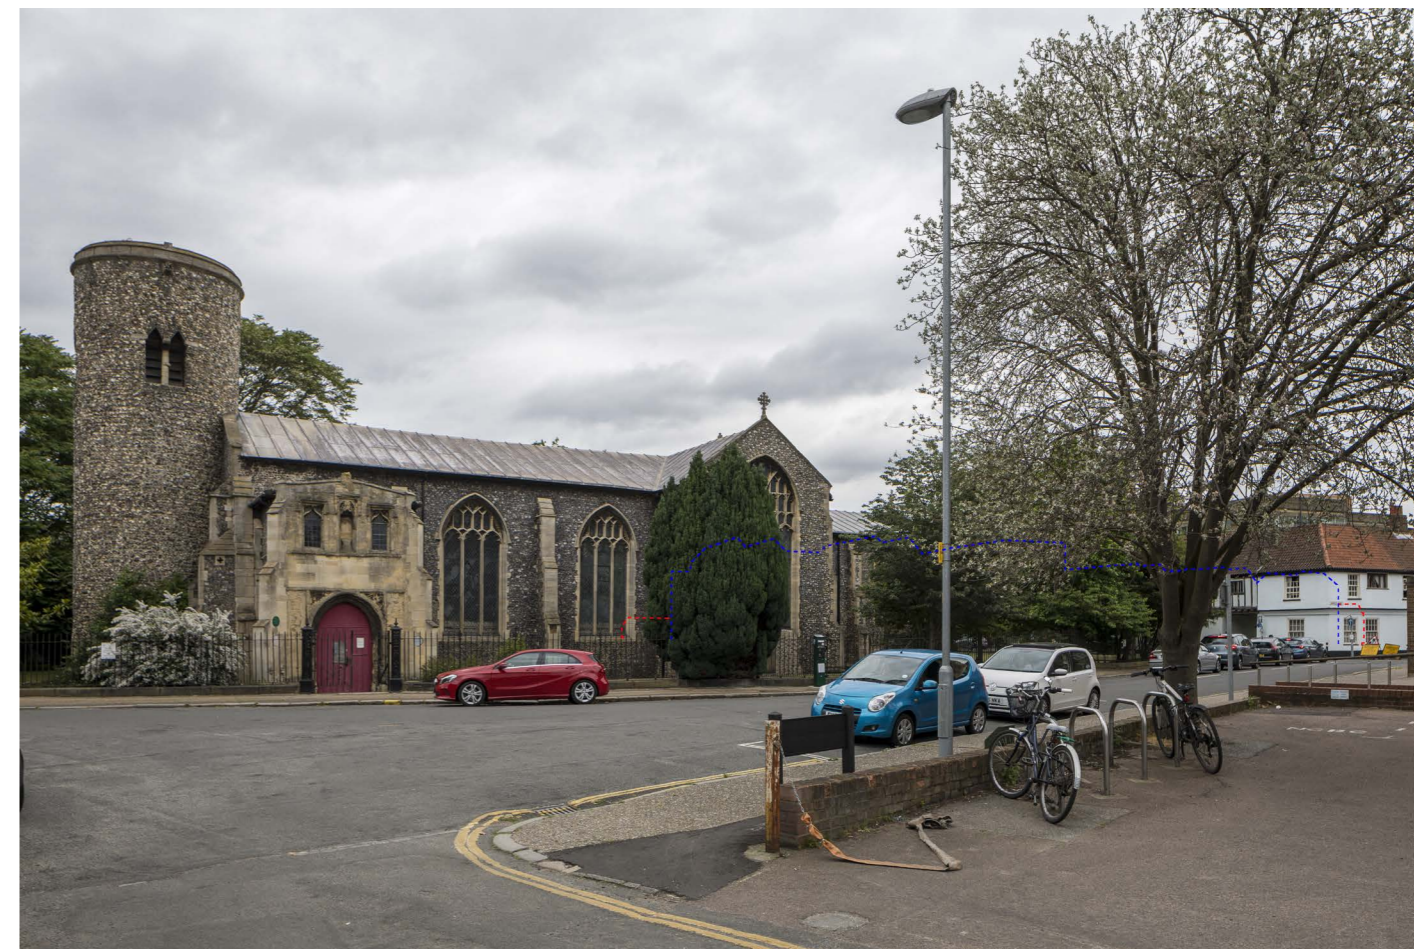
Revised View 38: Rosemary Lane

The Proposed Development would continue to be screened by existing built form of the St Mary's Church.

There is no change in the conclusion of effects from the previous assessment.

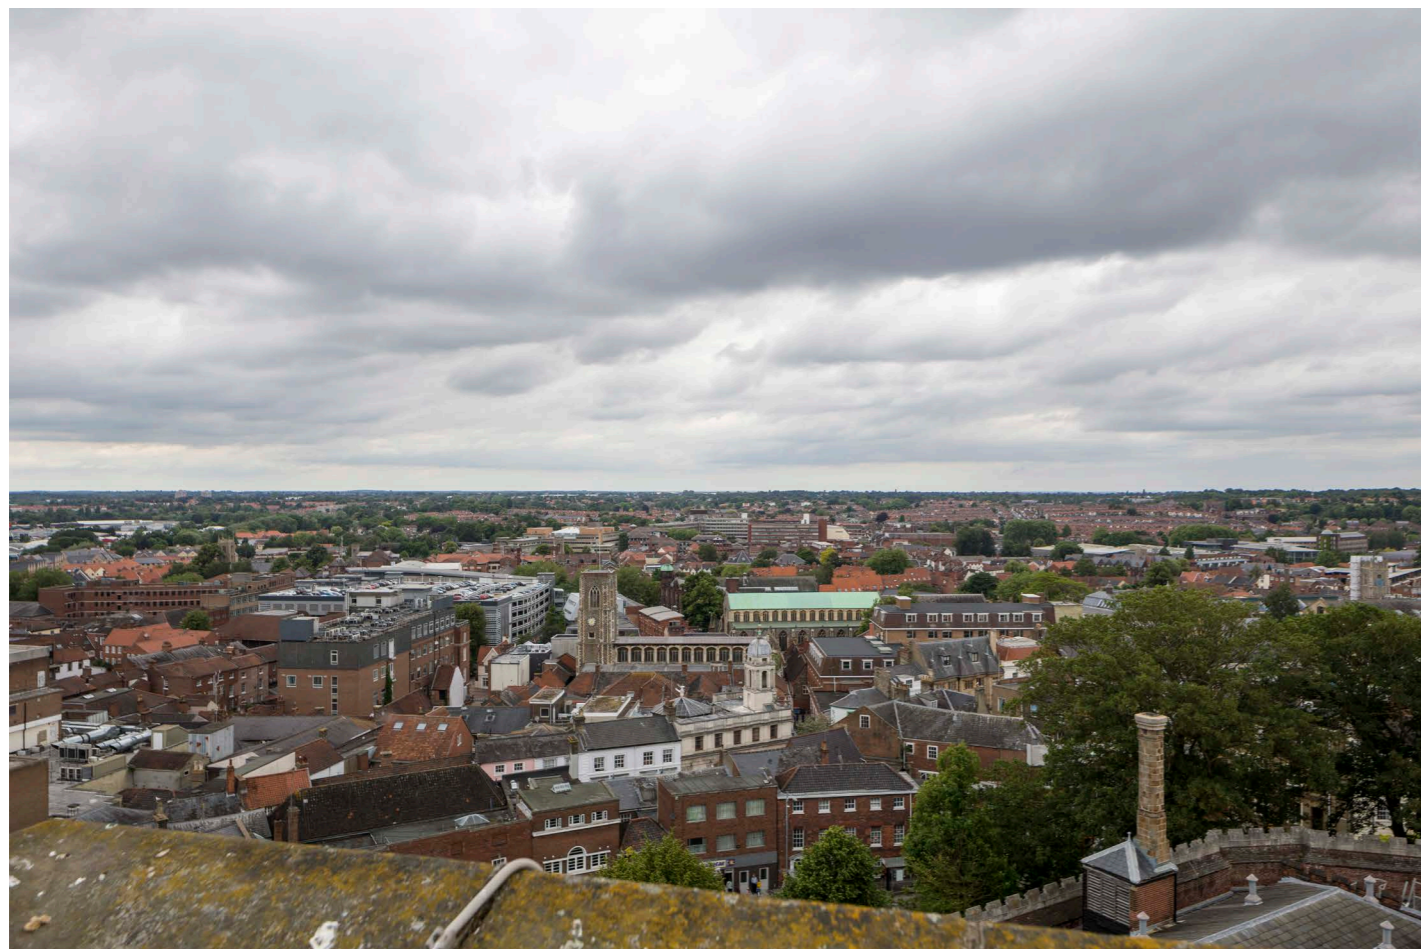
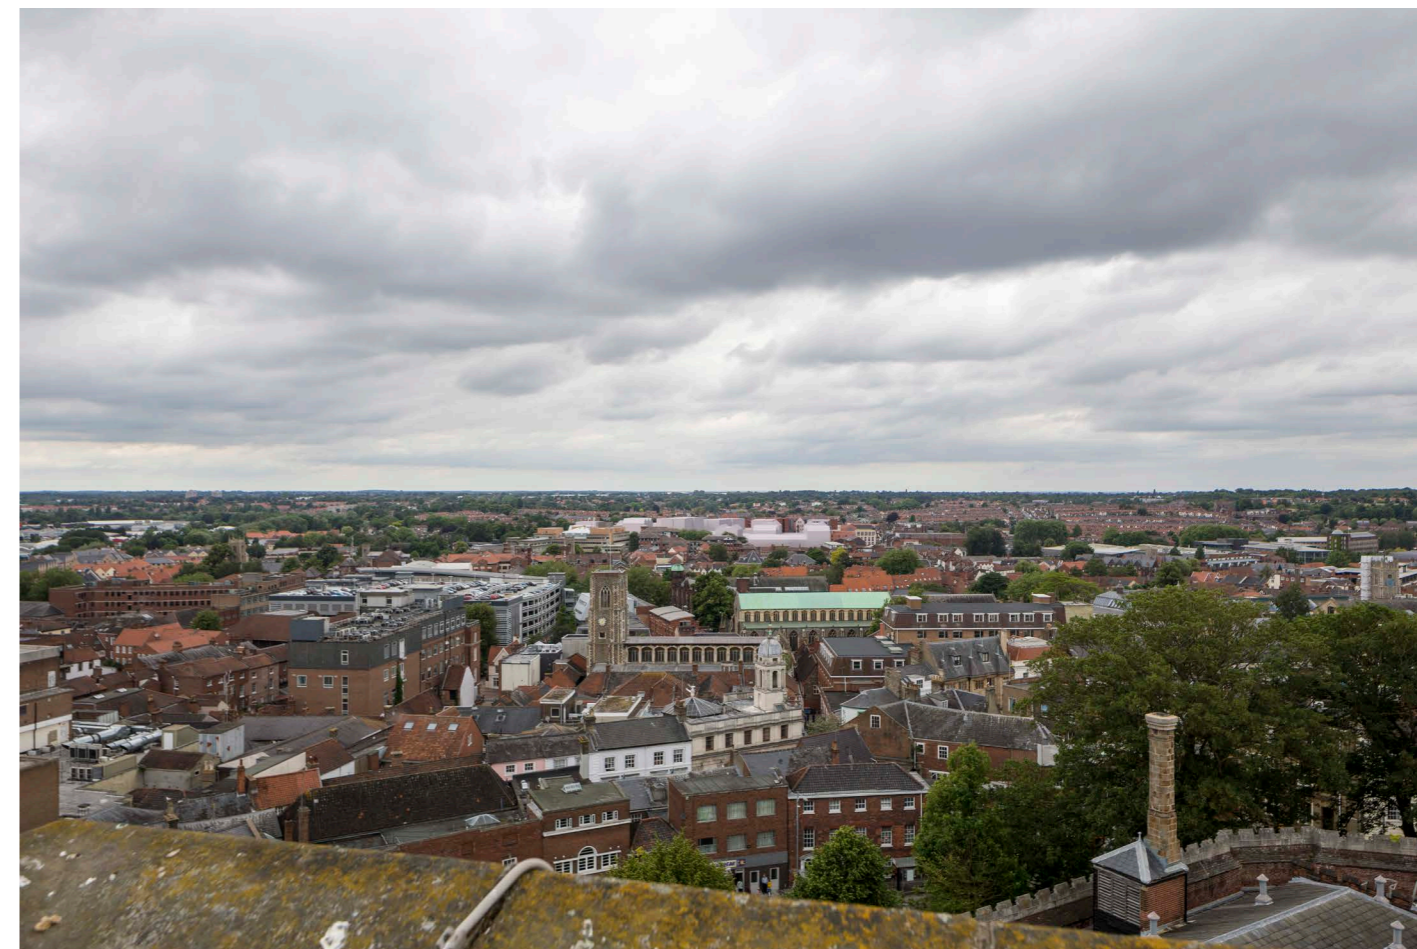
Previous View 39: Norwich Castle

Having accessed Norwich Castle Museum and either through the supplementary ticket option to access the castle battlements by guided tour or having privileged passage, one takes in a 360 panoramic and far reaching view across Norwich. At this raised vantage point location existing elements on the Site are visible within the distance, Gildengate House and Sovereign House in particular, beyond the more prominent elements within this view: the Natwest building; St Andrew's Church; and St Andrews & Blackfriars Hall.

Viewed from the Ramparts of Norwich Castle, the Proposed Development is viewed as part of the urban hinterland of Norwich, beyond the cluster of important heritage assets which are prominent in the foreground. Perceived within an immediate context of modernity and more historic forms, this view, even

with the scheme in a Hybrid form (part Detail, part Outline) clearly captures an intention to allow the development to calmly fall into the background. It would be perceived as part of the broader urban framework of Norwich, an extension of some of the more 'City' forms that are expressed by St Crispin's House and Cavell and Austin House closer to the viewer. Against the current baseline, the development would reduce the prominence of Anglia Square as part of Norwich as viewed from this location.

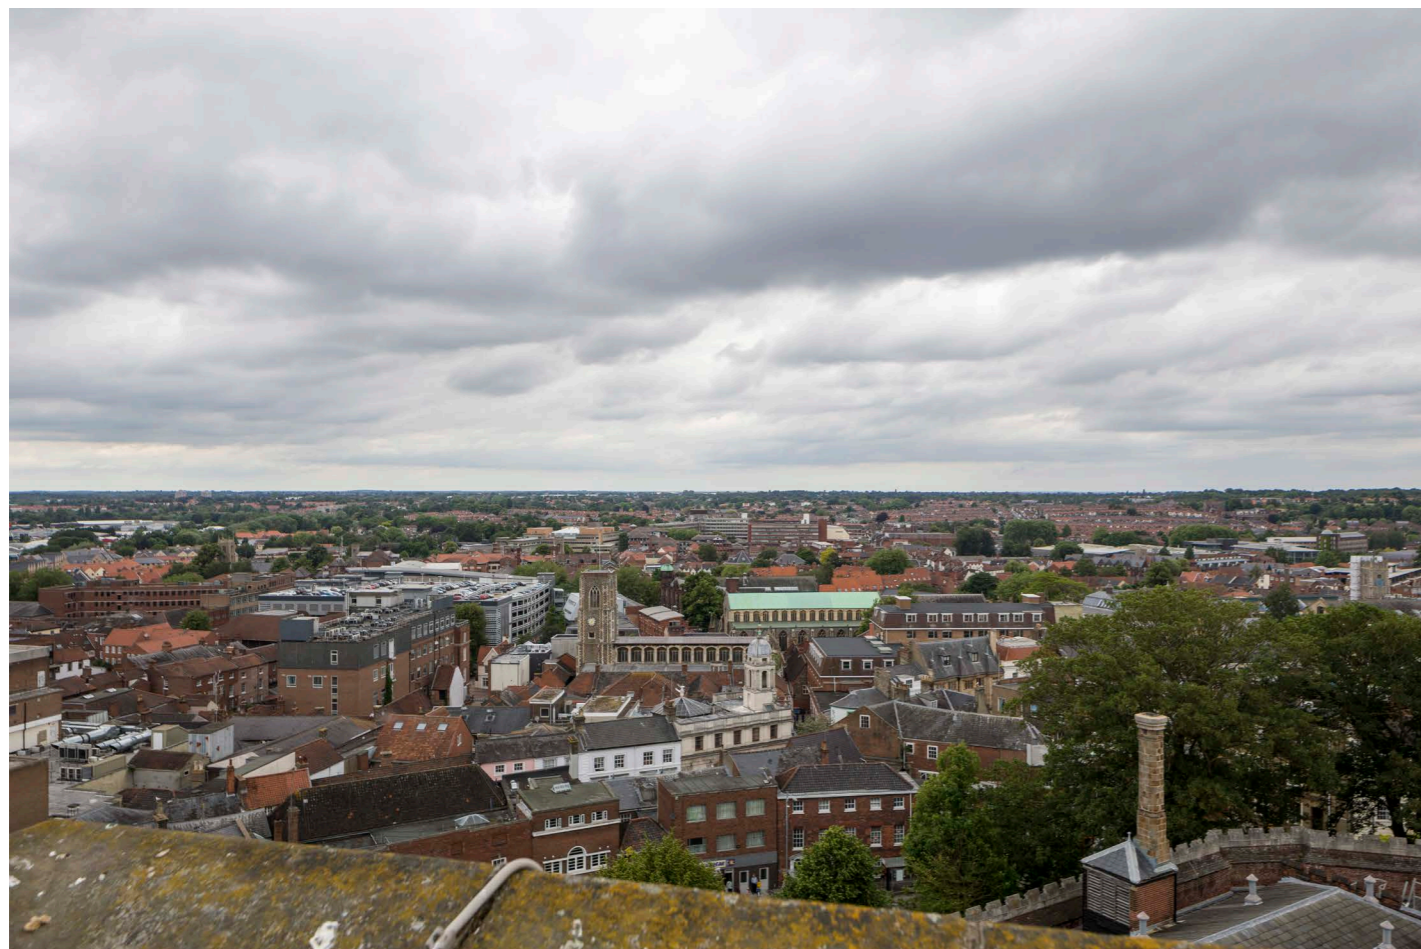
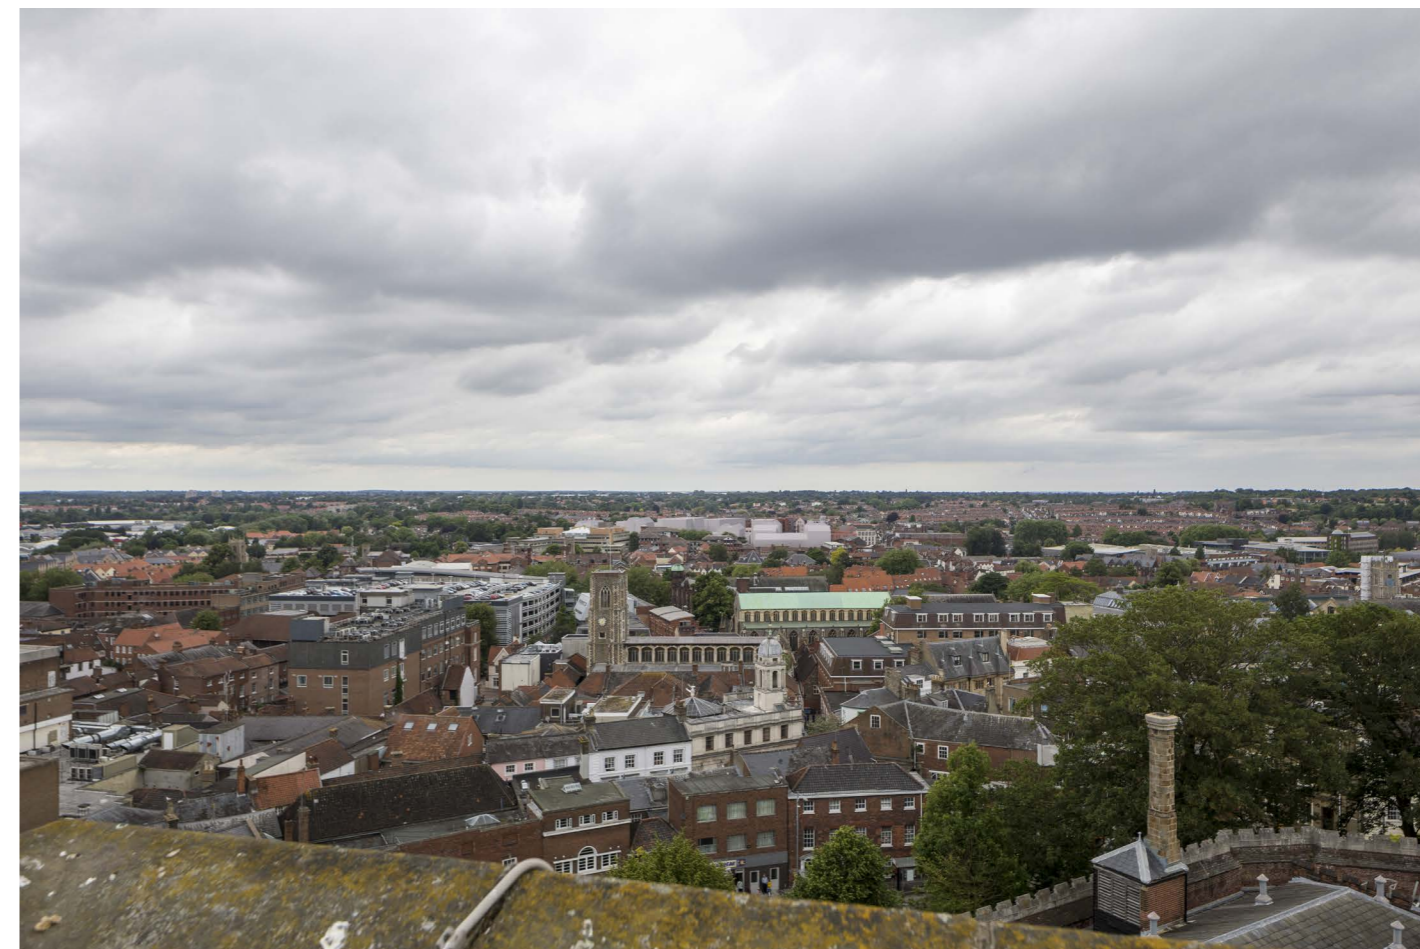
Revised View 39: Norwich Castle

The revised scheme here has minimally increased the height of blocks within the centre of the development. Importantly the scheme still maintains a strong sense of permeability, with views through the buildings to the townscape beyond. The change in orientation of the pitched roofscape to the right of the frame further increases the permeability and creates a more legible dialogue with the varied roofscape in the foreground. Overall, the revision increases the benefits of the scheme with the resultant effect remaining Moderate Beneficial.

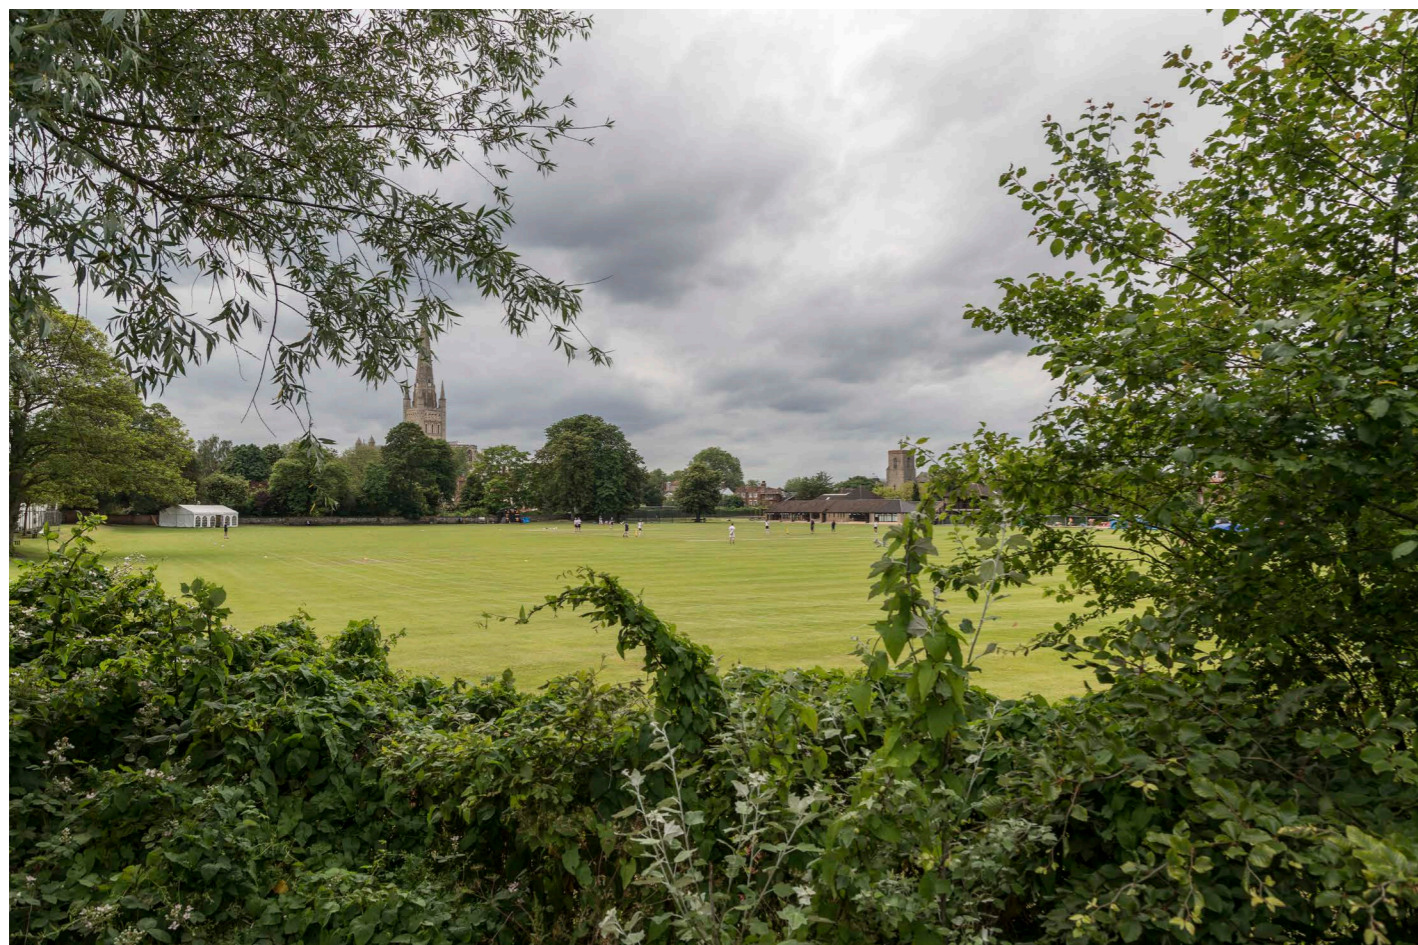
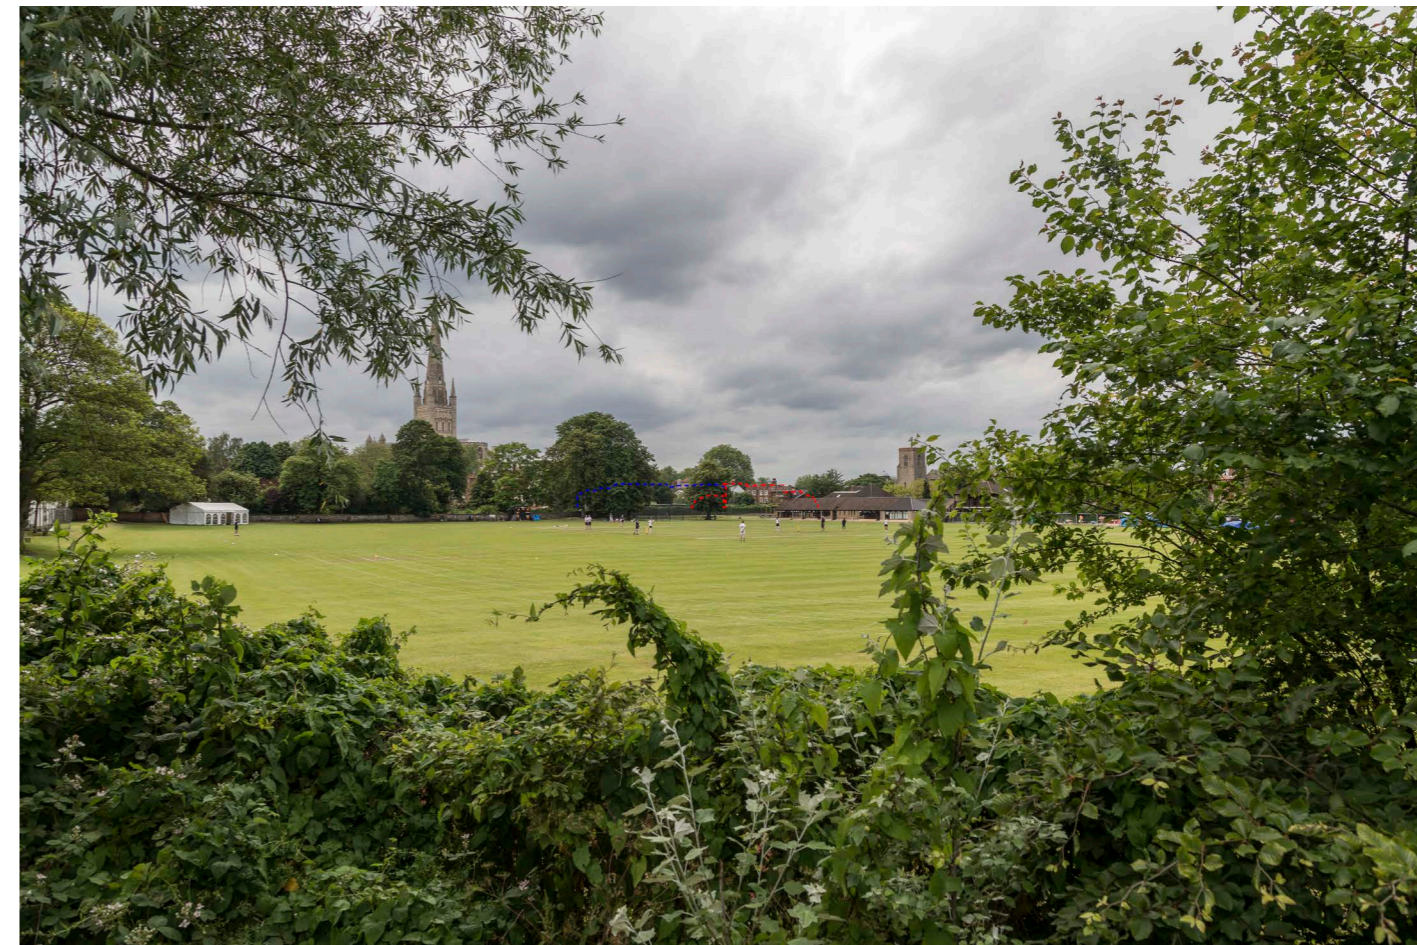
Previous View 40: Cathedral Meadow

Standing at the viewpoint location to the south-east of Cathedral Meadows, which has been identified as a protect viewpoint location within the Norwich City Centre Conservation Area Appraisal, the primary focus of this view are the sports pitches, which are viewed through light foliage. This is a pedestrian walkway which is in continuous use, although mainly during daytime hours.

This location is an identified and protected viewpoint within the Norwich City Centre Conservation Area and there are significant identifiable elements which form part of this view, Norwich Cathedral and The Great Hospital. Though the high vegetation slightly obstructs the appreciation of the view, its sensitivity and susceptibility are nevertheless considered to be high.

The Proposed Development would remain largely concealed from views from this location by intervening built form, distance and the mature tree line.

Where the Proposed Development is apparent, it will read as a recessive townscape element, part of the existing conflation of built form in the distance of this view.
