Previous View 37: Aylsham Road (additional view)

Appendix 1

RPS Archaeological Report .

Examination of building foundations at Pitt Street, Anglia Square, Norwich

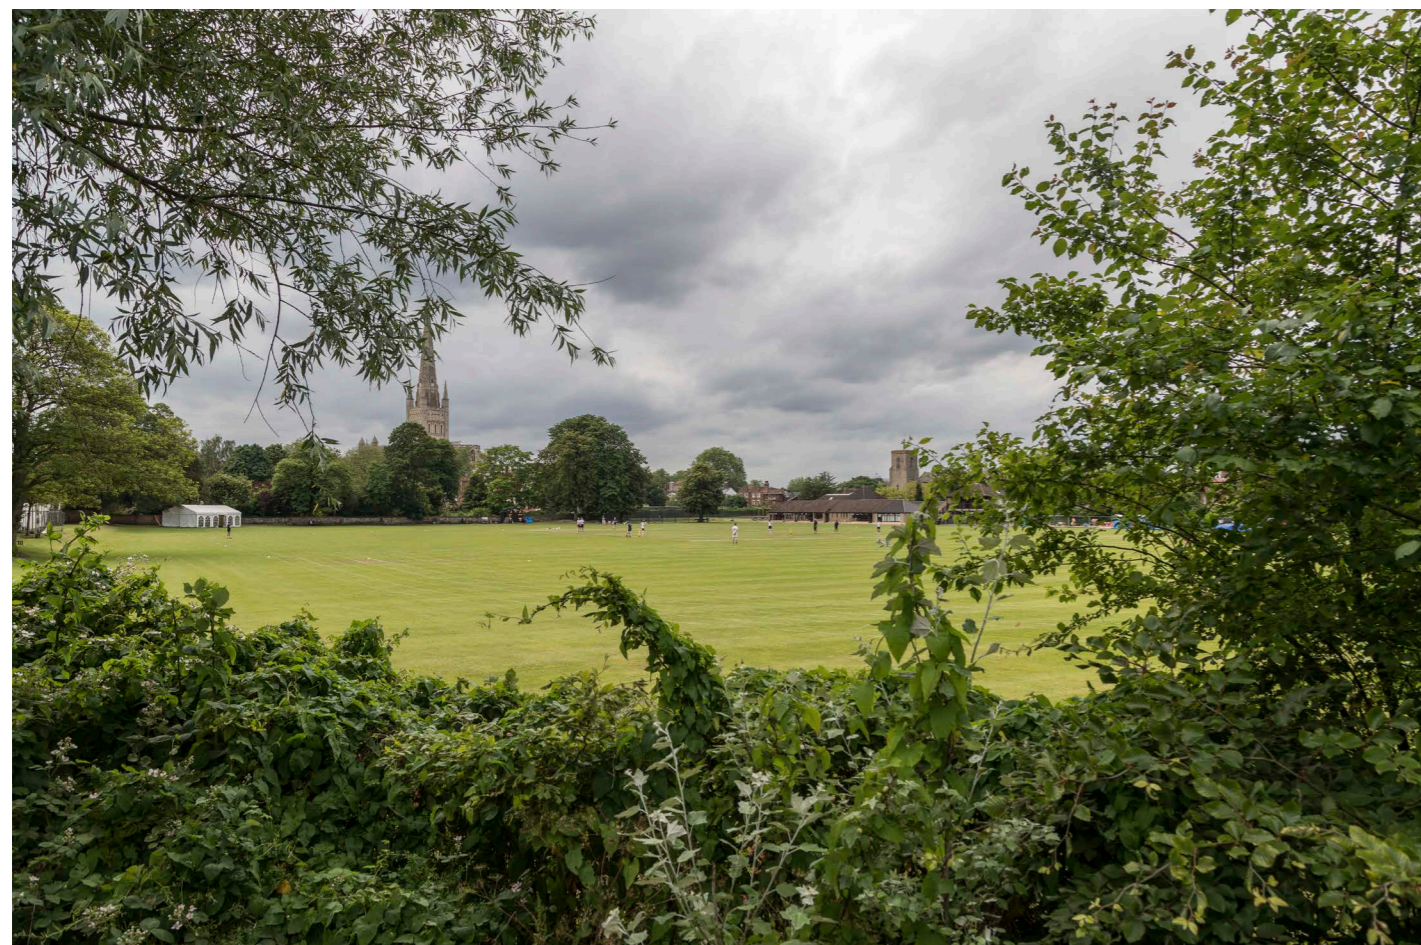
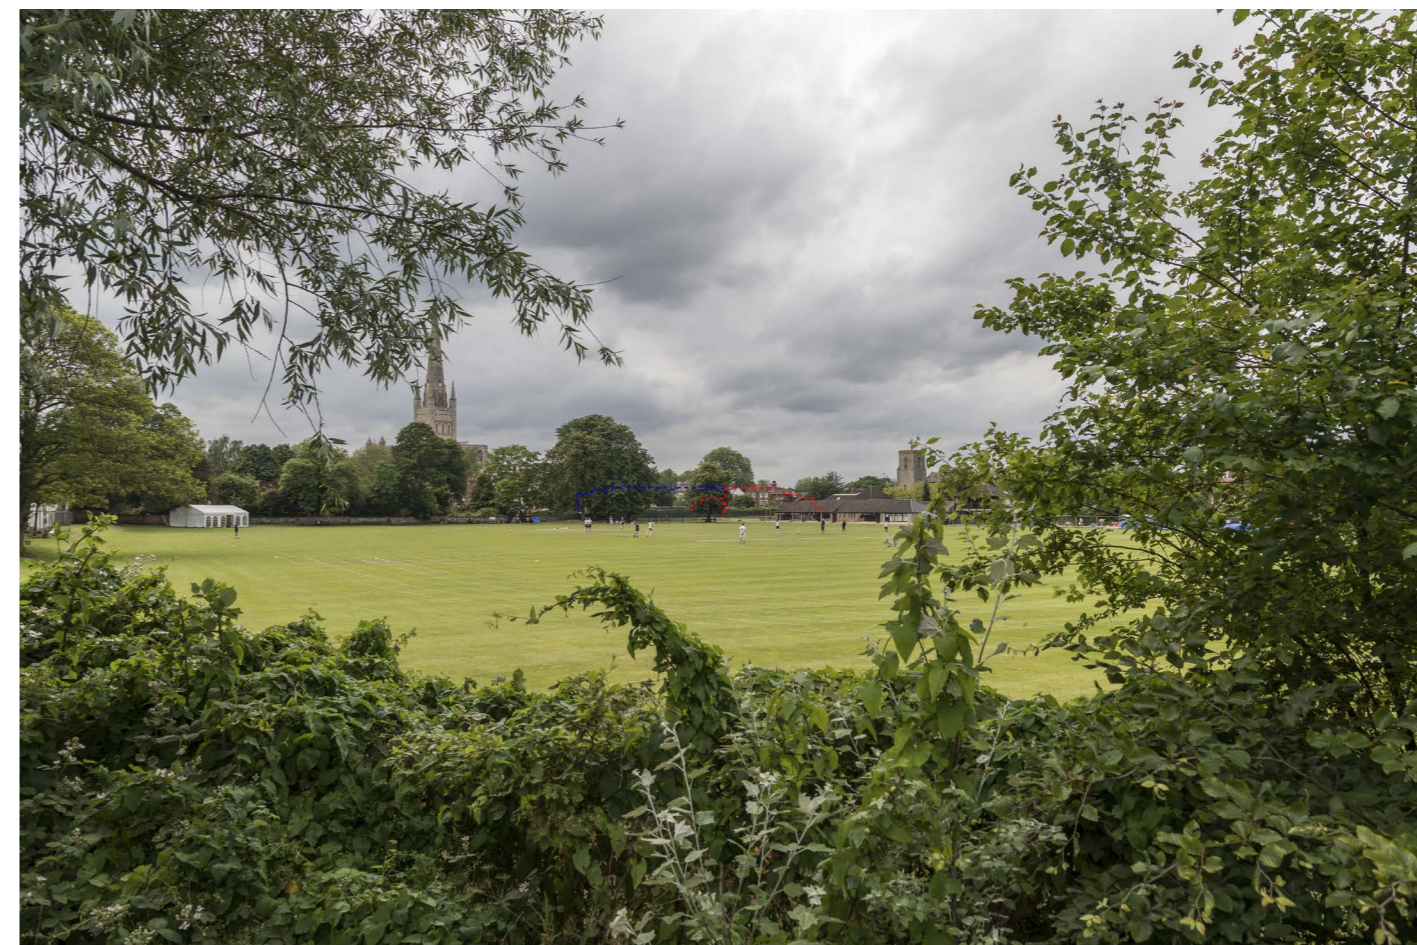
Revised View 40: Cathedral Meadow

The verified wireline illustrates that the changes from the submitted scheme are barely apparent. The Proposed Development would remain largely concealed from views from this location by intervening built form, distance and the mature tree line.

Where the Proposed Development is apparent, it will read as a recessive townscape element, part of the existing conflation of built form in the distance of this view. The residual effect would remain nil.

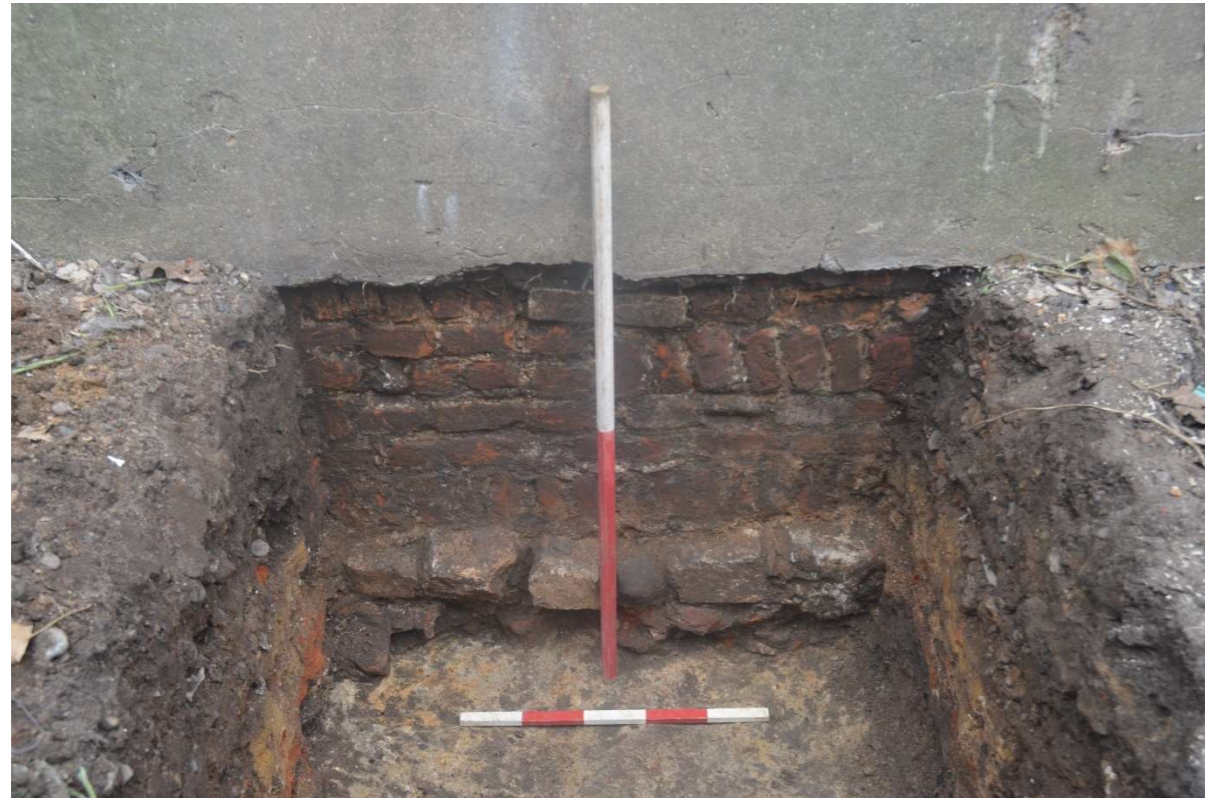
Figure 1: East facing of Test Pit 1 showing exposed limestone foundations.

Test Pit 1 was located externally against the southern portion of the eastern wall of the building. The southern edge of the test pit lay 1.15m north of the south-east corner.

The test pit revealed a beaten chalky sand surface (013) onto which was deposited a layer of made ground (012), presumably to make a level area prior to construction. A series of faced limestone slabs (011), representing the foundations of the present building were placed above the made ground. The current upstanding brick walls with limestone mortar (010) were built atop the limestone foundations. The external area was then backfilled with three further layers of made ground (016), (015), and finally (014) to reach the present ground level.

Upon this layer the building foundations were added, consisting of limestone slabs in Test Pit 1, brick in Test Pit 2, and a combination of material in Test Pit 4. The present brick structure was subsequently constructed above these foundations. Finally, both internally and externally, several layers of made were added to reach the present ground level. All finds recovered appear to be of contemporary 19th century date, this includes examples from the made ground material directly below the foundations (002), (012).

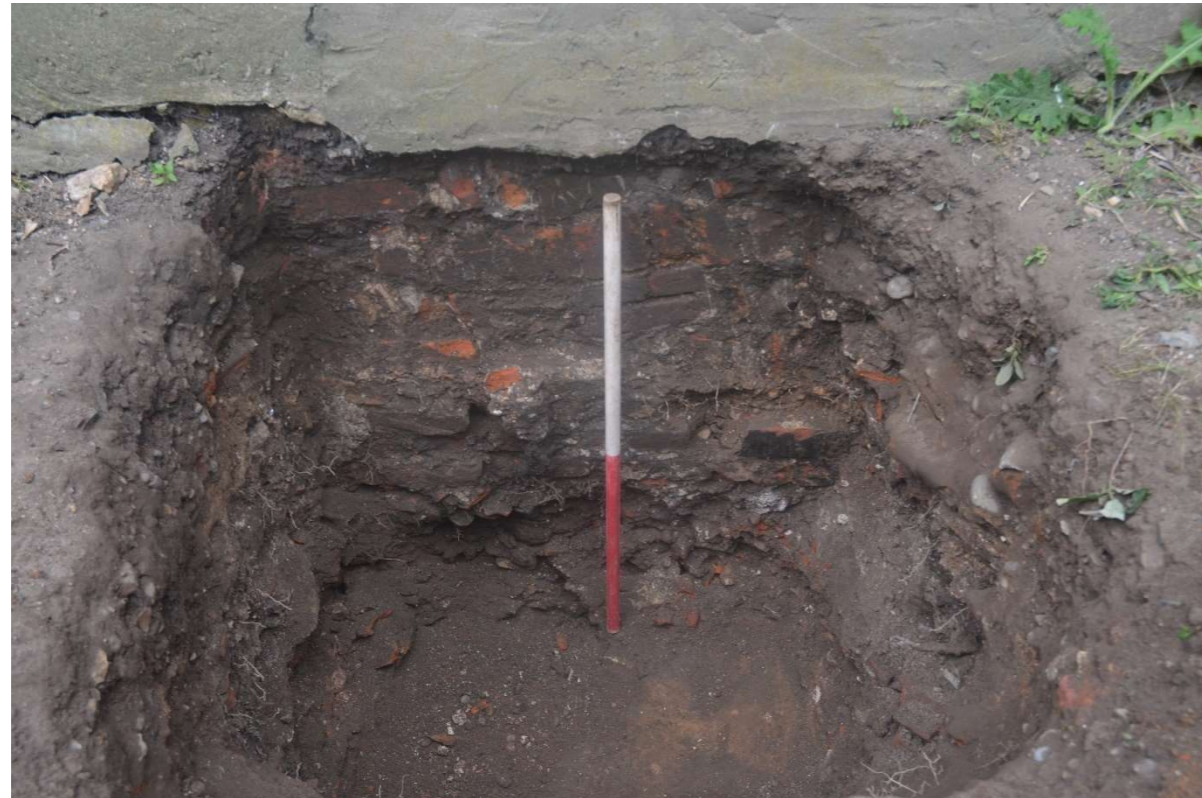
Figure 2: East facing of Test Pit 2, showing deep backfill above brick foundations.

Test Pit 2 was located externally against the central portion of the eastern wall of the building. The northern edge of the test pit lay 7.15m south of north-east corner.

The test pit revealed a different stratigraphy to Test Pit 1. Test Pit 2 was deeper and excavated to a full 1m depth due to the absence of the beaten chalk surface seen in Test Pit 1. At 1m depth, part of the test pit reached a friable silty sand natural (007). The other portion of the base of Test Pit 1 sat on layer (002), a thick deposit of made ground primarily consisting of roof tile, CBM and similar debris, similar to (012) in Test Pit 1. Onto the made ground was placed brick foundations (003), and the wall of the present structure (004). The external area was subsequently backfilled with two further layers of made ground (005) and then (006).

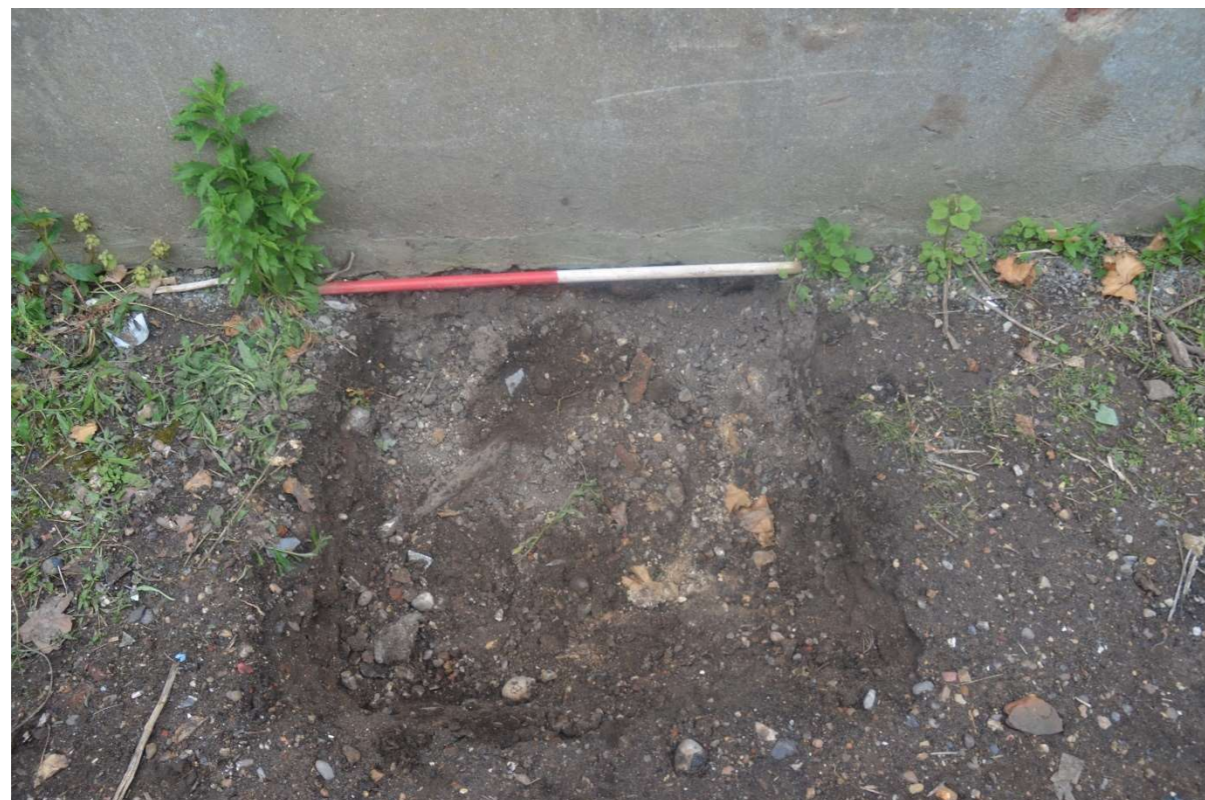
Figure 3: Test Pit 3, showing made ground encountered at level of service.

Test Pit 2 was located externally against the northern portion of the eastern wall of the building. The northern edge of the test pit lay 7.15m south of north-east corner.

The test pit revealed made ground in its top fill, before a cable was encountered, preventing further excavation.

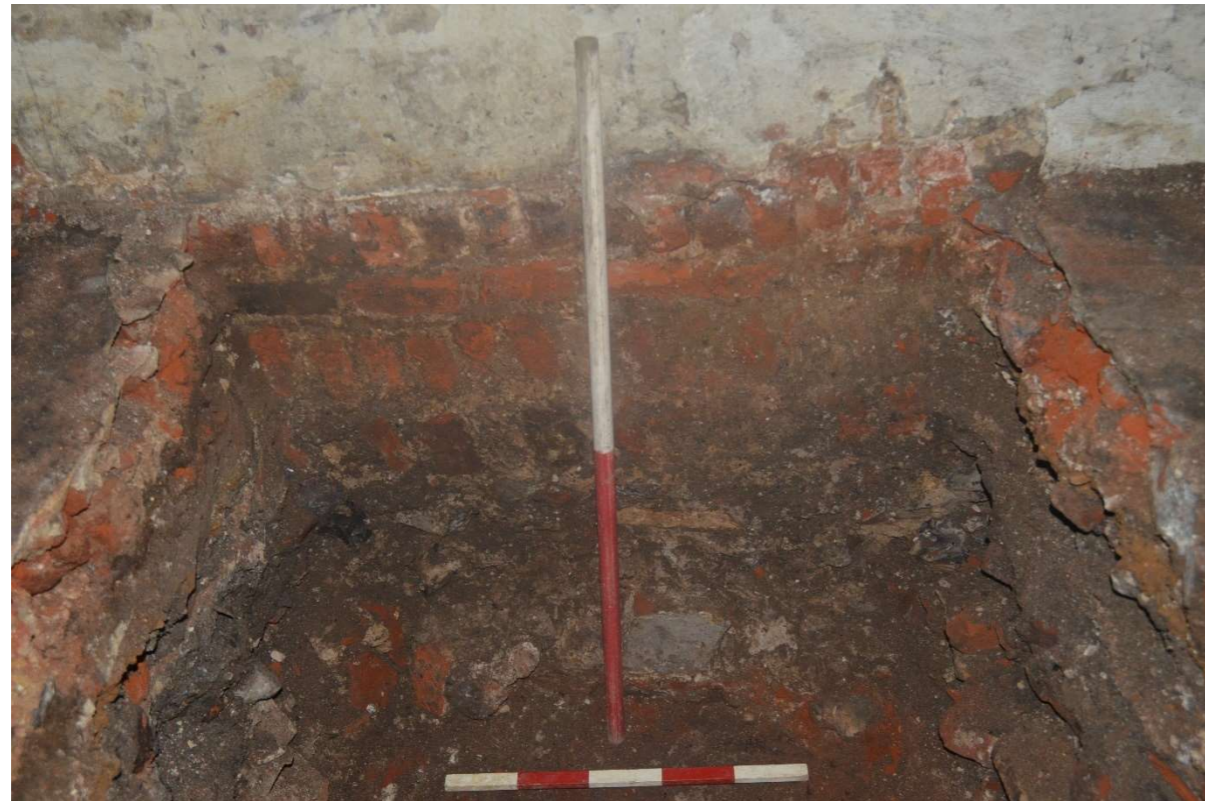
Figure 4: Test Pit 4, set inside the present building.

Test Pit 4 was located internally against the original northern wall. The latter is now an internal wall due to the addition of a concrete wall further to the north in the 20th century. The test pit was positioned directly opposite the present entrance in the southern wall.

The test pit revealed a very compact made ground cement surface at its base (020), onto which was laid the foundations of the present building. The latter consisted of irregular brick and stone (019), with a flint layer above (018). Above the foundations several courses of brick were added below the present ground surface (017). Adjacent to the wall, the test pit revealed several further layers of made ground primarily consisted of CBM, flint, and other building materials (026), (025), (024), (023), and (022). These layers were then capped with a thin layer of cement (021).
