ANGLIA SQUARE,  
NORWICH

**Bat Survey Report**

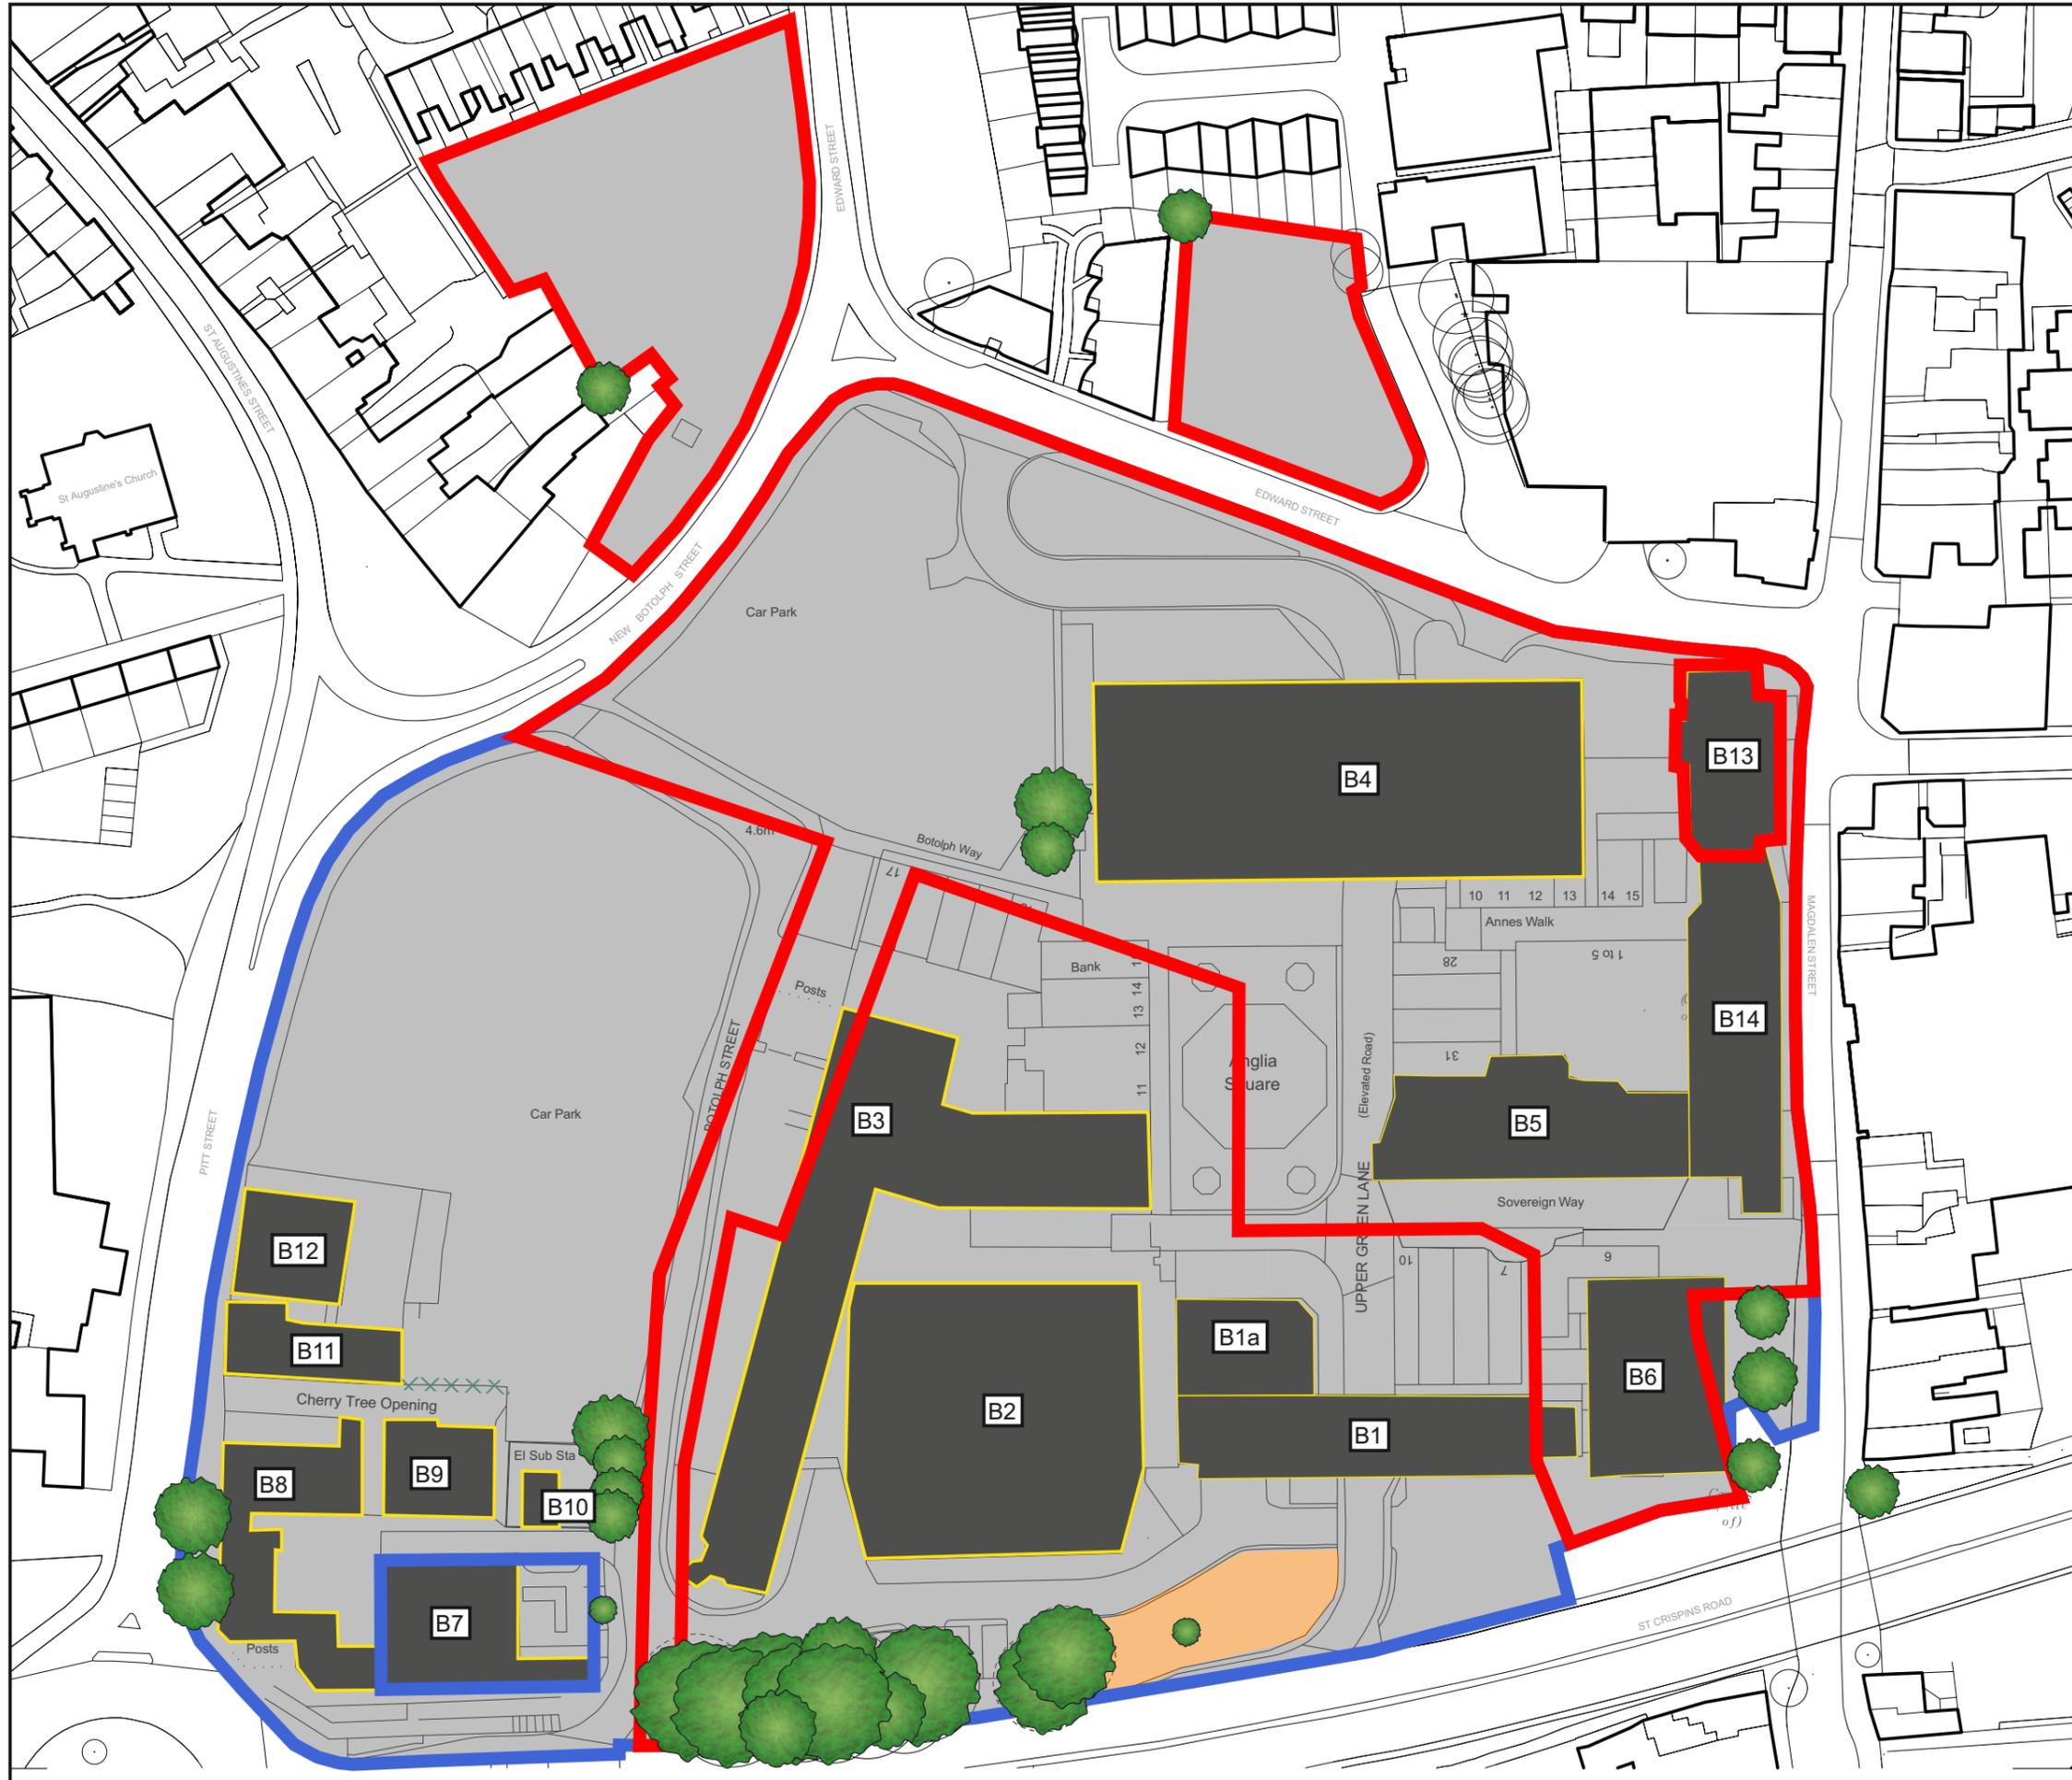
**PLAN ECO2:  
ECOLOGICAL FEATURES**

- 1.2.2. The site consists primarily of buildings and associated hardstanding, with an area of amenity grassland in the south. Trees are situated throughout the site, mostly along the southern boundary (see Plan ECO2).

- 4.1.1. The site consists of the 14 buildings with associated hardstanding, an area of amenity grassland and trees (see Plan ECO2).
- 4.1.2. Building B1 is a purpose-built office block known as Gildengate House. It is a six-storey building in a reasonable state of repair. It is of concrete, brick and glass construction. The building is currently used on a temporary basis as an artists' studio. Cracks and gaps are present on the stair column where concrete lintels are beginning to crack. Gaps are also present under the steel cladding on the edge of the roof.

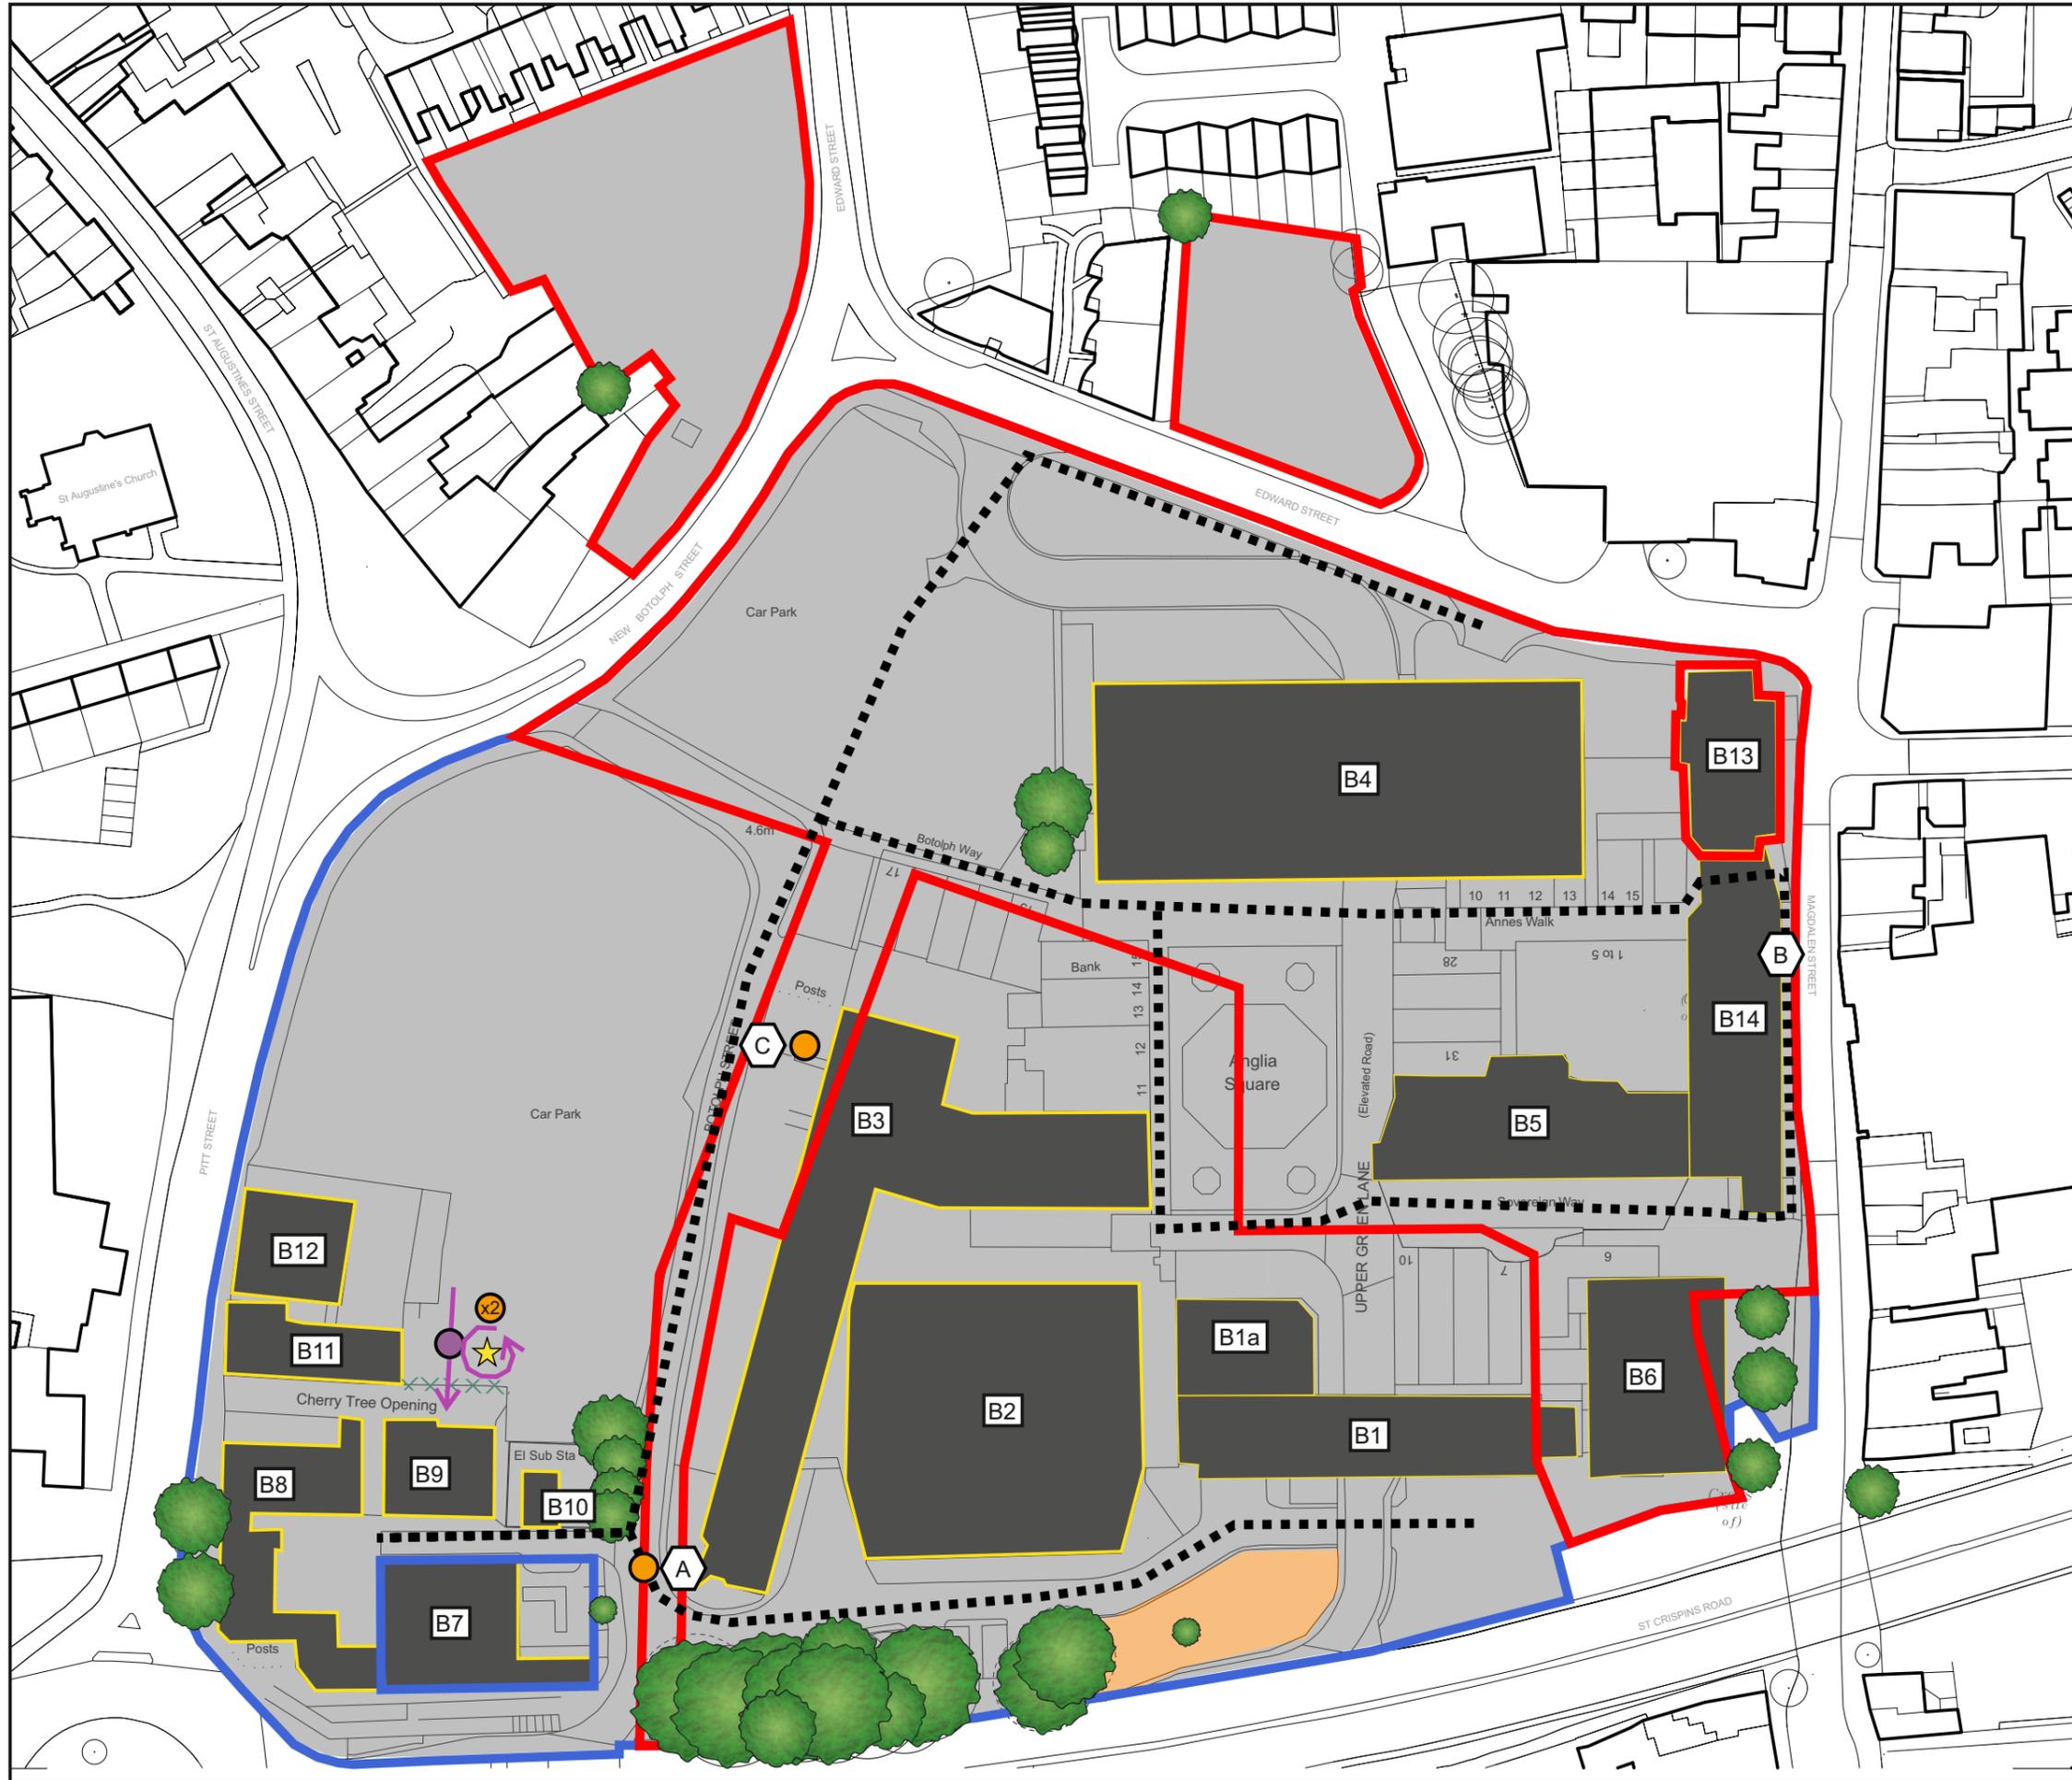
PLAN ECO3: BAT SURVEY RESULTS 14.06.22	Rev: A Jul 2022
---	--------------------

- 5.3.4. The results of the emergence survey undertaken on the Ivy-covered wall adjacent to Building B11 on 14 June 2022 are shown in Table 5.2. The locations of bats recorded and their flight paths are shown on Plan ECO3.

- 5.4.1. An activity transect survey was undertaken across the site in conjunction with the emergence survey on 14 June 2022.
- 5.4.2. A single surveyor walked a transect with their route shown on Plan ECO3.
- 5.4.3. The weather conditions and timings of the survey are summarised in Table 5.3 below.

- 5.4.4. The results of the activity survey undertaken on 14 June 2022 are shown in Table 5.4 and illustrated on Plan ECO3.

- 5.4.6. Overall, a low level of activity was recorded during the emergence and activity survey undertaken in June 2022. The earliest bat registration occurred 14 minutes after sunset. The timing of this registration suggests that a roost may be situated within the locality of the site, but likely not in the site itself. The observations made during the surveys suggest that a low number of common and widespread bat species are occasionally commuting over the site to forage elsewhere and are also foraging within the site itself to an extent.

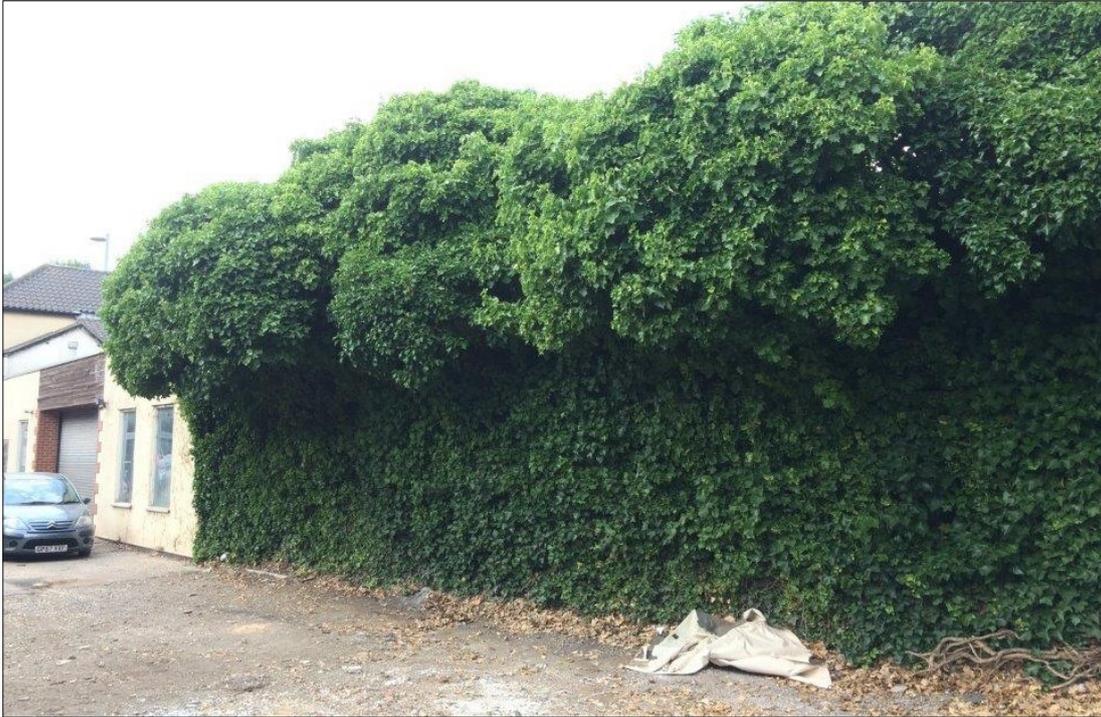
PHOTOGRAPH 1: Ivy-covered wall adjacent to Building B11

- 3.2.7. In addition to the external surveys, a single dusk emergence survey was undertaken on the Ivy-covered wall adjacent to Building B11 (Photograph 1), on 14 June 2022. The surveyor

- 4.1.12. Building B10 is a single-storey electrical substation of brick construction with a flat felt roof. This building is in good condition.
- 4.1.13. Building B11 is a two-storey brick building with a pitched / hipped concrete tile roof, with wooden soffit boxes (Photograph 2). There are no obvious gaps present. The building is currently occupied by a printing business. There is no loft space present. A separate single storey storage unit with steel sliding doors is present to the rear of the building, currently used as a storage facility by Scope. This warehouse has metal roofing panels with plastic skylights. There is a large Ivy-covered wall to the rear of the building (Photograph 1).

- 5.3.1. A single dusk emergence survey was completed on 14 June 2022 on the Ivy-covered wall adjacent to Building B11.
- 5.3.2. No bats were observed emerging from the wall or adjacent building.
- 5.3.3. The weather conditions and timings of the survey are summarised in table 5.1 below.

- 6.1.1. No evidence of roosting bats was recorded during the external inspection of the buildings on-site in January 2022. The emergence survey undertaken in June 2022 recorded no emergences from the Ivy-covered wall adjacent to Building B11. No emergences were observed from the adjacent building.
- 6.1.2. Common Pipistrelle was the most frequently recorded species across the site, but bat activity was low overall, during both the emergence and activity survey in June 2022. Bats were observed foraging within the site and commuting over the site.
- 6.1.3. The trees on-site do not offer any opportunities for roosting bats.

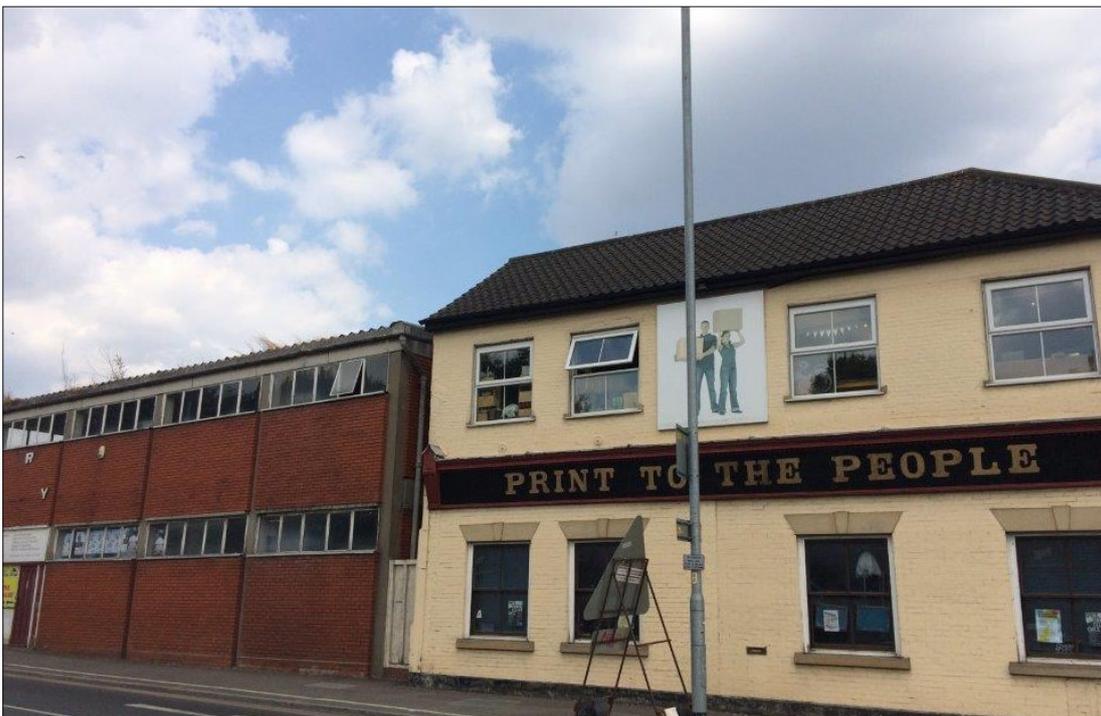
PHOTOGRAPH 2: Buildings B11 and B12

- 4.1.14. Building B12 is a two-storey brick-built building adjoining building B11. It has a felt corrugated steel roof (Photograph 2).
- 4.1.15. Building B13 is not included within the hybrid application site boundary but is an enclave within the site. It is a two-storey brick-built building with a flat roof with artificial slates around the edge. The building is in good condition with no obvious gaps.
