Phase 2 Site Investigation Report

at Carrow Works,
Bracondale, Norwich,
Norfolk, NRI 2DD

for Unilever (UK) Ltd &
Britvic Soft Drinks Ltd

Report Reference:
LP01671/ Phase 2/ DRAFT

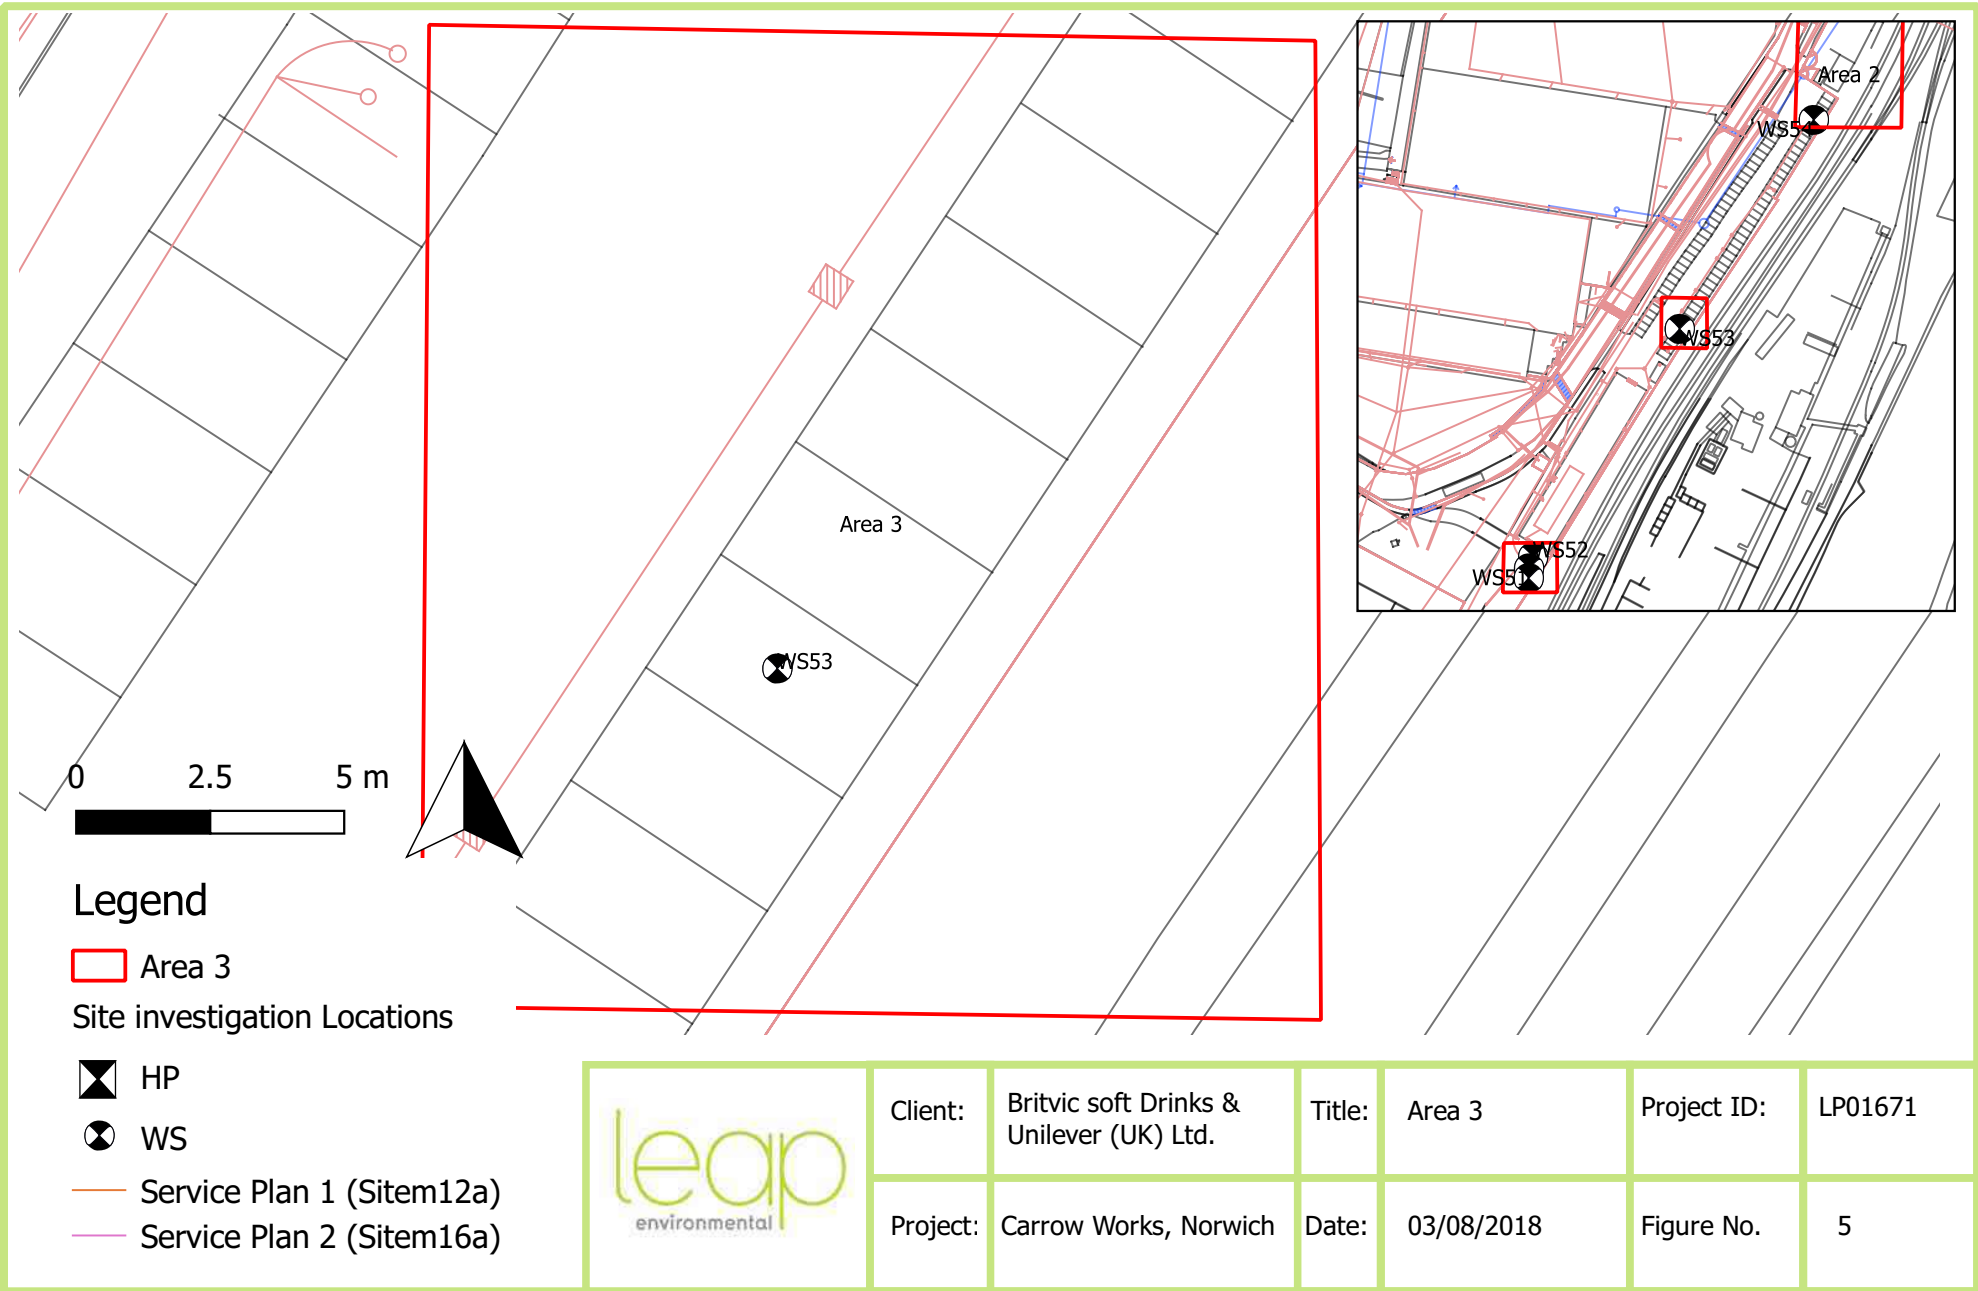
Client:	Britvic soft Drinks & Unilever (UK) Ltd.	Title:	Area 3	Project ID:	LP01671
	Project:	Carrow Works, Norwich	Date:	03/08/2018	Figure No.	5

- Area 3
- Site investigation Locations
- HP
- WS
- Service Plan 1 (Sitem12a)
- Service Plan 2 (Sitem16a)

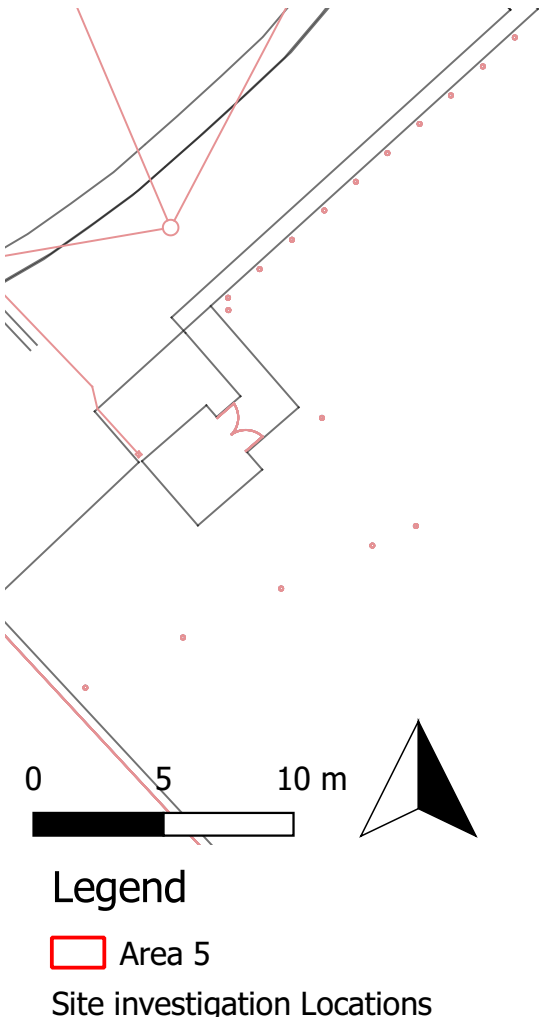
Client:	Britvic soft Drinks & Unilever (UK) Ltd.	Title:	Area 5	Project ID:	LP01671
	Project:	Carrow Works, Norwich	Date:	03/08/2018	Figure No.	7

- Area 5
- Site investigation Locations
- HP
- WS
- Service Plan 1 (Sitem12a)
- Service Plan 2 (Sitem16a)

WS44
