BETHEL HOSPITAL, NORWICH
GAZETTEER
ISSUE 3
NOVEMBER 2016

This Gazetteer has been written to accompany the Conservation Management Plan (CMP) for Bethel Hospital. It is a room by room assessment of most of the site with the occupied flats generally having a single entry. The Gazetteer is intended as a reference guide to allow the status of a particular structure or interior to be checked if a change or conservation works are proposed. A location plan and photographs are included for each entry.

The Gazetteer has been prepared by the authors of this document based on a site visit to each area in late January and early February 2016.

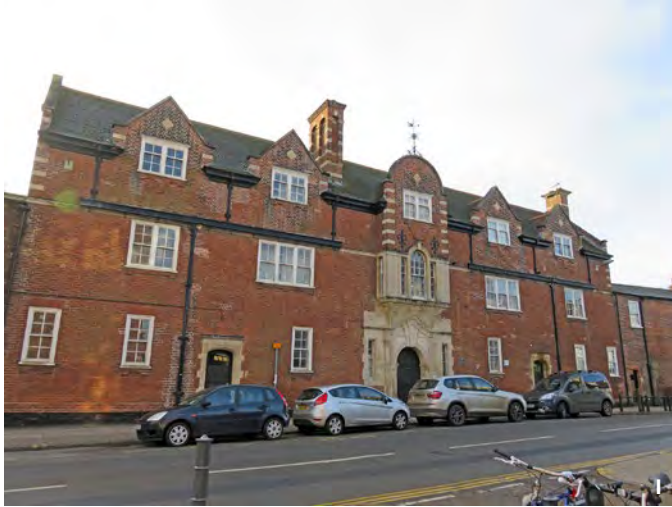
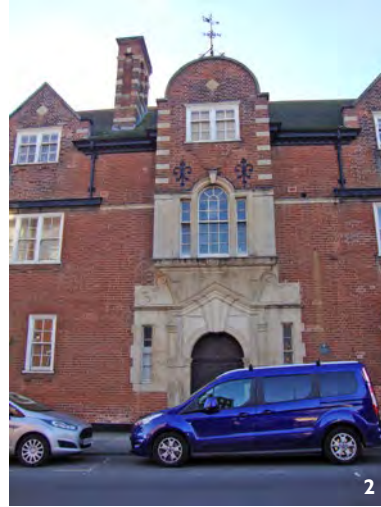
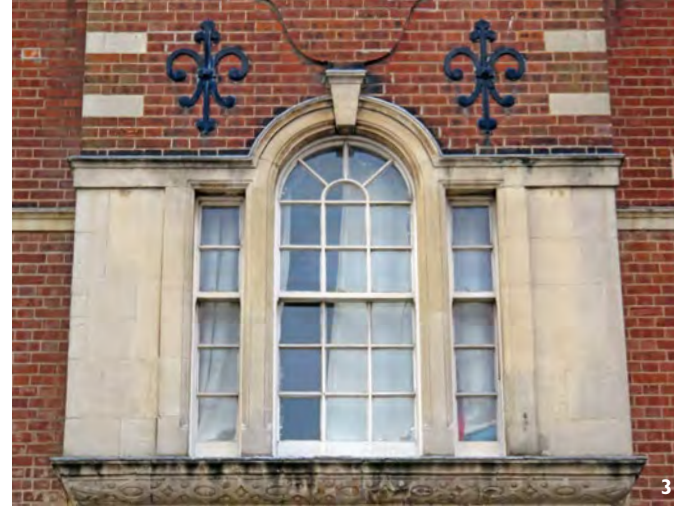
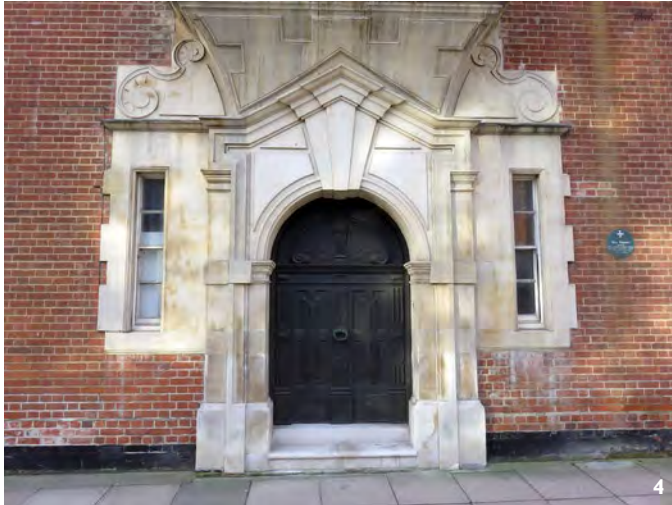
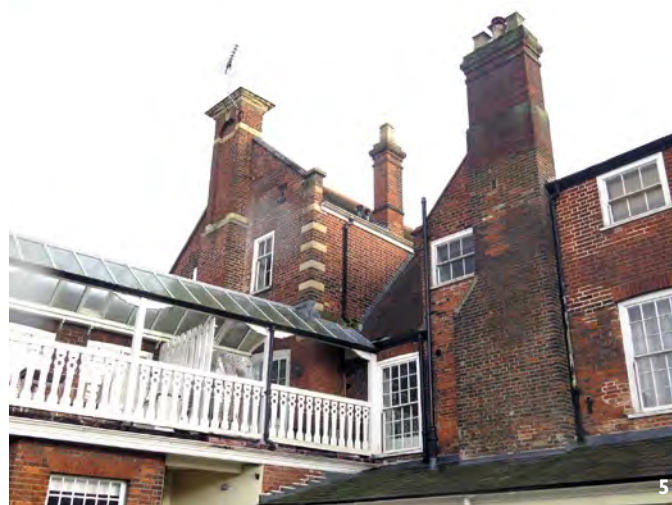
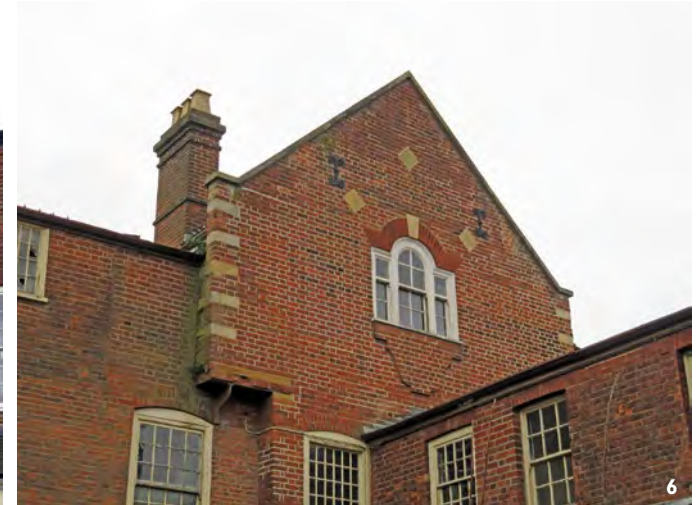
The brickwork is in adequate condition although there is approximately three metres linear length of mortar joints missing and a number of areas which have been repointed in cement mortar. There are some areas of staining to the brickwork below the windows either side of the main door and from every overflow pipe. The paint on the window frames and windows is peeling, badly in some cases.

The stone string course over the first floor windows is stained, particularly under the gutter. The stone surrounds to the side doors and the main central door are very badly stained in places. There are areas of spalled stone around the base and the sides of the central door surround. There is also some spalled brickwork in the painted plinth. There is some cracking to the stone plinth to the west chimney and also to the brickwork to the east chimney.

There is considerable moss growth to the black painted damp-proof course at the base of the elevations. There is some vegetation growth from the gutters and on the roof, as well as some moss growth on the parapet coping of the north roof slope at the west end of the elevation. The rainwater pipe adjacent to the door into G36 is cracked and there is water running down the elevation and significant staining and moss growth at this point.

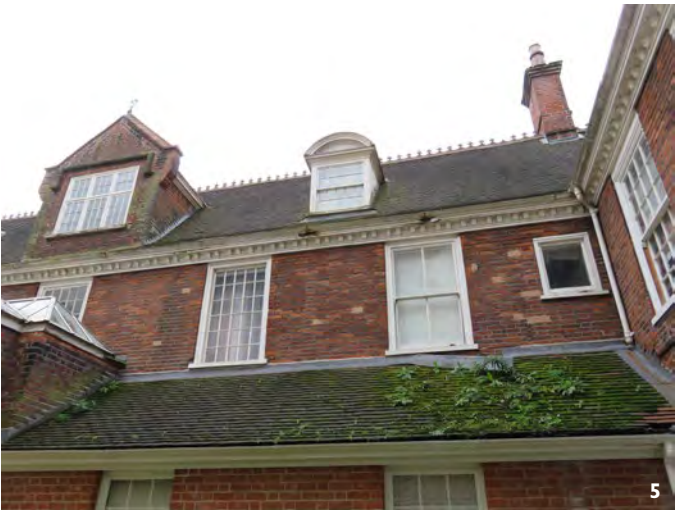
- 4 West wall
- 5 South Elevation: rotten areas of cornice corresponding to failed gutter joints and slipped lead flashing and vegetation growth

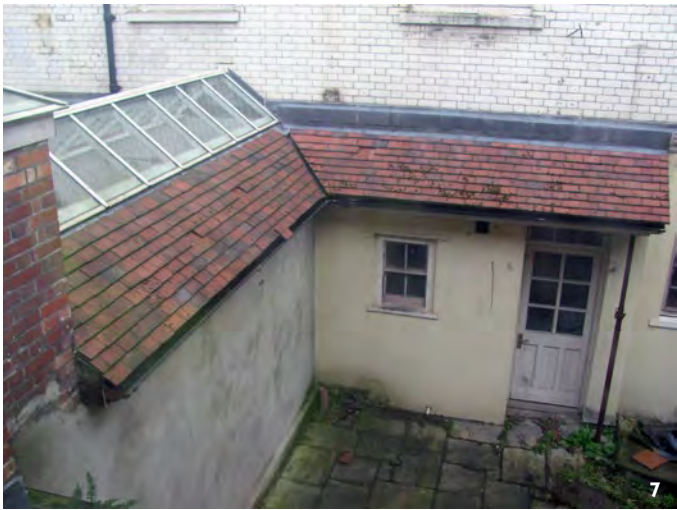
- 1 East elevation
- 2 View of the courtyard from the Central Range
- 3 North elevation
- 4 West wall
- 5 Upper part of the south elevation
- 6 Lower part of the south elevation
- 7 Slipped and missing tiles to west elevation

The west elevation is in fairly poor condition. The render has not been painted and now has areas which have gone green. There are areas of green brickwork under the corridor rooflight and one missing and one slipped tile.

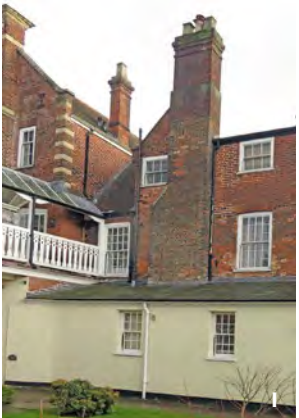
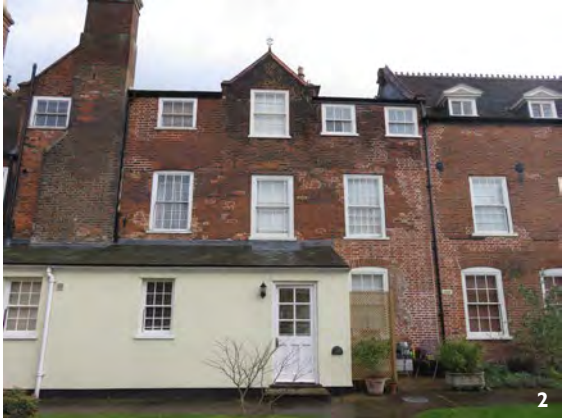
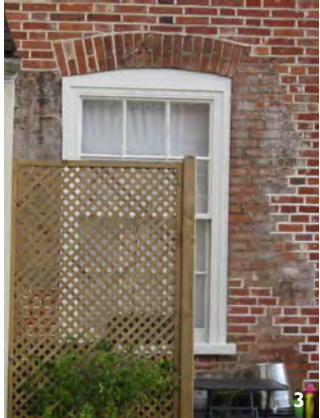
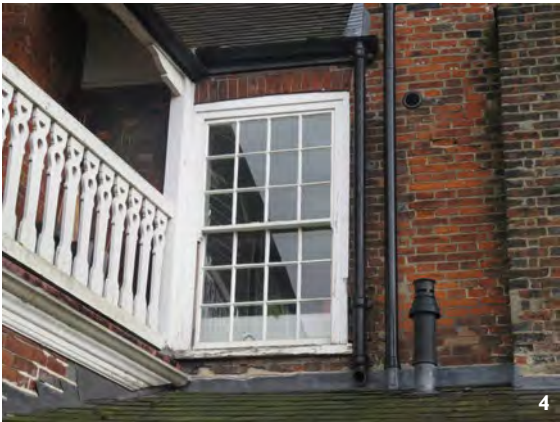
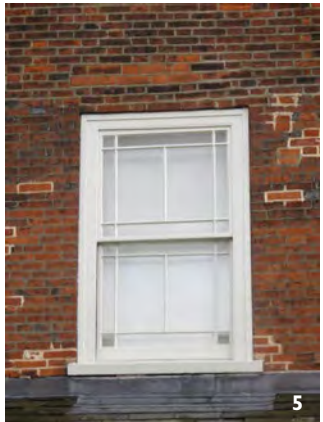
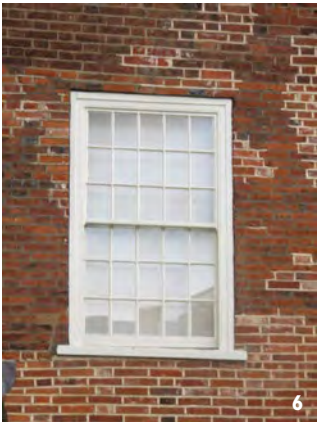
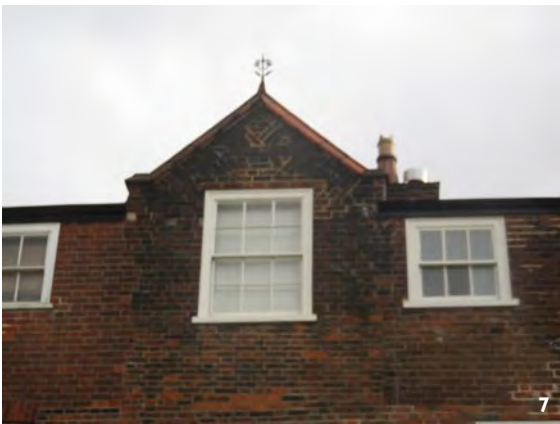
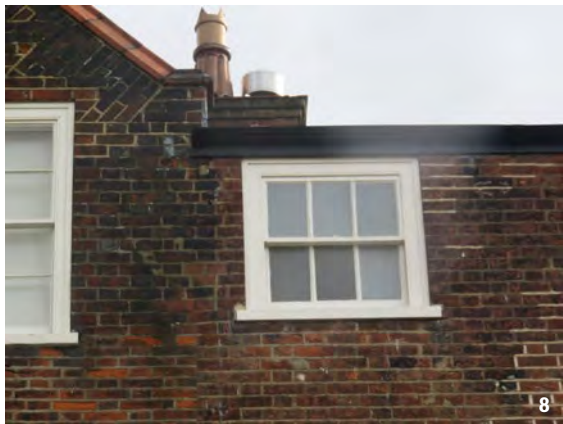
- 1 West elevation
- 2 West elevation
- 3 Ground floor window
- 4 Modern sash at northern end
- 5 First floor sash window, the only one of this design in Bethel
- 6 Southern first floor sash window
- 7 Gable dormer
- 8 Typical second floor window

Generally good condition. Some green moss/lichen growth to the lean-to roof and to the chimney. Windows adjacent to chimney in slightly worse condition with staining to the sills. Rainwater pipe by chimney looks in poor condition with area of decay at first floor level. There has been a significant amount of repointing and some of the bricks are stained black but otherwise brickwork appears in good condition.

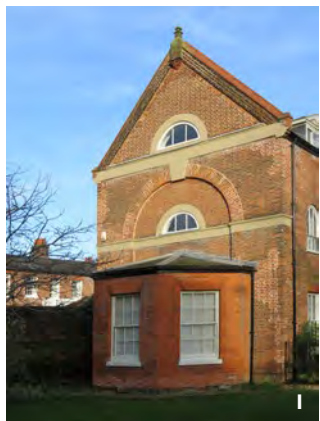
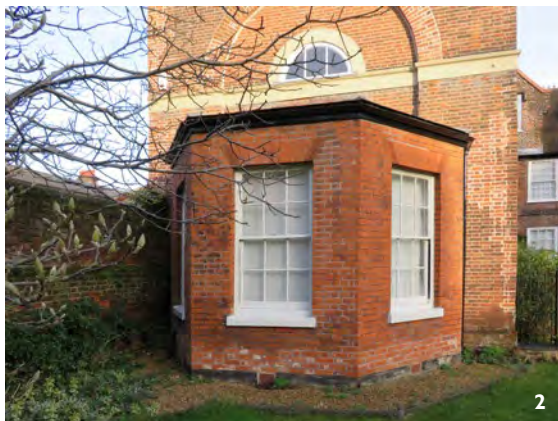
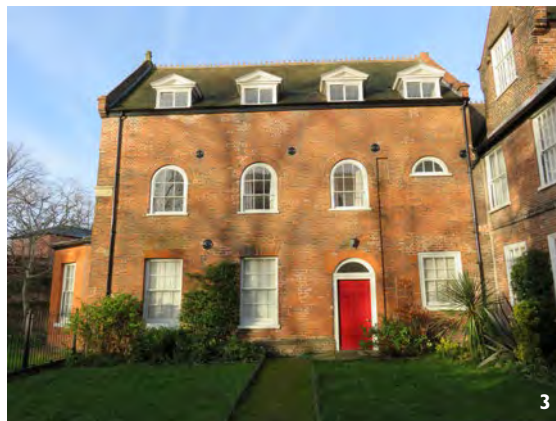
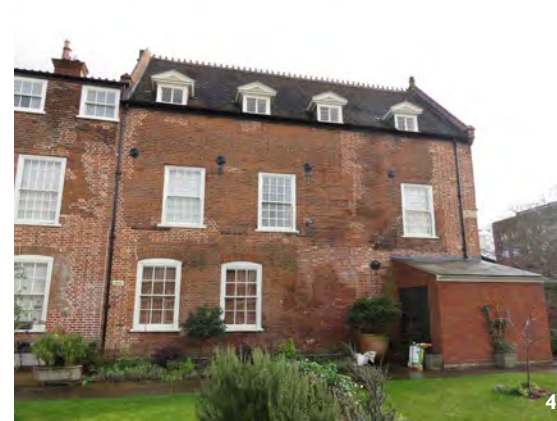
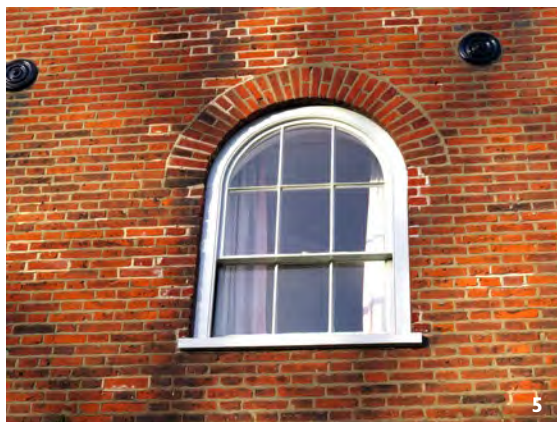
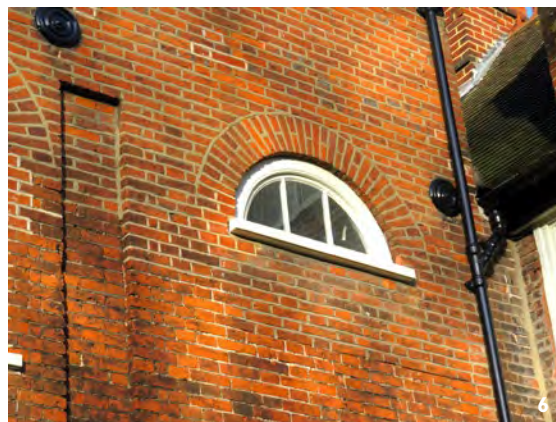
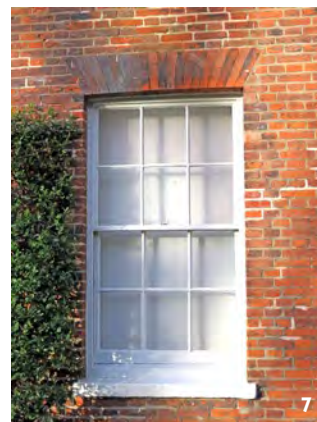
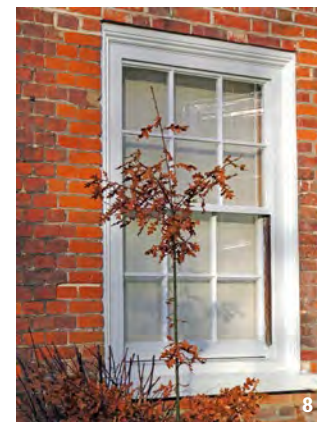
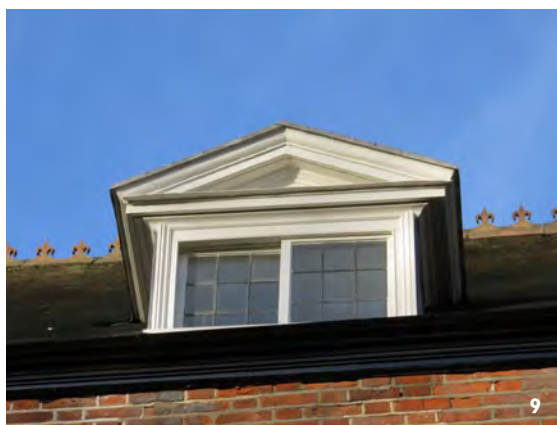
- 1 South elevation
- 2 Bay
- 3 East elevation
- 4 West elevation
- 5 Typical first floor sash window
- 6 First floor lunette in east elevation
- 7 One of two southern sash windows at ground floor of east elevation
- 8 North ground floor window in east elevation
- 9 Typical dormer

Generally good. Some local areas of repointing needed; areas of cement mortar. Some areas of spalling brickwork and in areas it looks like the brickwork has been covered with mortar. Crack above the door from the light. Isolated damp over southernmost ground floor window.

The roof is quite green but no missing tiles. Small amounts of vegetation to the capping tiles over the parapet walls and also to the brickwork at the top of the gable end.

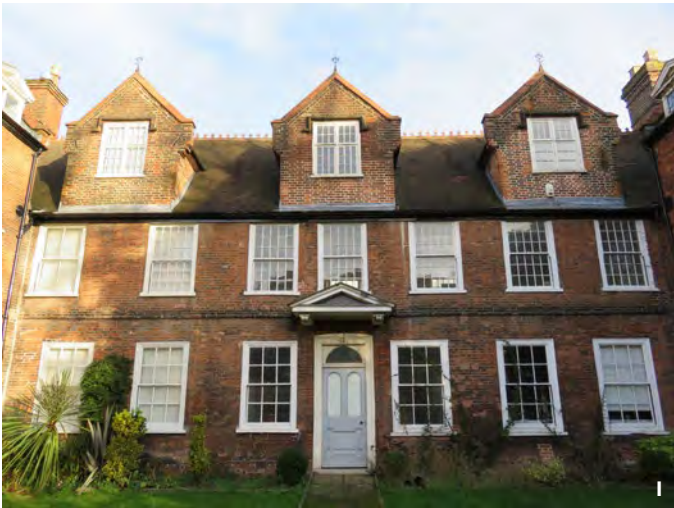
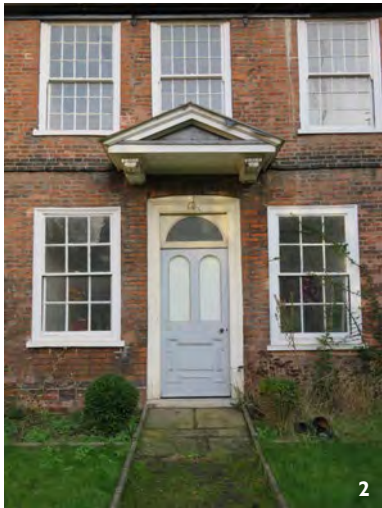
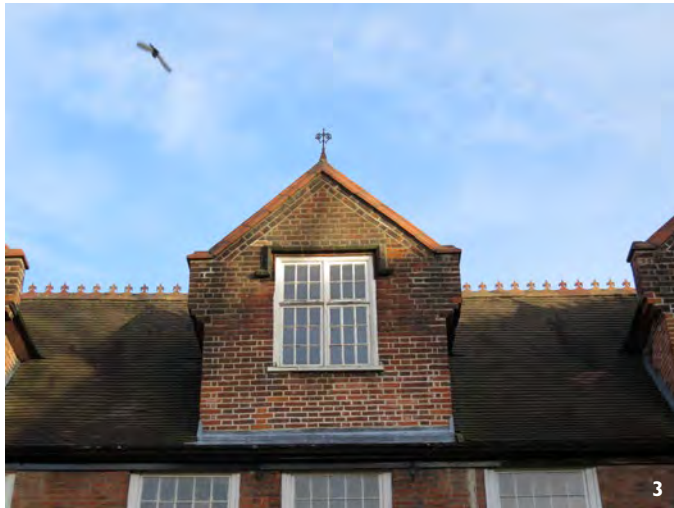
- 1 South façade
- 2 Exterior door
- 3 Typical second floor dormer

The brickwork is in a fairly poor condition. There are a number of areas of spalled brickwork and missing mortar throughout the elevation and a large crack at first floor level to the west of the central window. The brickwork under the east and west dormer windows appears to be bulging.

The pediment over the door is in particularly poor condition; it has no lead covering so the timber is exposed. The brickwork between the top of the pediment and the window above is in a very poor condition.

The roof tiles are in adequate condition, however there does appear to be some missing or slipped tiles on the east side of the central dormer and also in the south east corner of the roof. The gutter appears to be in adequate condition although there are some areas which may be damp directly below it.

The windows and timber door are in poor condition with peeling paint to windows and sills and the glazing to the door boarded up.

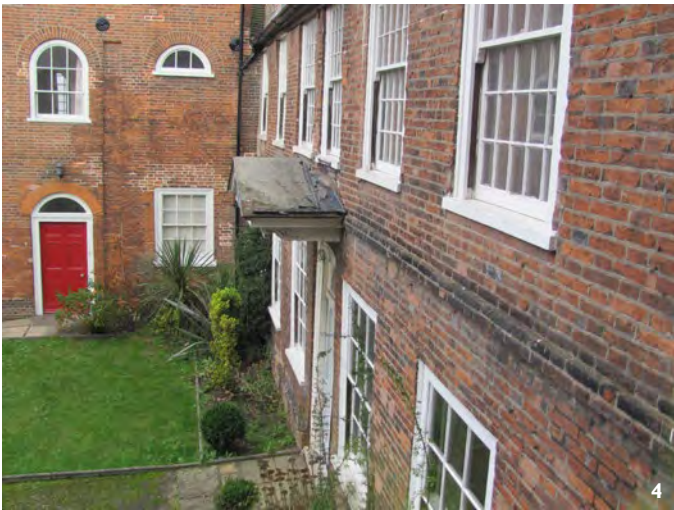
- 4 No lead covering to pediment over door
- 5 Bowing to second floor dormer

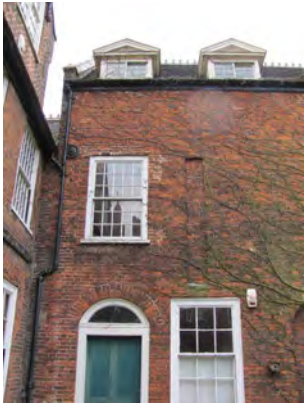
Plant growth over elevation and blocked gutter

The south elevation of this range has severe structural problems and has been temporarily shored with scaffolding. The west elevation is covered with plant growth. This elevation is also damp in places and the gutter needs repairing and cleaning. This has led to water ingress and mould growth internally on the second floor. The swan neck of the rainwater pipe at the north end of the elevation is blocked and causing damp to appear internally at the ground floor.

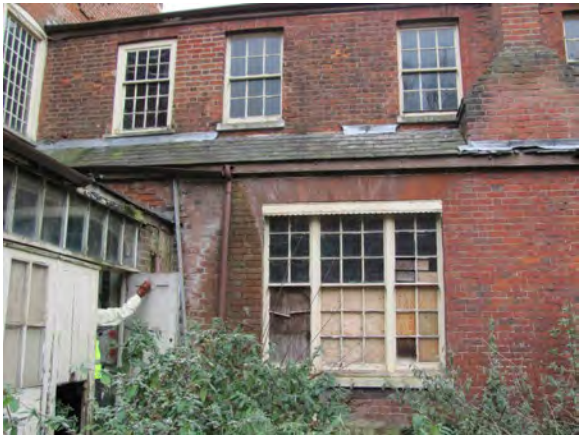
Missing flashing and gutter

The brickwork is in adequate condition with some areas of spalled brickwork and some bricks which have been replaced or covered with a cement mortar. At the west end of the ground floor lean-to is a considerable area of damp brickwork where the gutter has broken away.

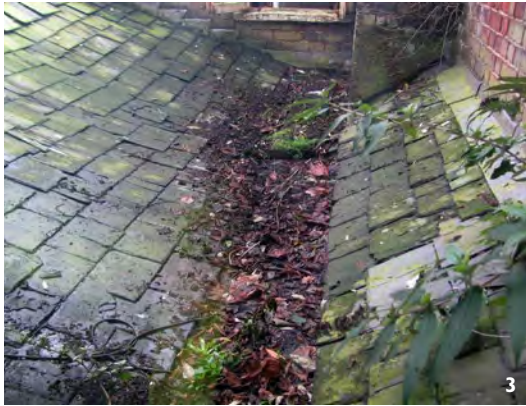
- 3 Leaf and vegetation build up to valley gutter
- 4 Flashing over hip slipped past eaves
- 5 Severe cracking to chimney

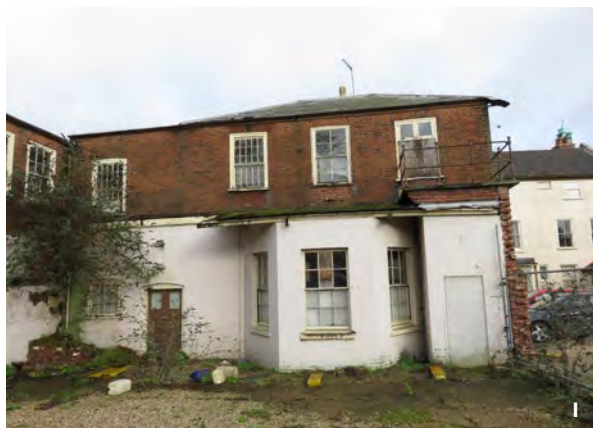
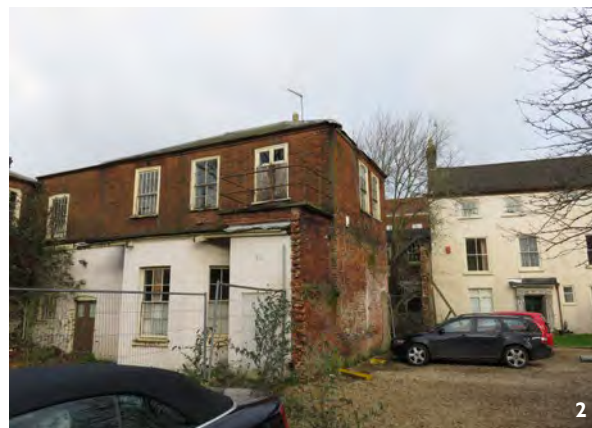
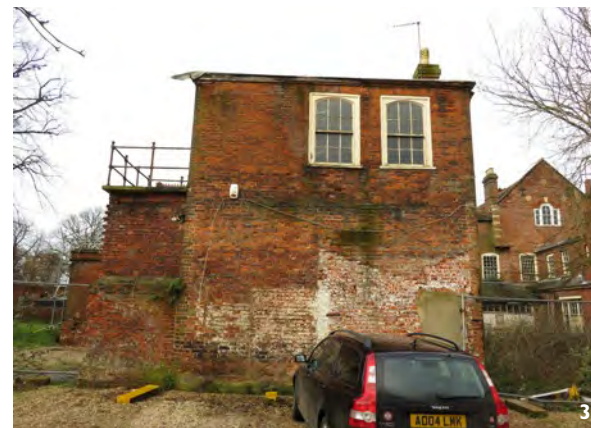
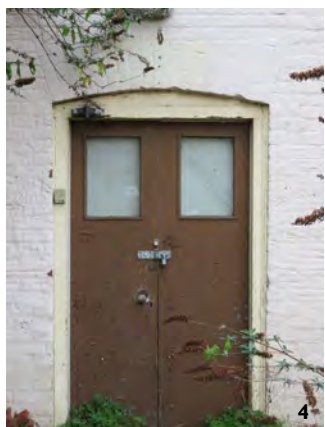
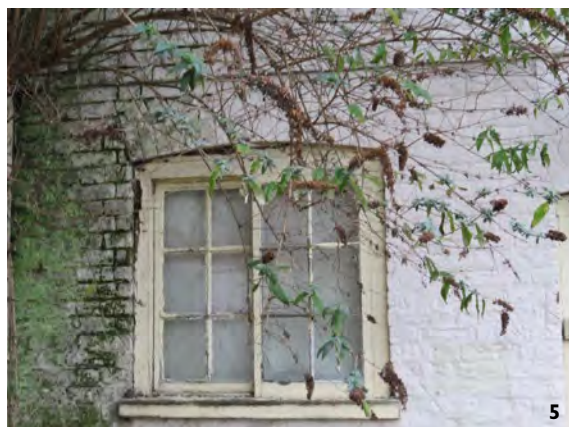
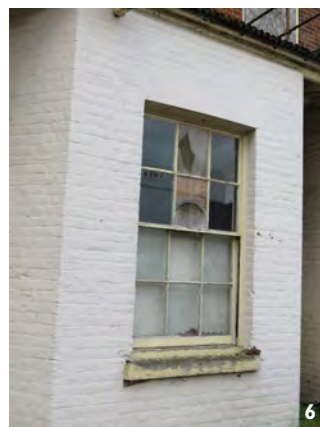
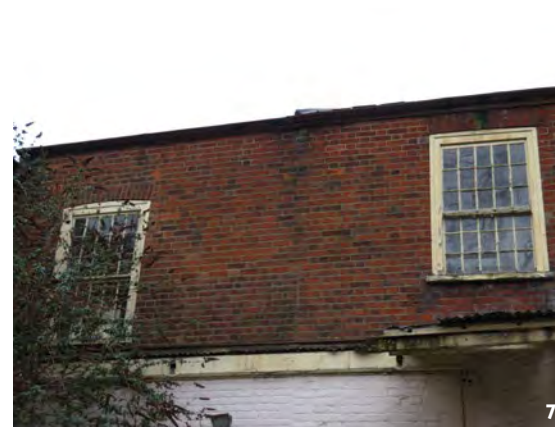
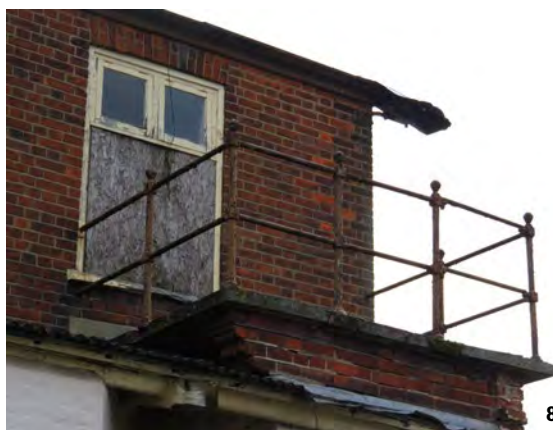
- 1 South elevation
- 2 South and east elevations
- 3 East elevation
- 4 Door
- 5 Horizontal sliding sash
- 6 Typical window in bay
- 7 First floor windows and brickwork joint
- 8 Railings

As on the north side of this roof, the lead flashings have slipped off the roof past the eaves. The corrugated sheet roof over the canted bay is in poor condition and is very green. The rest of this corrugated roof has been removed leaving a small section against the south elevation.

On the east elevation is evidence of a former roof line, now removed, leaving the brickwork in a poor condition. The render is in poor condition, but the brickwork is in reasonable condition. The windows are rotten with broken and missing glazing.

The first floor metal railing is badly rusted and the flat roof over the store looks in poor condition, although this was not inspected more closely.

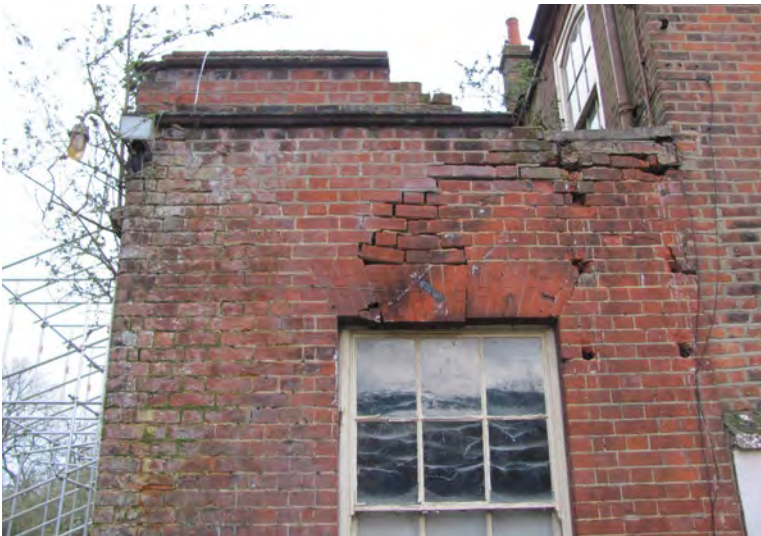
Window head dropped causing collapse of parapet

The brickwork is green and spalled in some places with moss growth to the tiled pediment over the door. There are two large cracks to the south elevation, one from the sill of the easternmost window and one from the brick arch over this window extending towards the string course. There is considerable moss and vegetation growth on the wall behind the rainwater pipe. The window head has dropped resulting in cracking and open coursing and the loss of the north end of the parapet.

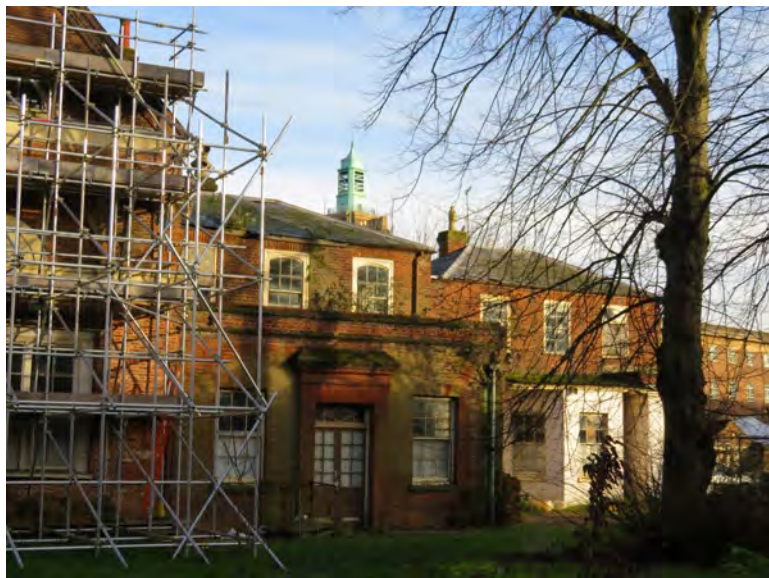
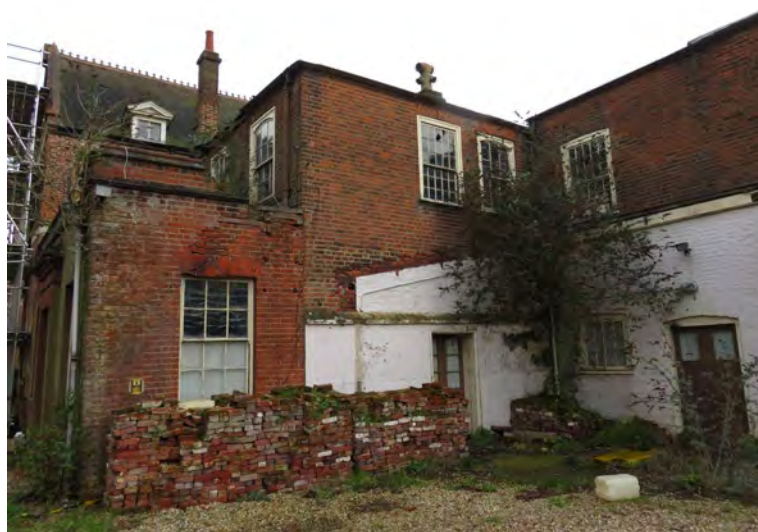
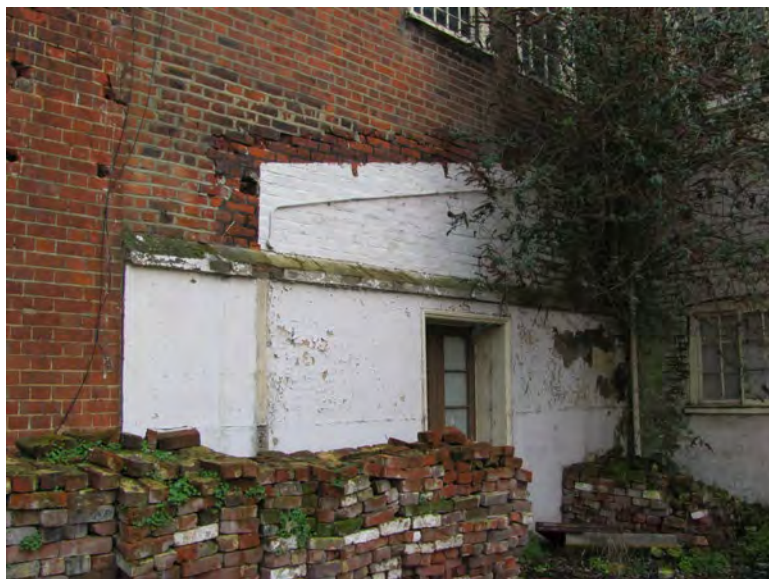
There are missing and slipped slates to the roof and the lead flashing has slipped off past the eaves. The gutter appears to be missing from the south end of the elevation and the fascia in poor condition.

There is considerable amount of spalled brickwork and a number of bricks replaced or covered with cement mortar. The door has been covered with cement render. There is some vegetation growth where this elevation meets the plinth of the adjacent wall and areas of damp.

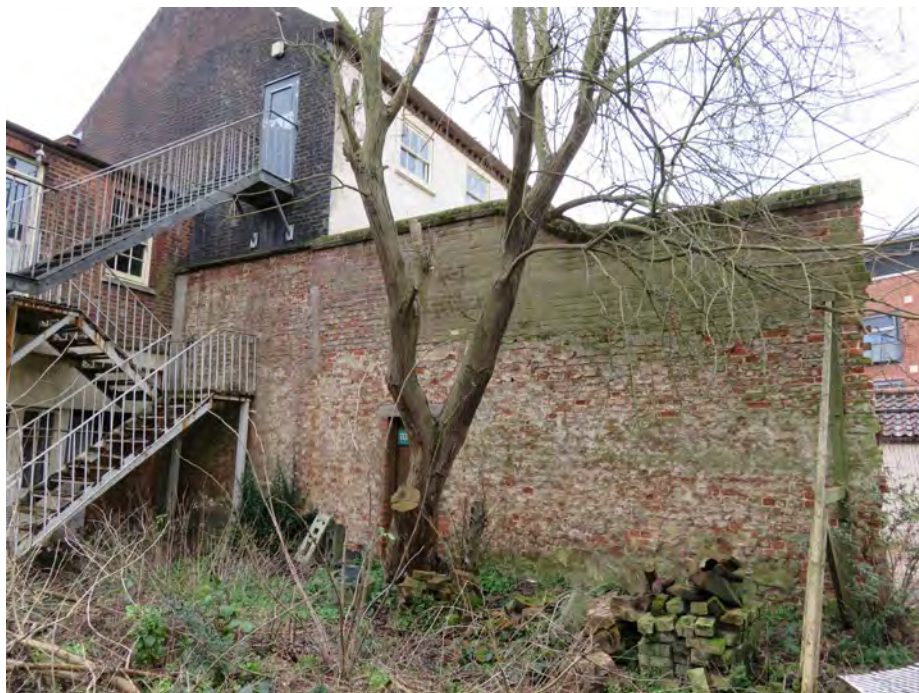
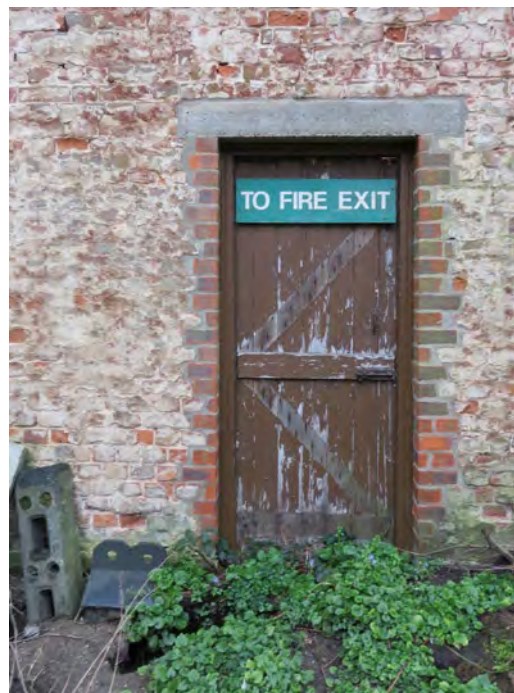
South end of wall missing. Remaining wall being supported. From the east, brickwork marked where render removed. Cement infills or replacement in places. There is a large crack from the coping down eight courses. The coping has considerable moss growth and some broken bricks. The timber gate is in poor condition with most paint gone.

From the west, the brickwork is green with a considerable amount of spalled bricks and areas of repair in cement mortar. Some render still remains at base, but most has been removed or fallen off.

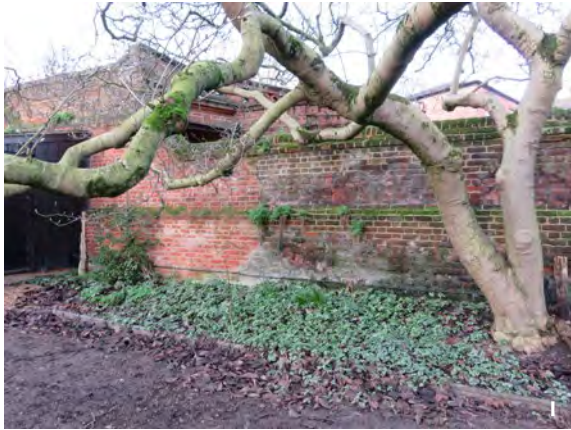
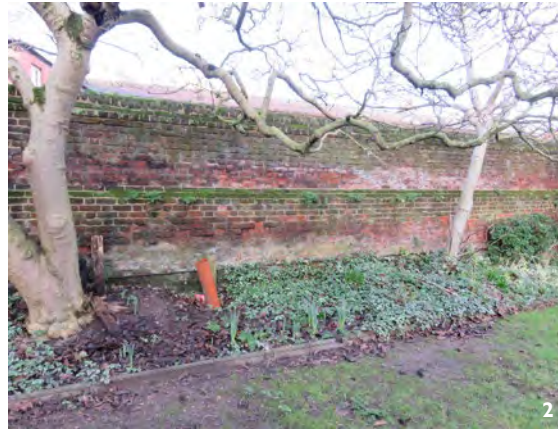
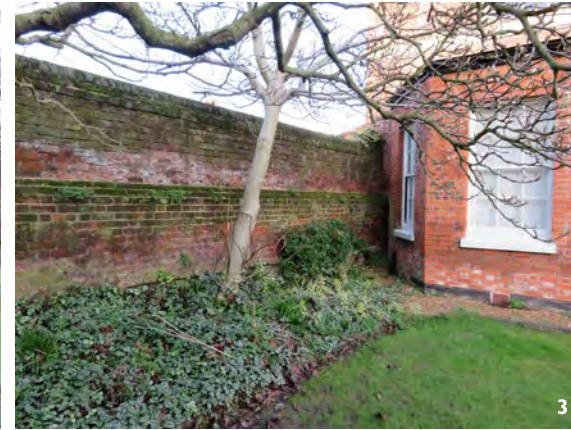
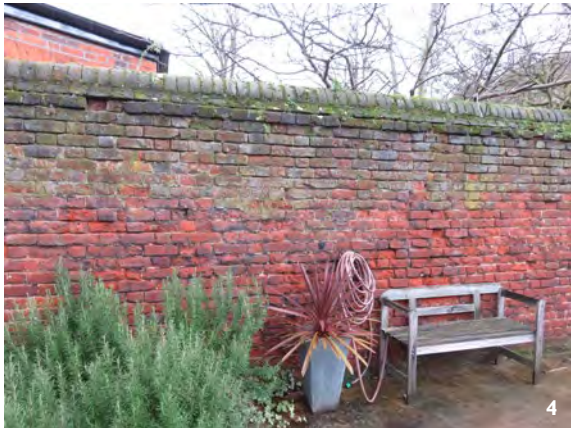
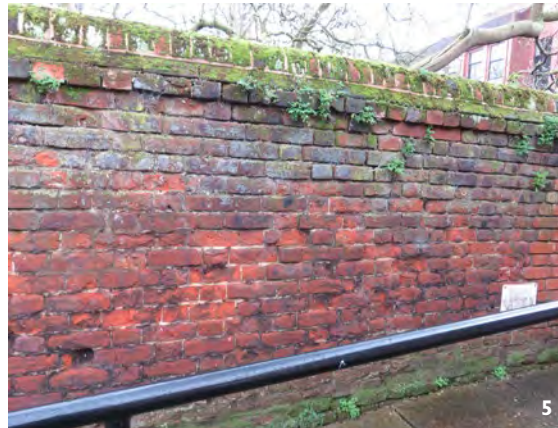
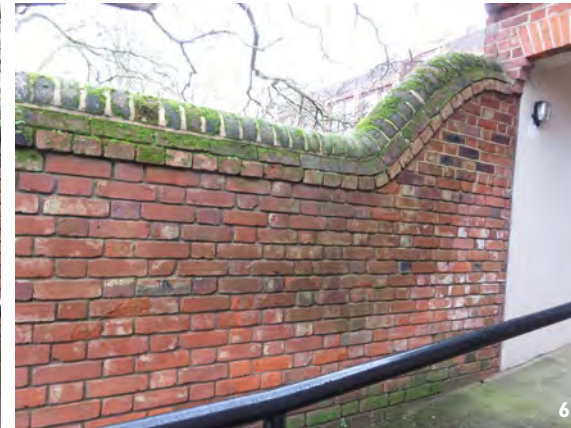
- 1 West side (part of central section)
- 2 West side (southern section)
- 3 East side (southern section)
- 4 East side (northern section)
- 5 Modern door, steps and shed at southern end
- 6 West side (northern section)

Generally reasonable. From Little Bethel Court side, the wall is greener and damper towards the top and the base and has moss growth to the coping bricks and vegetation to the base. There are a number of spalled bricks and areas of missing mortar. From the east, the wall is green with more moss and vegetation growth at the base, top and where the wall widens. Again there are a number of spalled bricks and areas of missing mortar.

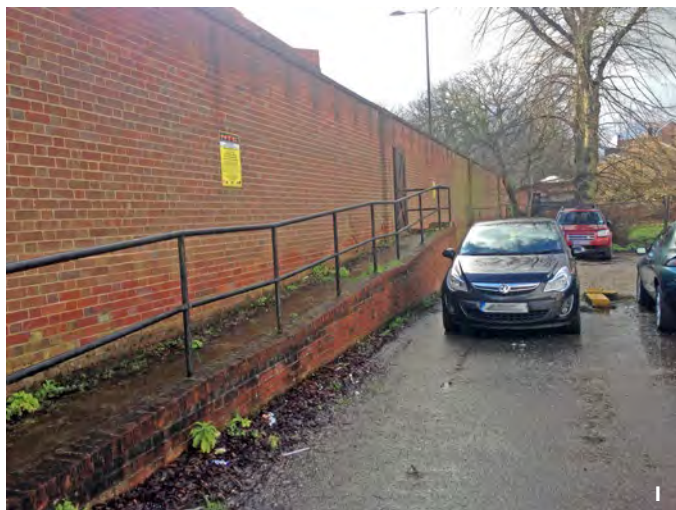
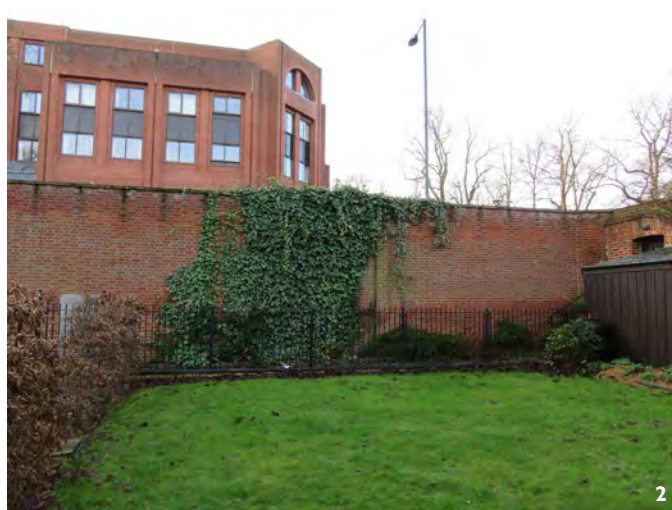
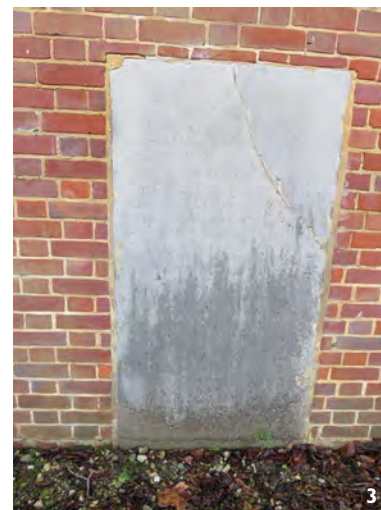
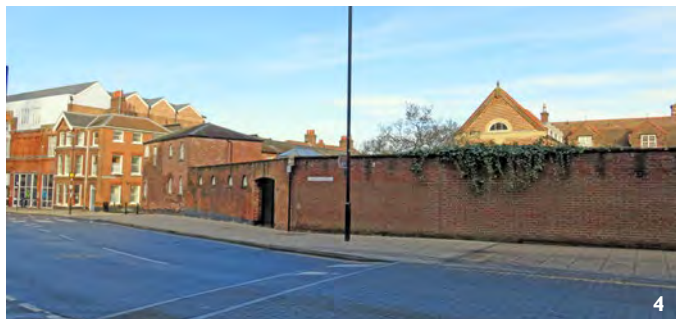
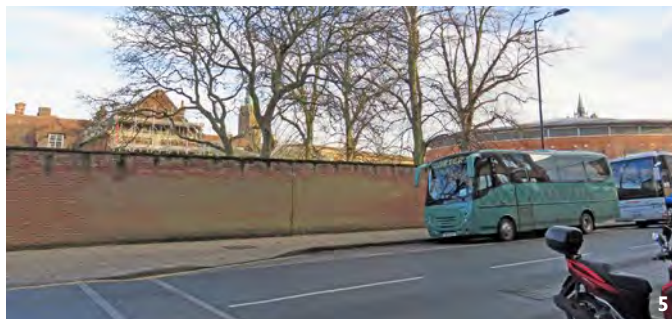
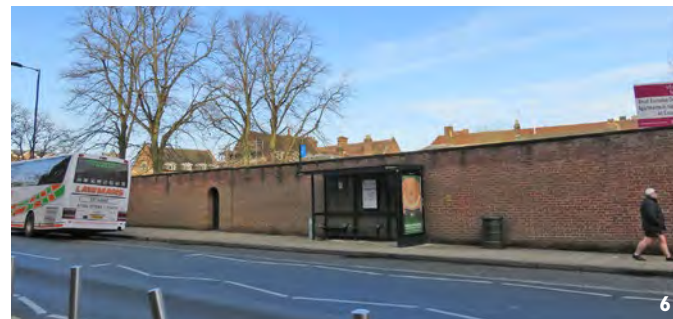
- 1 North side (eastern end and brick ramp)
- 2 North side (western end)
- 3 Mary Chapman commemorative stone
- 4 South side (western end)
- 5 South side (central section)
- 6 South side (eastern end)

Generally the wall is in reasonable condition, with some green staining and some areas of damp at the top and some moss growth to the coping stone. At the west end of the wall there is some ivy growth spreading over the top of the wall.

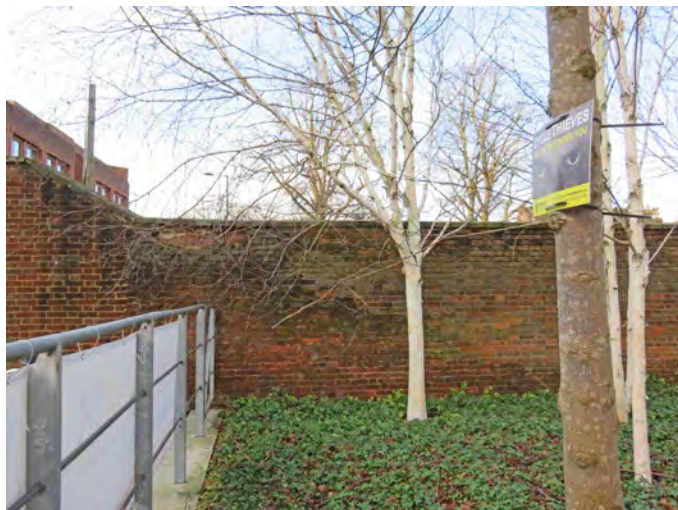
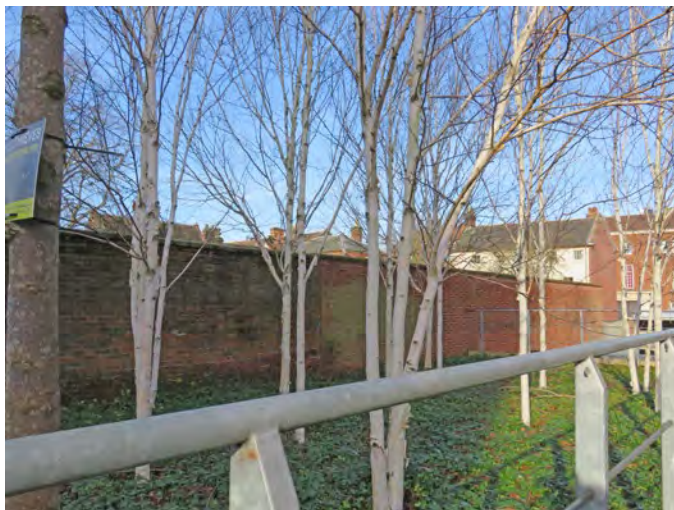
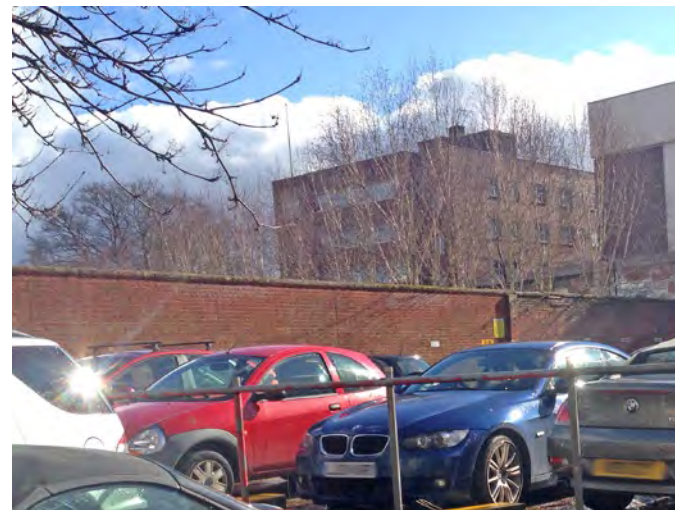
Generally in good condition with some green staining and minor moss growth to the top of the wall and coping.

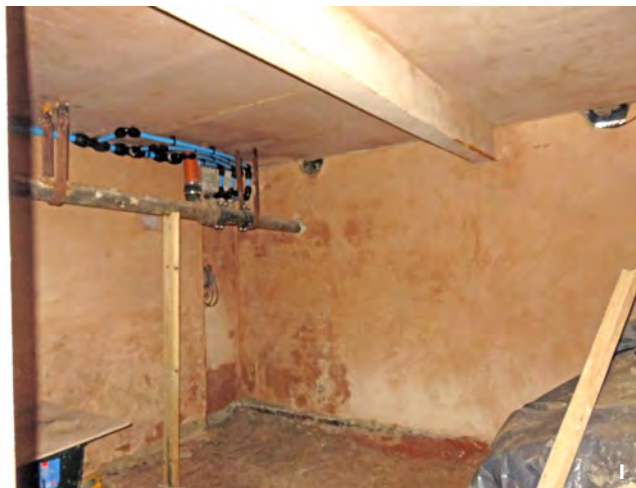
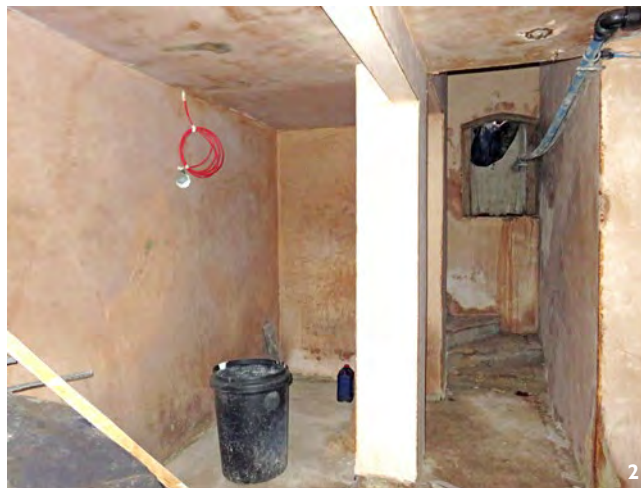
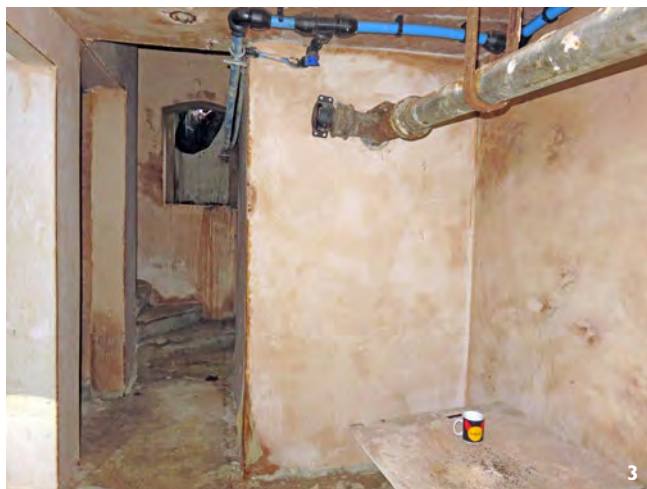
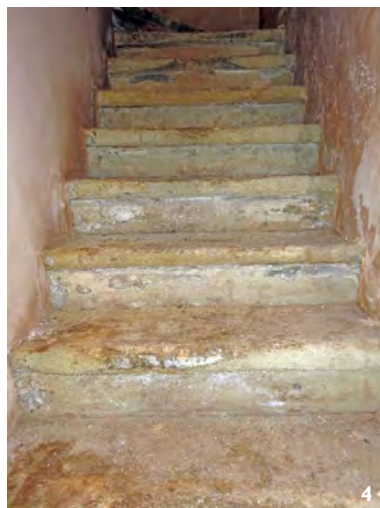
INTERNAL - BASEMENT: B3, BOARDMAN RANGE

- 1 West wall
- 2 East wall
- 3 South wall
- 4 Historic concrete stairs

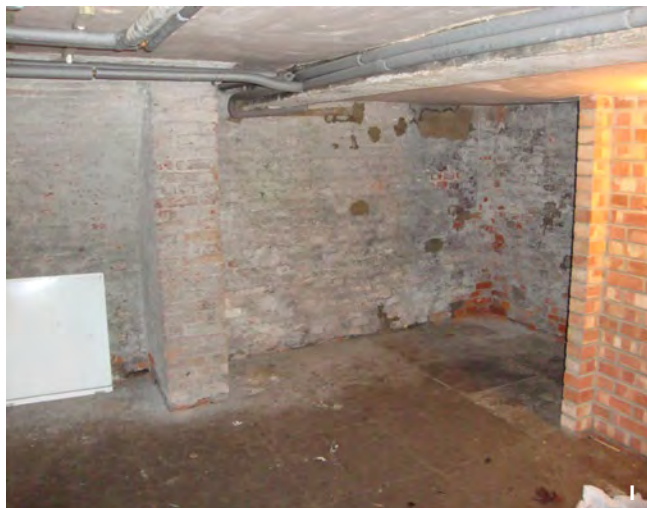
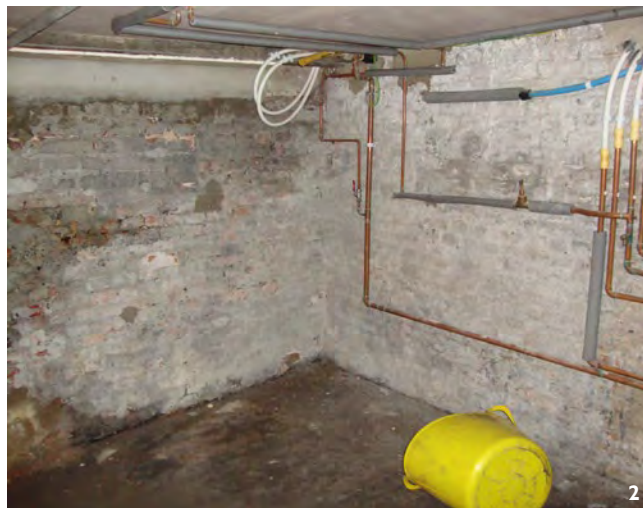
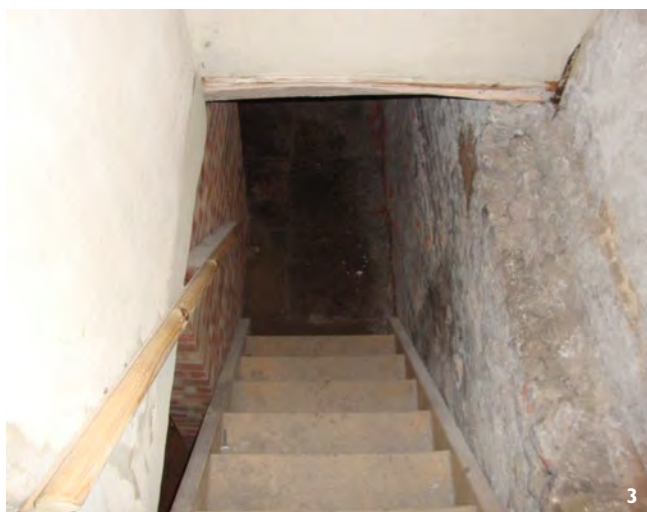
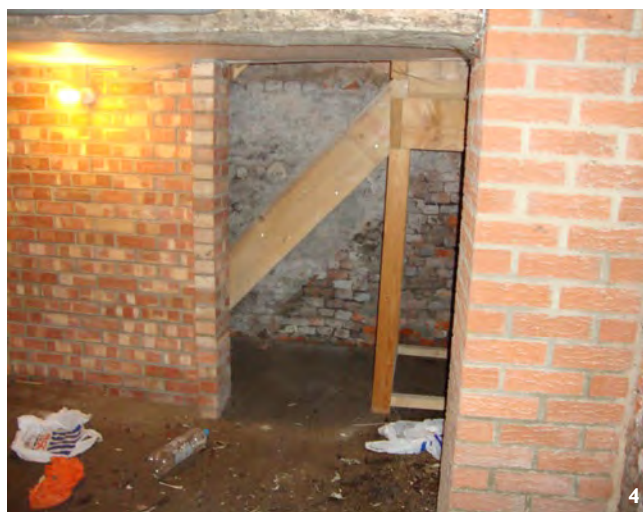
INTERNAL - BASEMENT: B4, EASTERN 1750s RANGE

- 1 Basement looking north-west
- 2 Basement looking south-east
- 3 Modern timber rail
- 4 Basement looking west

Good

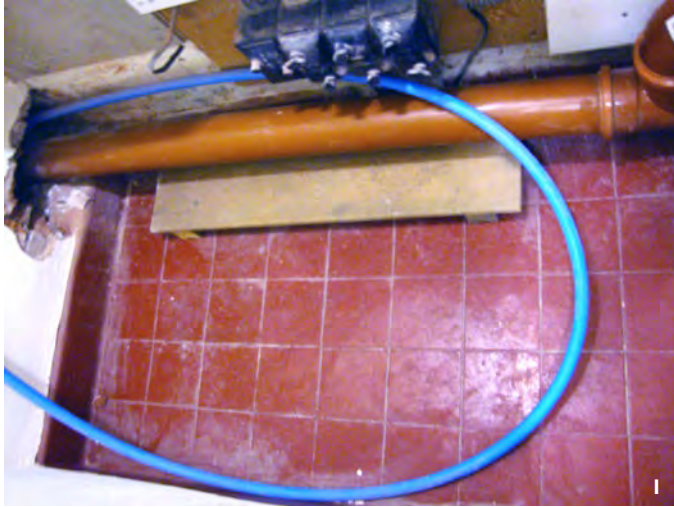
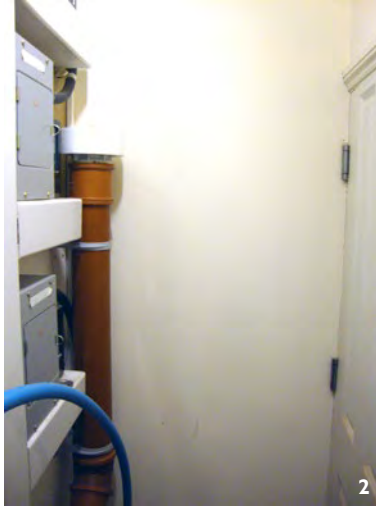
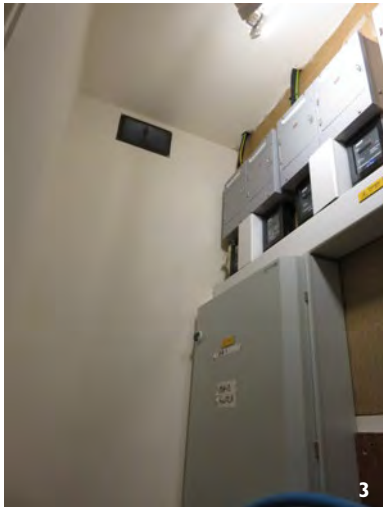
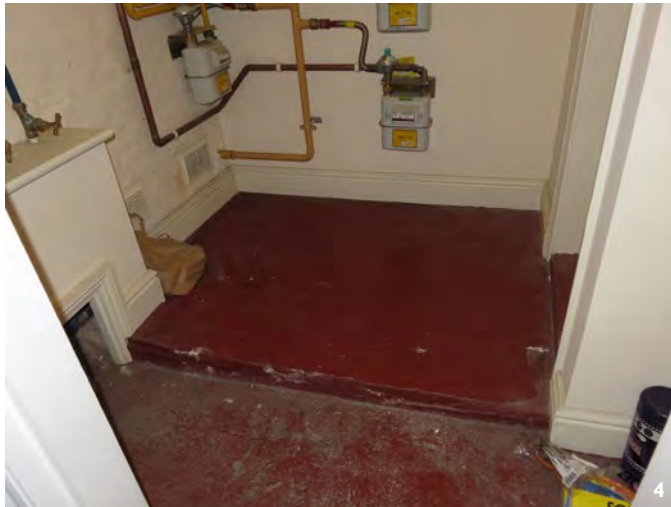
INTERNAL - GROUND FLOOR: G22 AND G23, BOARDMAN RANGE

- 1 Terracotta tiles
- 2 G23 looking west
- 3 G23 looking south-east
- 4 Step in G22

Fair – large hole for service pipe.
