BETHEL HOSPITAL, NORWICH
GAZETTEER
ISSUE 3
NOVEMBER 2016

This Gazetteer has been written to accompany the Conservation Management Plan (CMP) for Bethel Hospital. It is a room by room assessment of most of the site with the occupied flats generally having a single entry. The Gazetteer is intended as a reference guide to allow the status of a particular structure or interior to be checked if a change or conservation works are proposed. A location plan and photographs are included for each entry.

The Gazetteer has been prepared by the authors of this document based on a site visit to each area in late January and early February 2016.

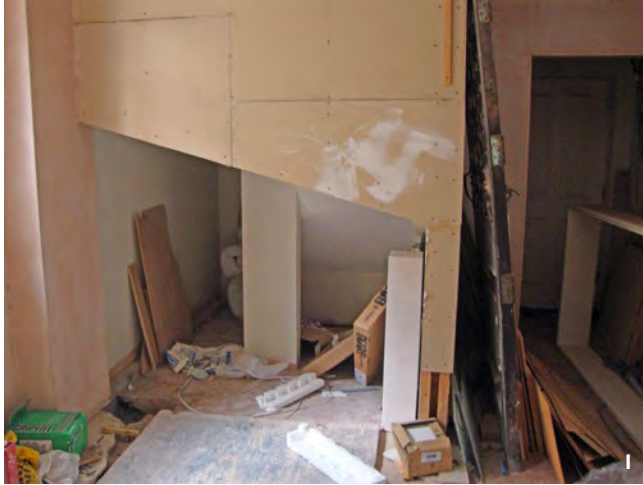
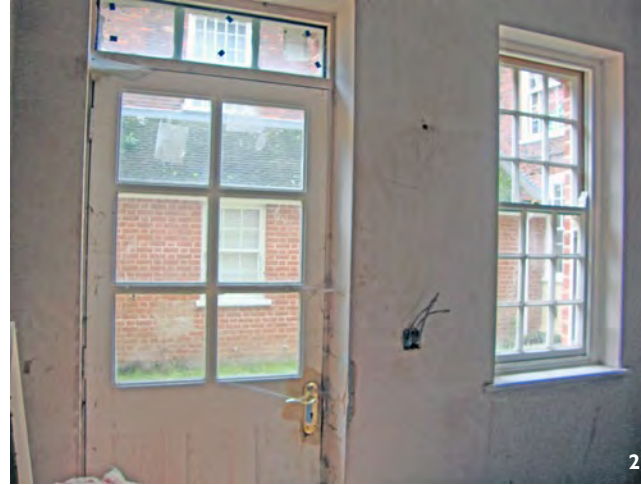
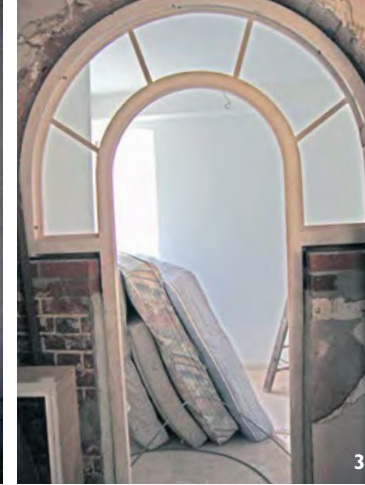
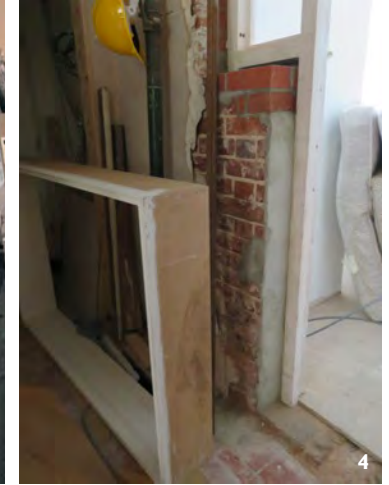
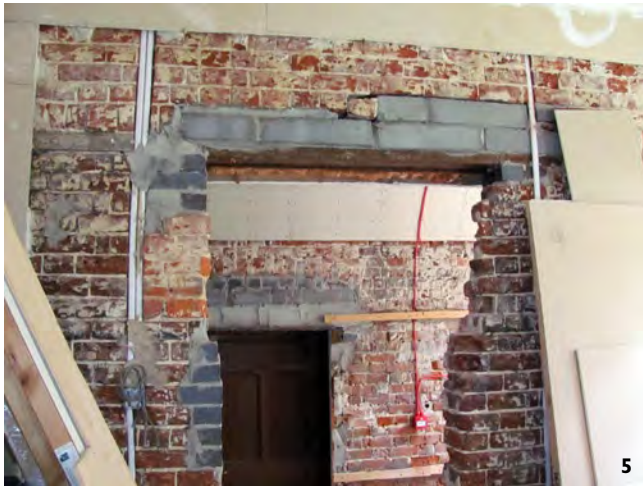
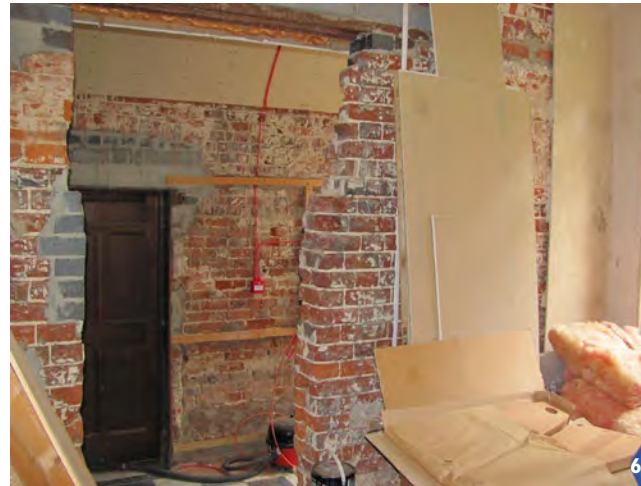
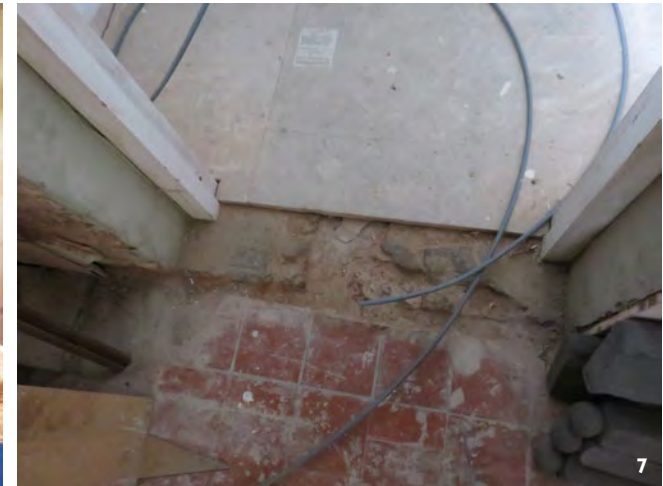
INTERNAL - GROUND FLOOR: G26, BOARDMAN RANGE

- 1 Area below stairs (G25)
- 2 Door and window
- 3 Modern joinery in opening to G27
- 4 Pier of historic brickwork, possibly mid-nineteenth century
- 5 View of doorway to G30 with modern bricks and cement mortar
- 6 Permitted modern opening in east wall to Central Passage showing variety of brickwork
- 7 Slate threshold and historic tiles

Part complete with open unguarded access to cellar. There is no plaster finish to ceiling or walls. No door, frame or architrave to doorway to G30 or door to archway to G27. Cement mortar and some modern bricks and blocks used in repairs to reveals of archway and doorway. One loose brick over lintel to doorway. Electrical first fix but second fix not completed.

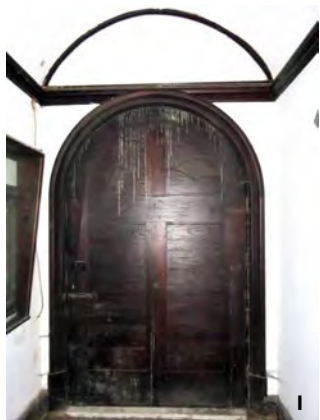
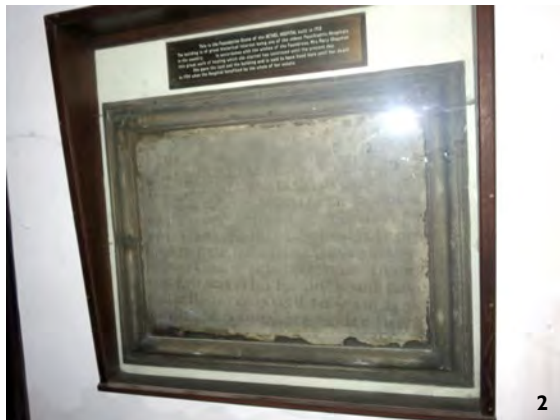
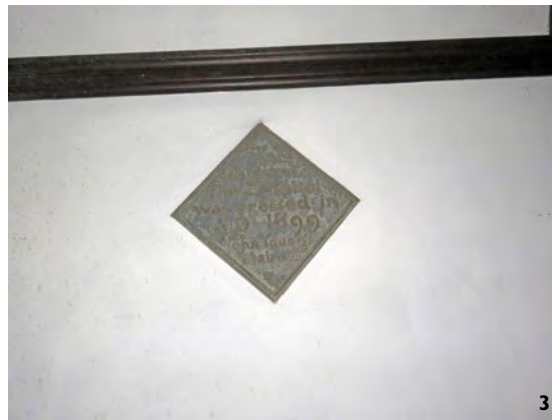
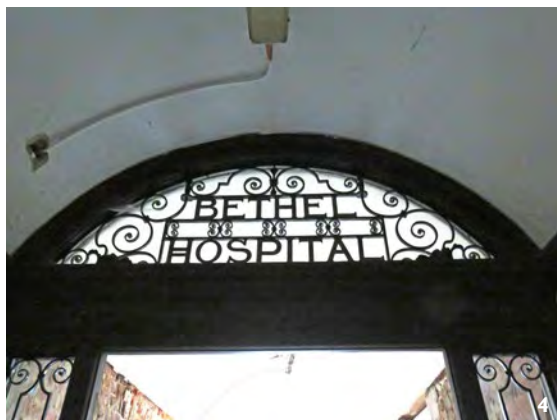
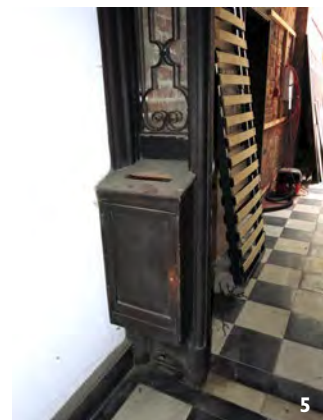
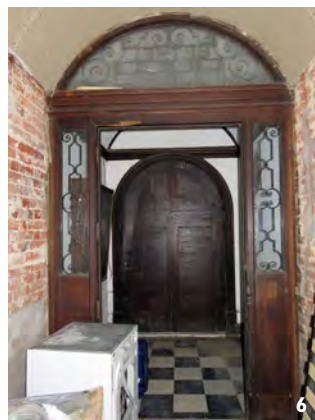
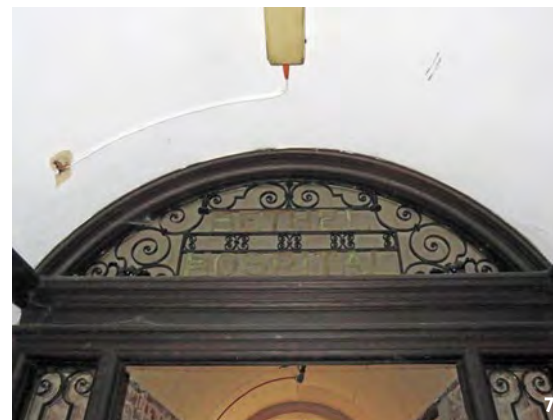
- 1 Entrance hall with timber front door
- 2 1713 foundation stone
- 3 1899 foundation stone
- 4 Fanlight
- 5 Post box
- 6 Screen
- 7 Top of Screen

Adequate condition. Some staining to timber door and woodwork. Damage to plaster to walls and vaulted ceiling for services. Letter box on west side of door is rusted.

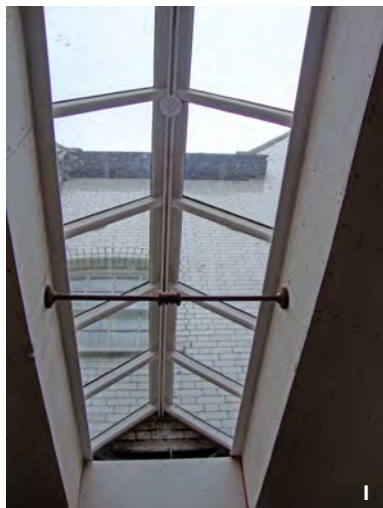
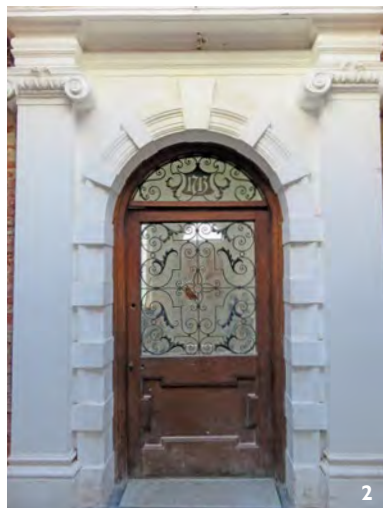
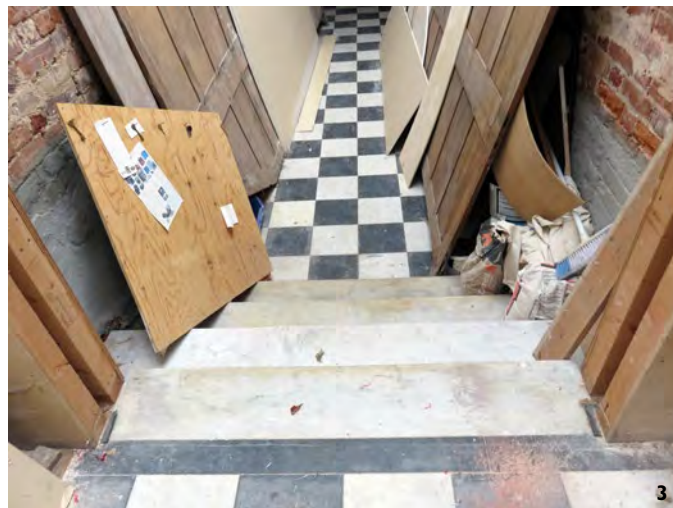
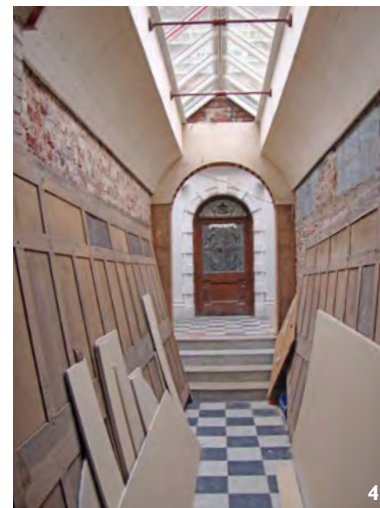
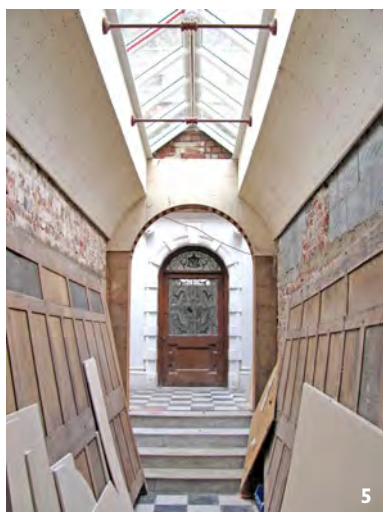
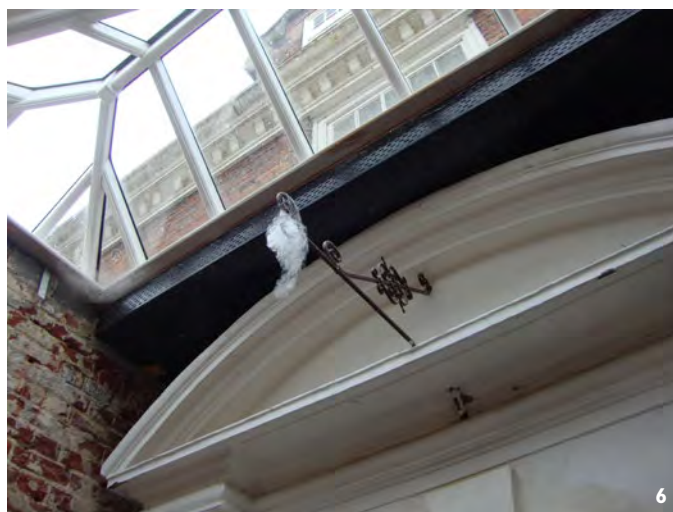
- 1 Modern ceiling light
- 2 Historic timber door into 1713 central range
- 3 Marble steps
- 4 Looking southwards down passage
- 5 View of corridor looking south
- 6 Semi-circular pediment

art complete. There is no plaster finish to ceiling or walls. Cement mortar and some modern bricks and blocks used in repairs to walls. No timber panelling to walls. Marble floor and steps looks in reasonable condition. Damage to base of door surround and adjacent columns to door into G39.

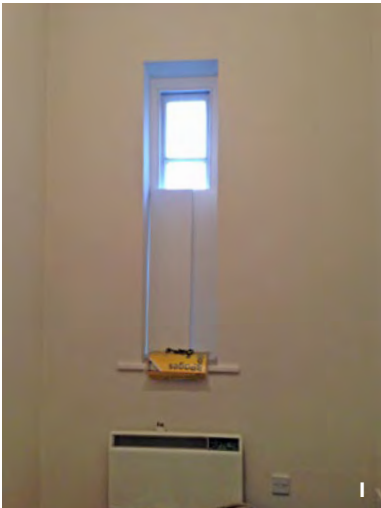
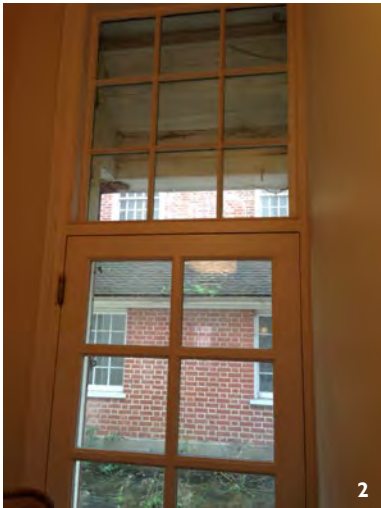
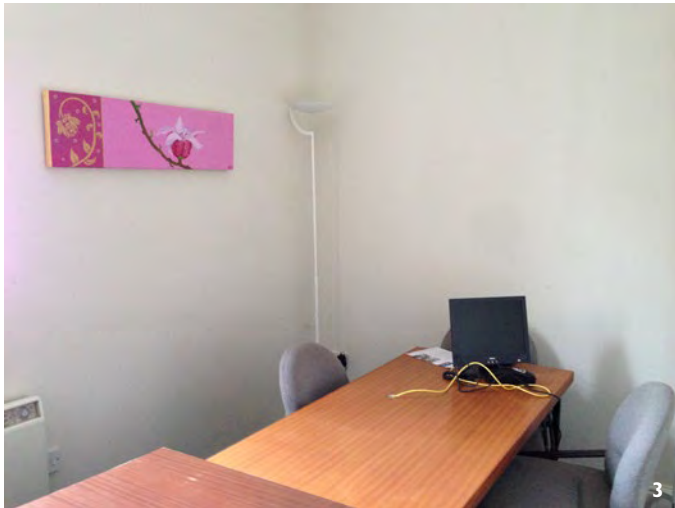
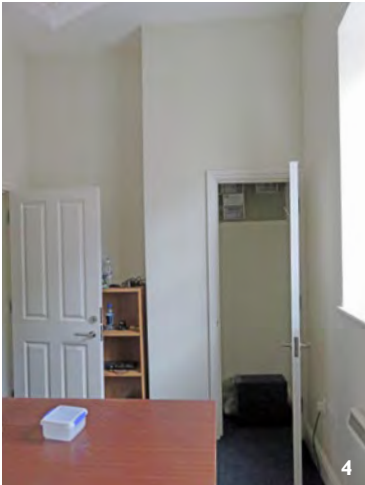
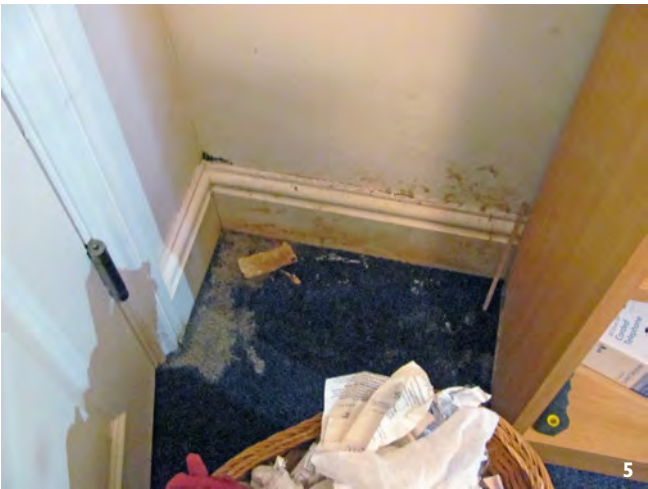
- 1 G32
- 2 Fan light above south door
- 3 G34 east end
- 4 G34 west end
- 5 Mould growth to west wall in G34 (south-west corner)

Generally good condition. Damp and mould growth to low level areas of walls and skirting in rooms G34 and G33. Floors should be inspected for decay

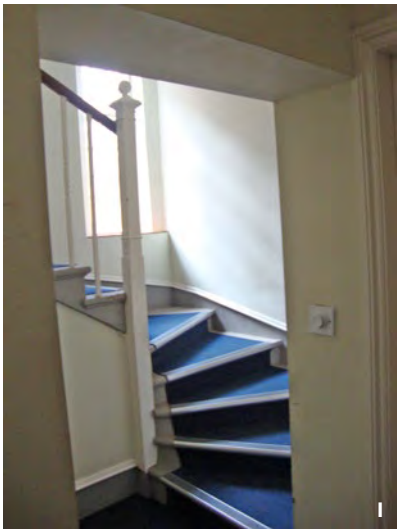
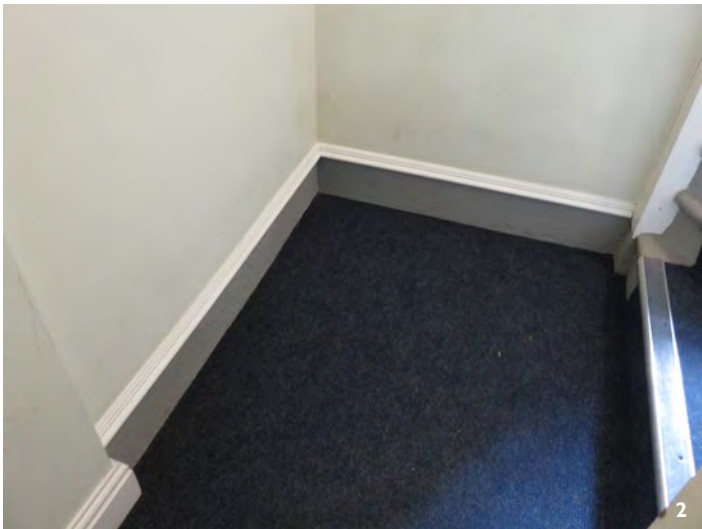
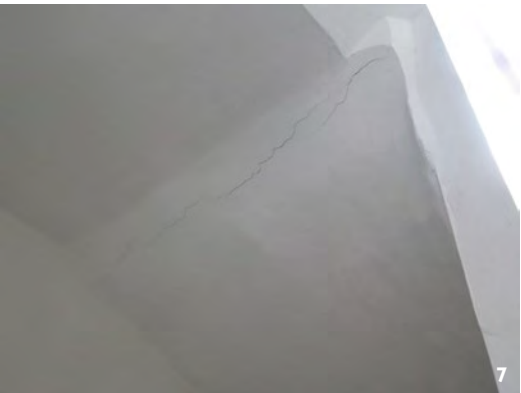
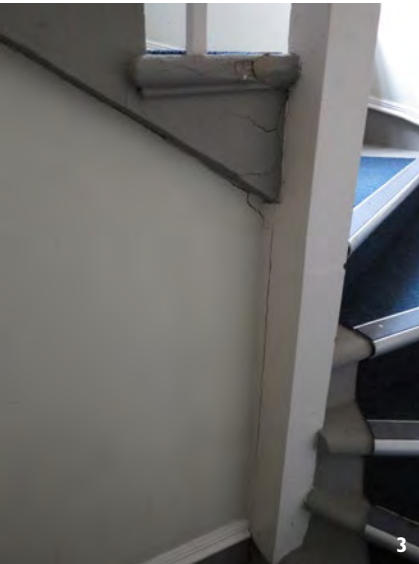
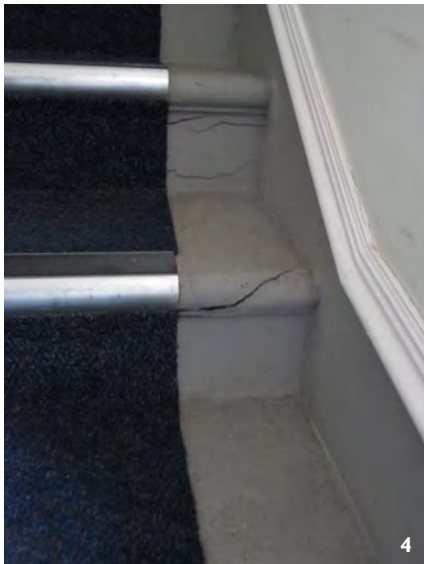
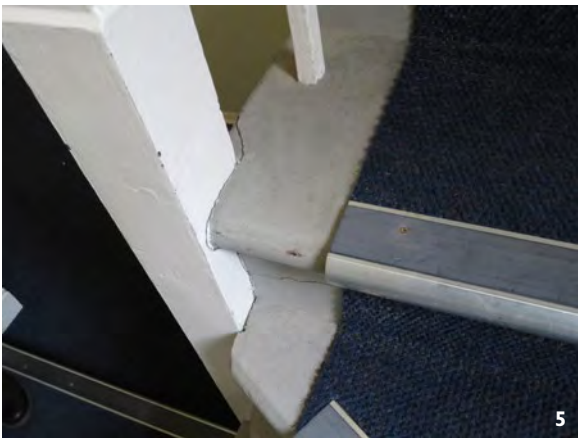
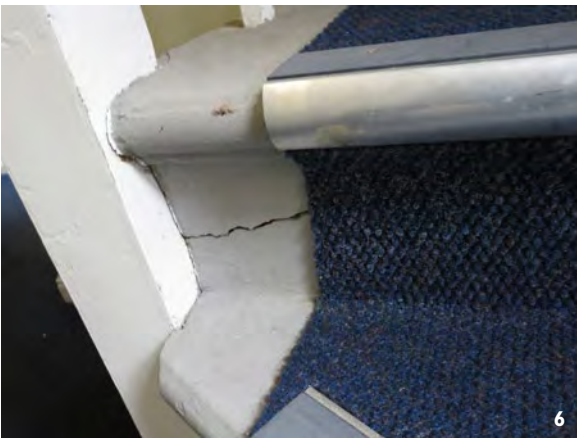
- 1 Stairwell and staircase
- 2 Modern moulding added to the concrete skirting
- 3 Cracking around newel post
- 4 Cracking to steps across from cracks around newel post
- 5 Cracking to tread
- 6 Cracking to riser
- 7 Cracking rear newel post where stair meets first floor landing

Considerable cracking to stair treads and around newel post around winder steps due to water ingress through basement window.

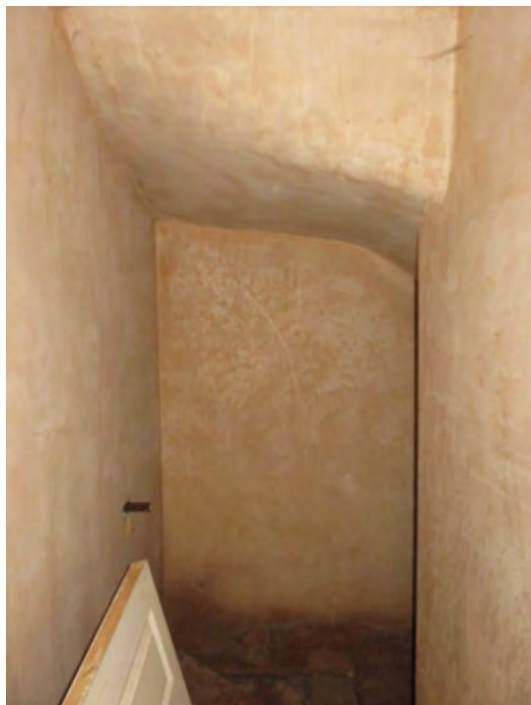
G38

Very damp. Water ingress from missing window on half landing to stair. Water running down walls. Floor damp and plaster beads all rusted. Stairs badly worn and spalled.

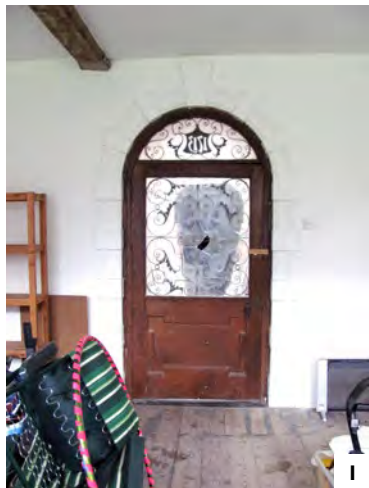
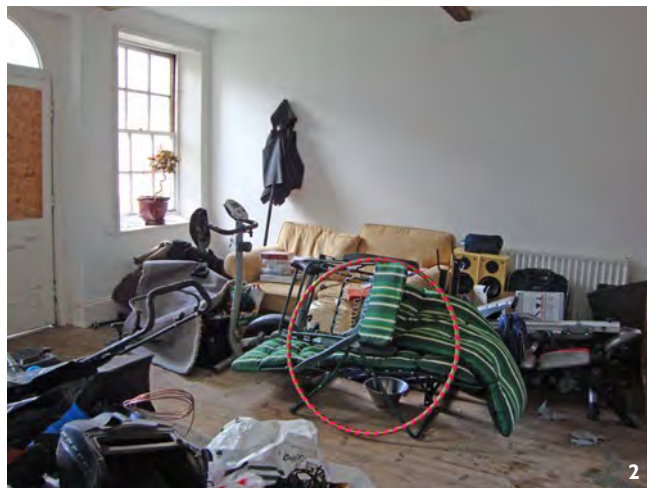
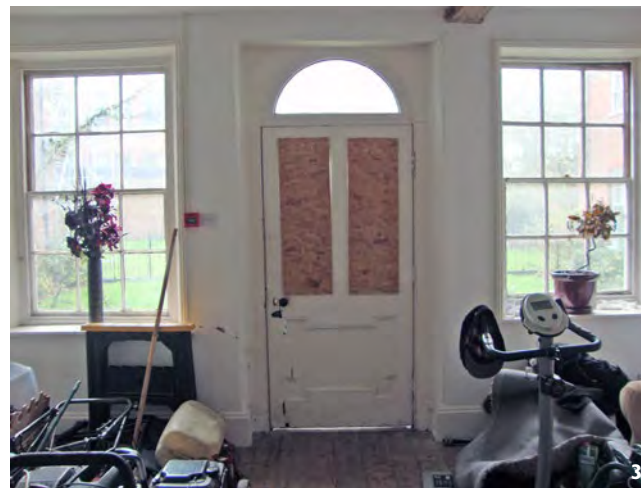
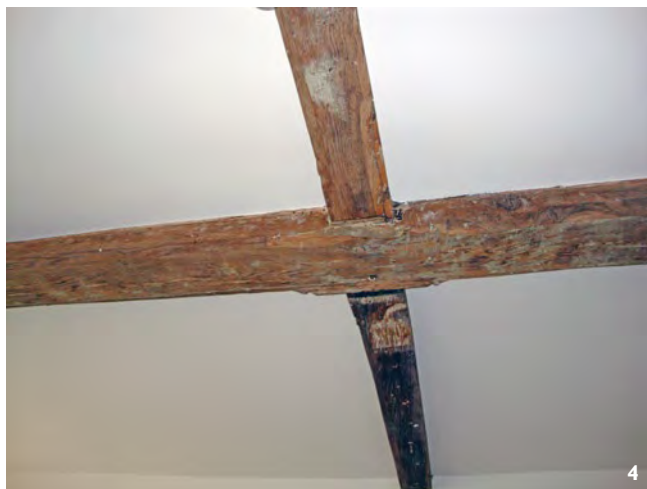
- 1 Door to G30 with broken glass
- 2 Modern west partition wall
- 3 Exterior door
- 4 Chamfered and stopped beams

Good although external door and windows only in adequate condition. Glazing panels to door boarded up and windows poorly fitting and one broken pane of glass. Glass broken to door into G30.

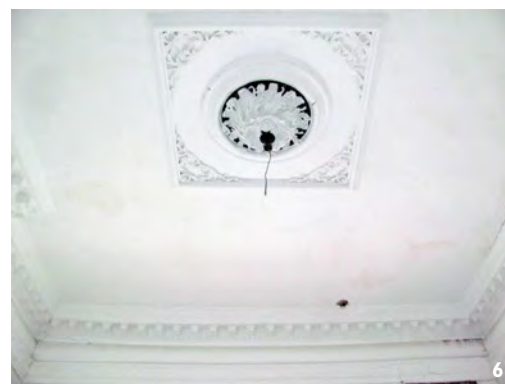
- 1 Tripartite window
- 2 Looking towards entrance to Boardroom
- 3 Fireplace
- 4 Stucco work on fireplace surround
- 5 View of unplastered south wall
- 6 View of cracks to ceiling rose
- 7 Boardroom door from other side
- 8 Severe cracking to south east corner
- 9 Crack to ceiling along west wall
- 10 Damp to south end of west wall

Poor. Structural cracking to south wall and south end of east and west walls. No plaster to south wall or south ends of east and west walls. Considerable cracking and damp damage to plaster at south end of west wall above dado. Cracking to cornice, ceiling and ceiling rose. Damp stains to ceiling throughout. Timber panelling below dado cracked. Window in poor condition. Floorboards and fireplace surround and grate in good condition.

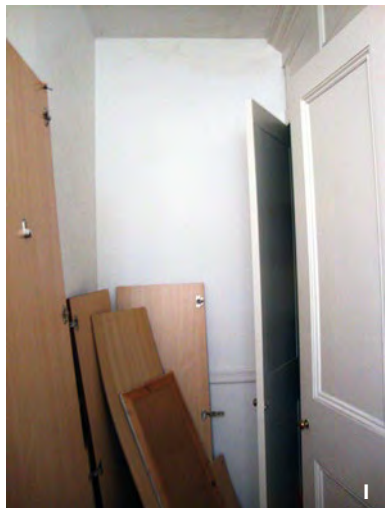
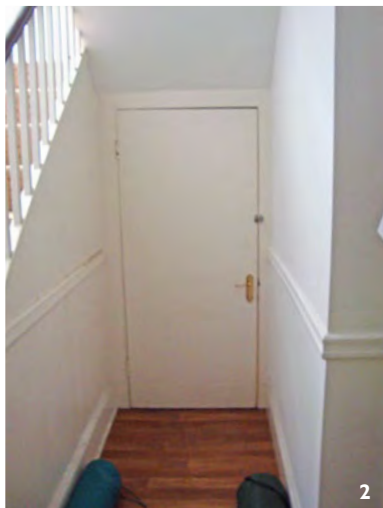
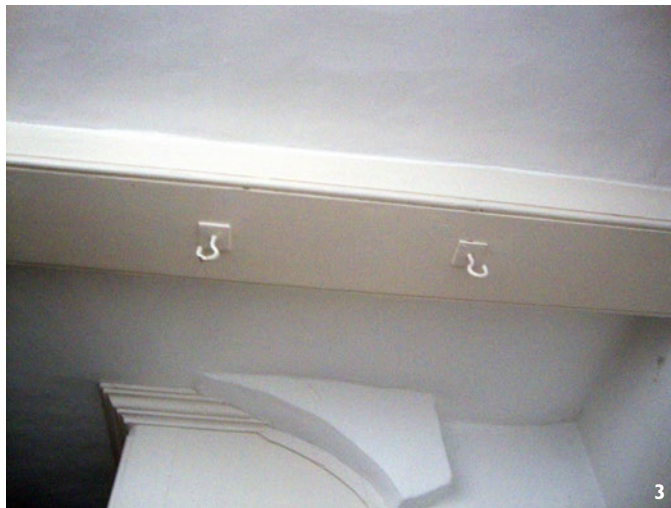
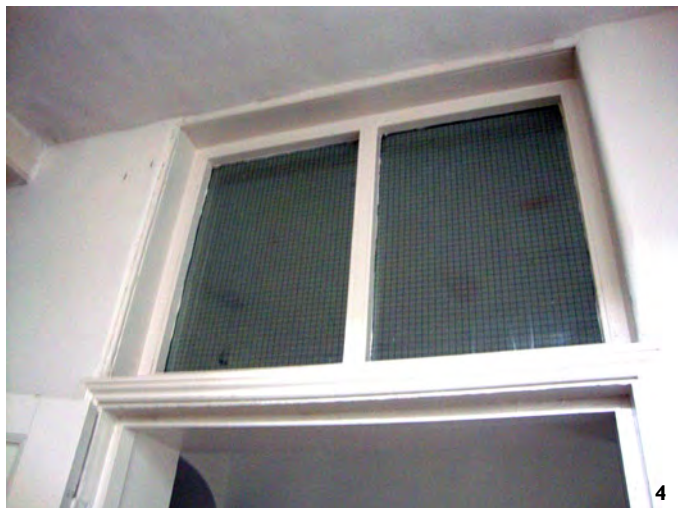
INTERNAL - GROUND FLOOR: G48, 1713 CENTRAL RANGE

- 1 Historic cupboards
- 2 Basement door
- 3 Hooks screwed into beam
- 4 Fanlight above door

Good

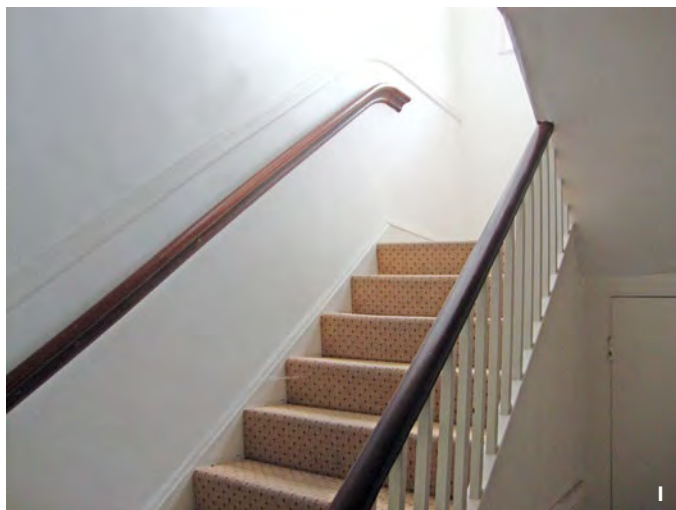
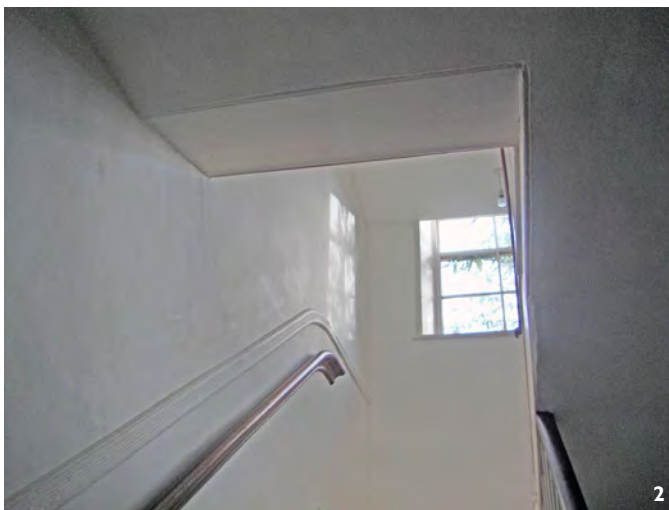
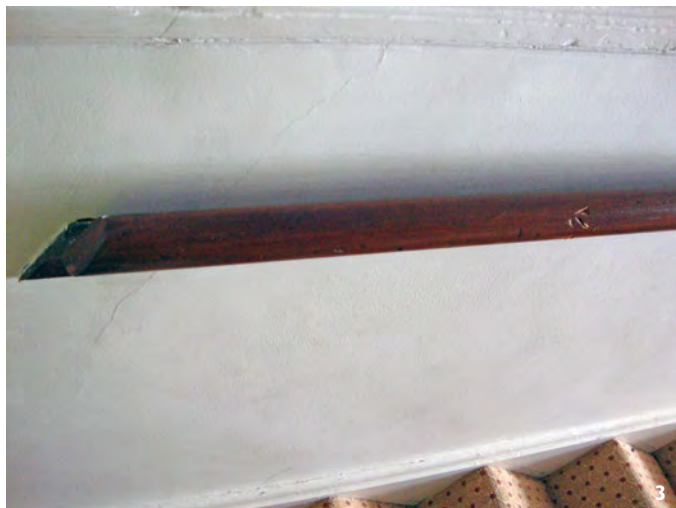
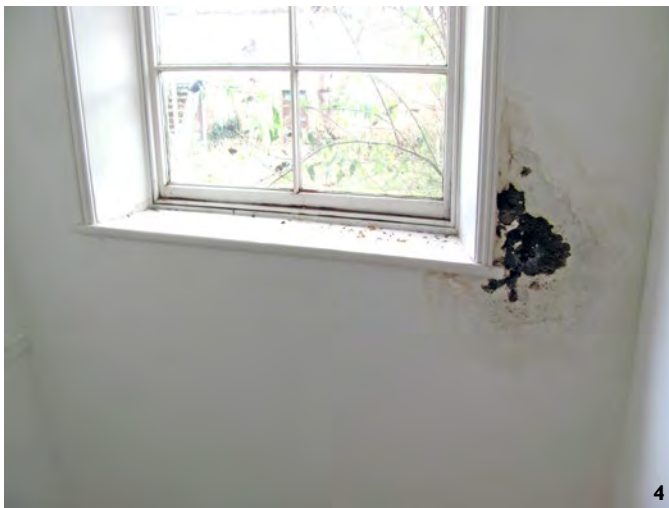
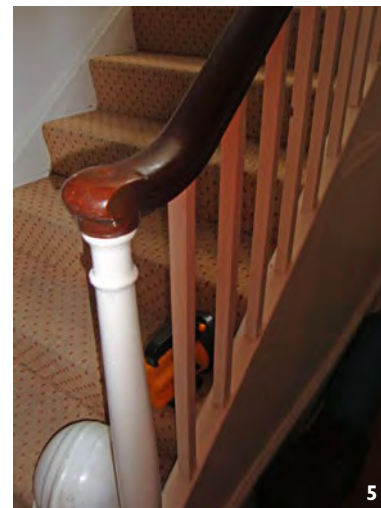
INTERNAL - GROUND FLOOR: G48A, 1713 CENTRAL RANGE

- 1 Staircase
- 2 Sash window above landing
- 3 Historic balustrade
- 4 Mould growth to half landing
- 5 Newel post

Good with the exception of an area of mould and decay due to water penetration, to the east wall adjacent to the window on the half landing.

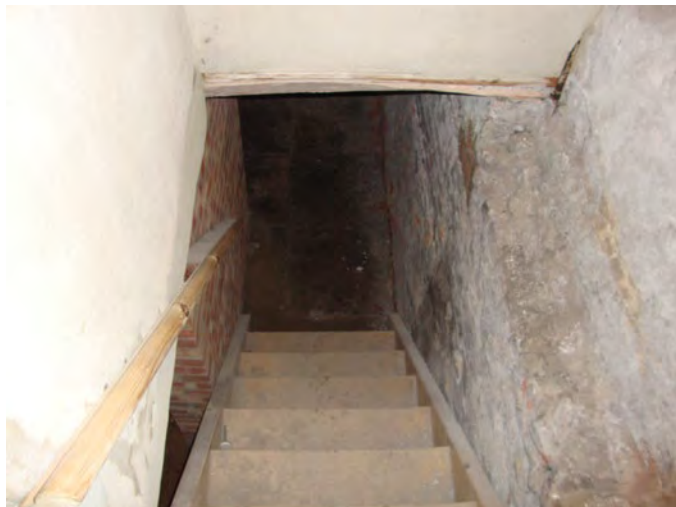
Timber Staircase

Good.

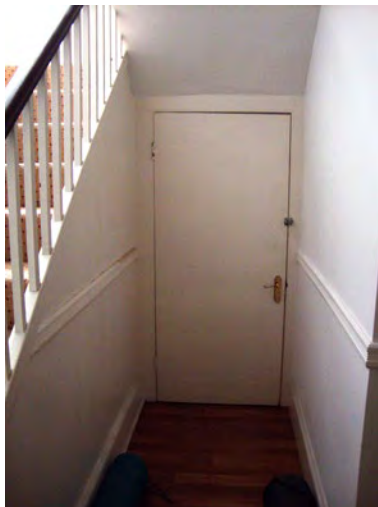
Cellar door

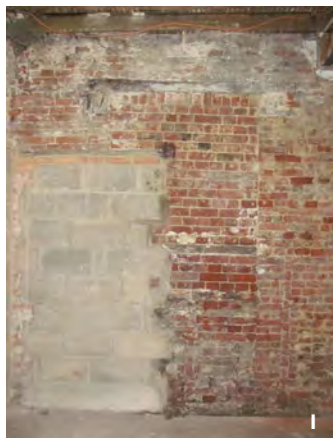
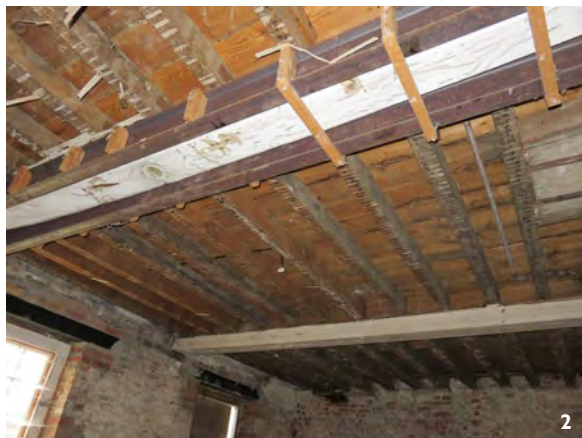
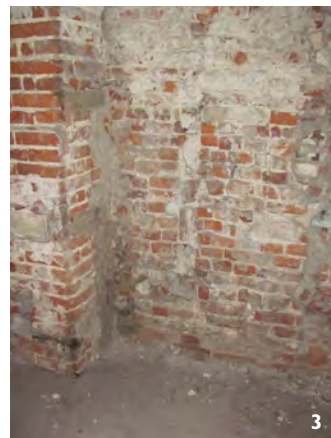
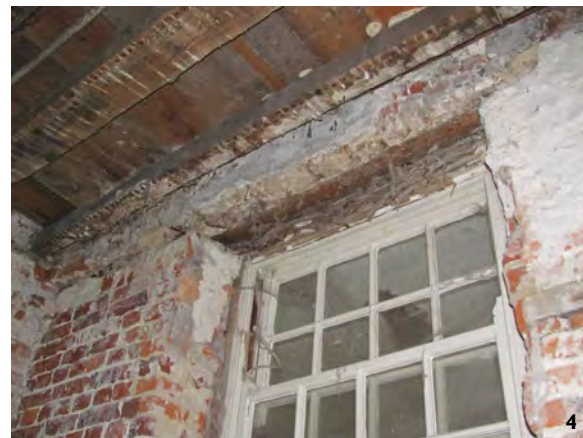
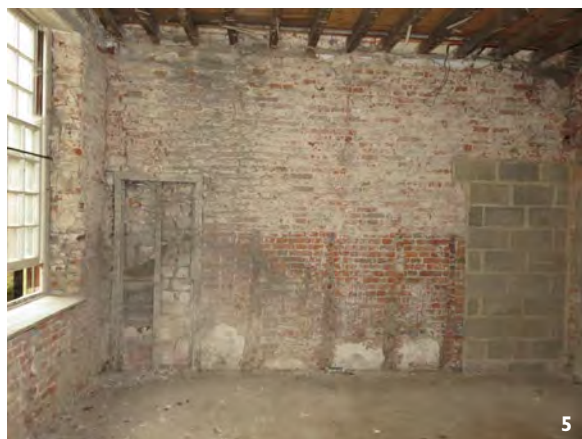
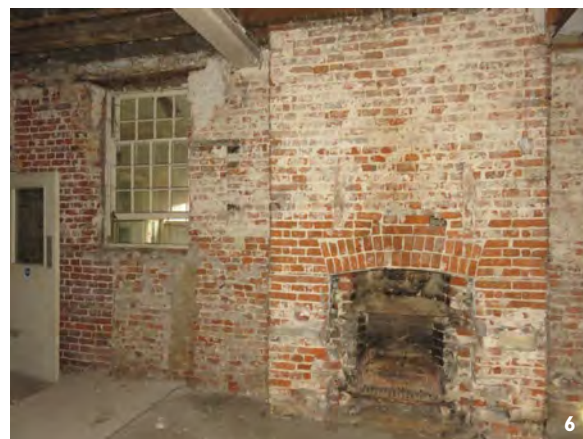
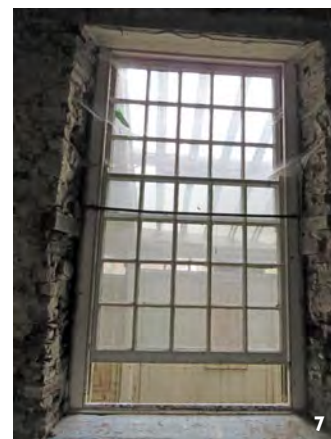
INTERNAL - GROUND FLOOR: G5I, 1713 EASTERN RANGE

- 1 Infilled large door or window and later infilled door at southern end of west wall
- 2 No plaster or laths to ceiling
- 3 Badly repaired brickwork
- 4 Rotten timber lintel and broken sash cord
- 5 Blocked doors in south wall
- 6 Blocked door or window in east wall and chimney
- 7 15 over 15 sash window

Poor. There is no plaster to walls. There is no ceiling plaster or laths. Previous doorways are blocked up with concrete blocks. Brickwork has been badly repaired and repointed with cement mortar. Bricks are missing or broken, particularly to window reveals and sills and around fireplace. New Catnic lintels over window and doorway in west wall. Door way is boarded up. The timber lintel over the northernmost window in the east wall is rotten. Windows are in a poor condition with broken sash cords and rotten frames and no window sills.

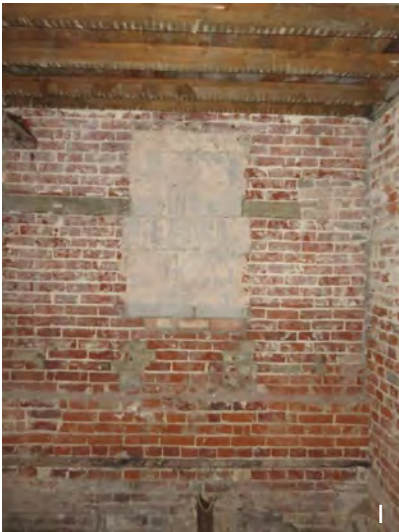
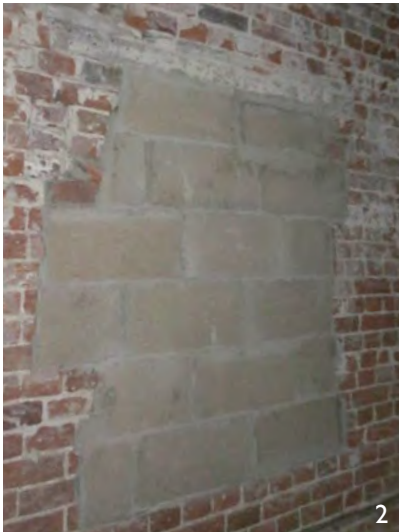
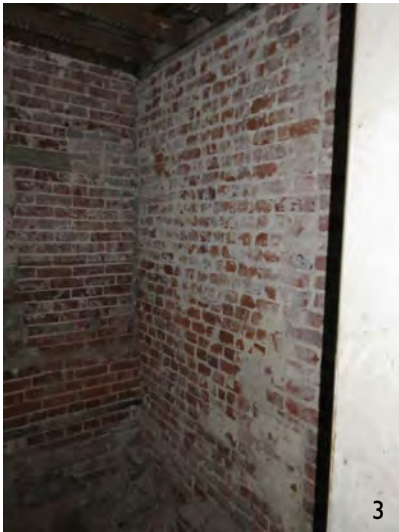
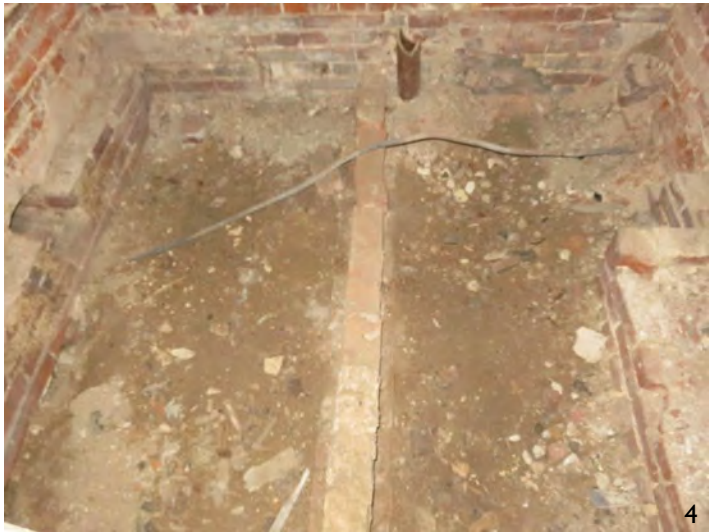
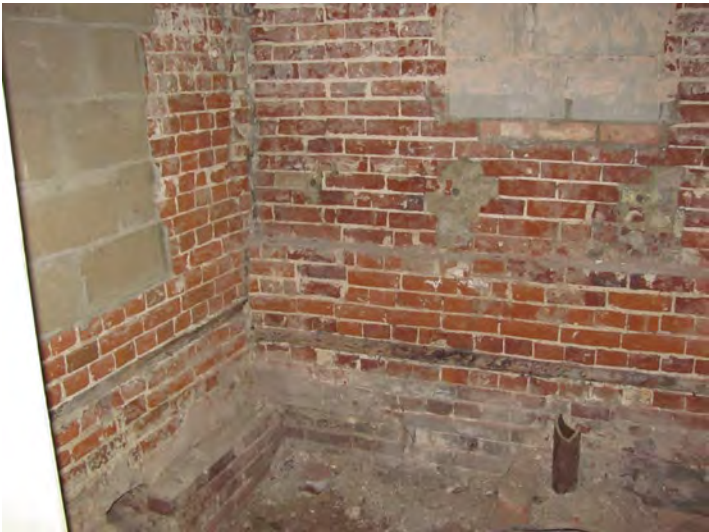
INTERNAL - GROUND FLOOR: G52, 1713 EASTERN RANGE

No floor and badly repaired brickwork

- 1 South wall
- 2 West wall
- 3 East wall
- 4 Missing floor

No access available for inspection. No floor. Poor condition as viewed from room G51. There are no finishes to wall. There is no ceiling plaster or laths. Repairs to brickwork in concrete block and cement mortar.

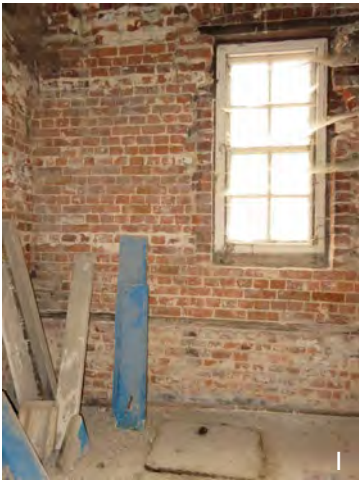
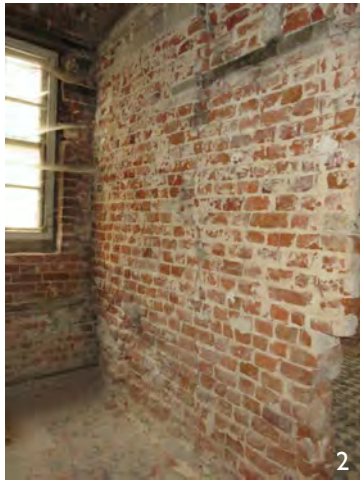
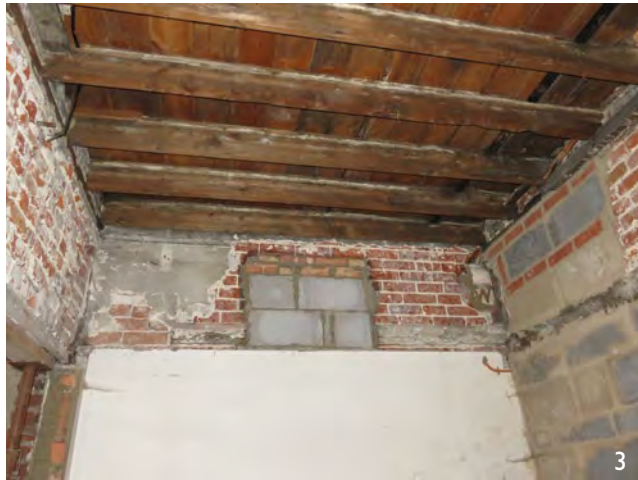
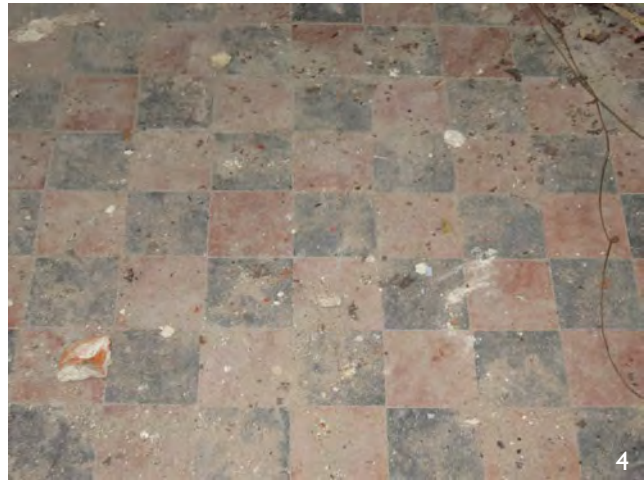
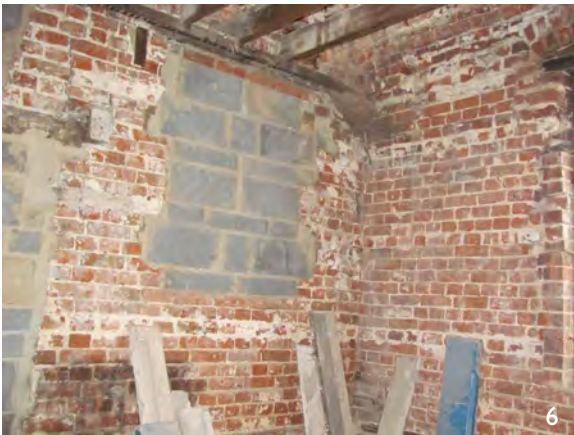
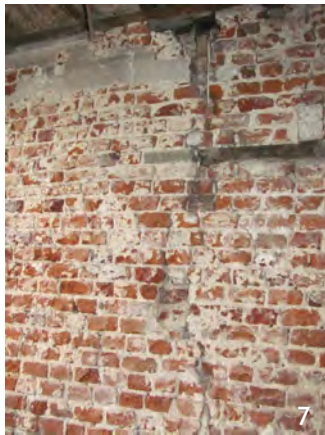
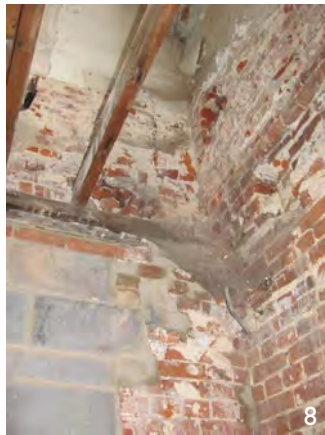
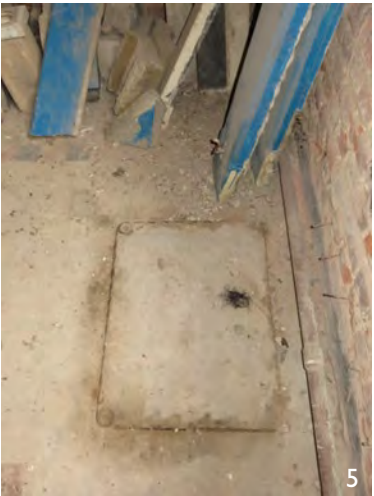
INTERNAL - GROUND FLOOR: G53, NORTHERN EXTENSION TO 1713 EASTERN RANGE

- 1 North wall
- 2 East wall
- 3 Blocked openings in south and west walls; east wall not toothed in
- 4 Floor tiles
- 5 Man hole cover
- 6 Blockwork and cement mortar used to fill blocked up openings
- 7 Large crack to east wall
- 8 View up through exposed floor structure to F32

Poor condition. There is no plaster to the walls. There is no ceiling plaster or laths. Openings are blocked up with concrete blocks. Brickwork has been repaired with cement mortar. Bricks are broken or missing, particularly to reveals of window. There is a large crack with missing bricks in east wall.

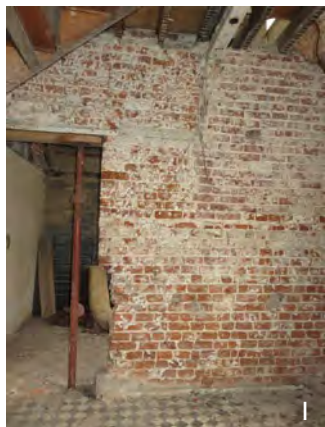
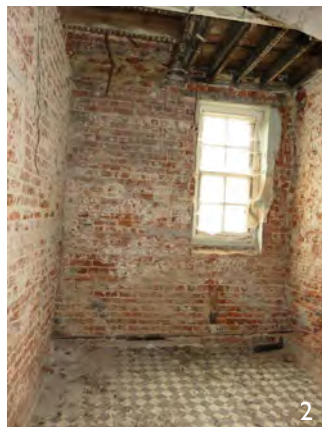
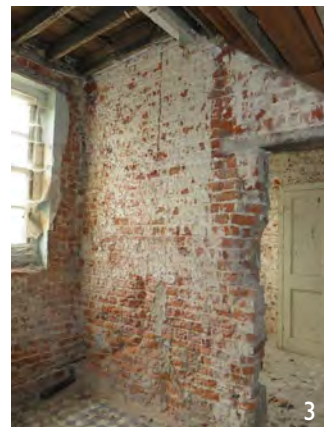
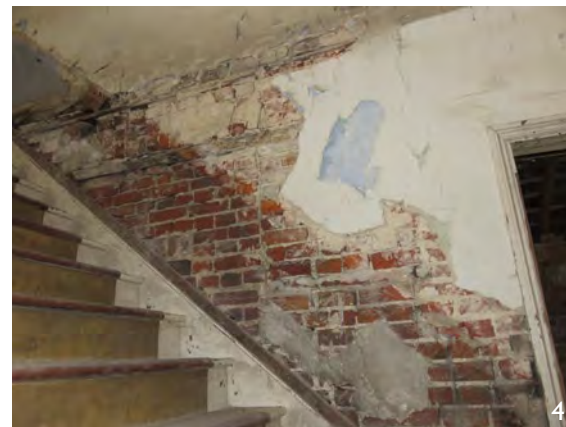
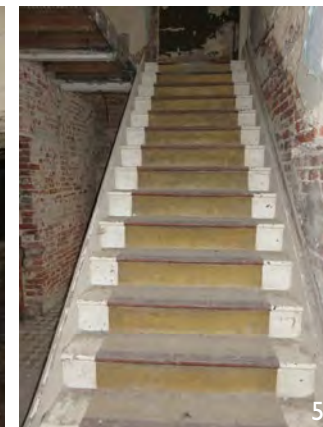
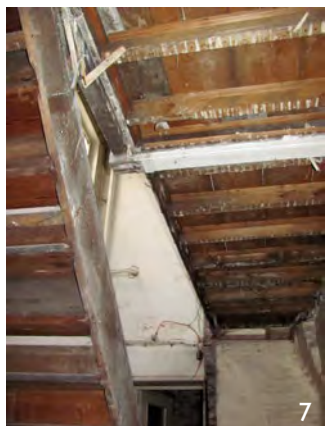
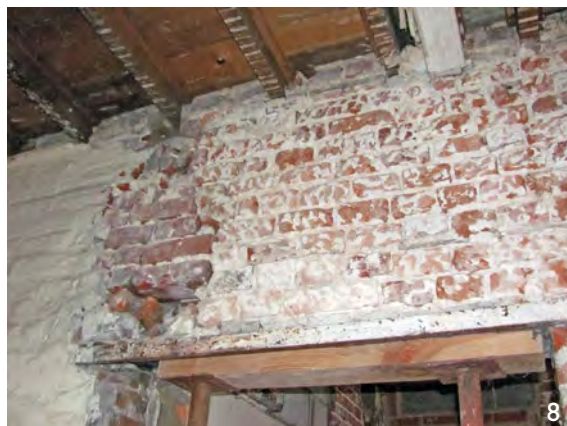
INTERNAL - GROUND FLOOR: G54, NORTHERN EXTENSION TO I713 EASTERN RANGE

- 1 East wall
- 2 North wall
- 3 West wall
- 4 West wall with evidence of blocked window
- 5 Stair
- 6 Masonry in south-west corner
- 7 No ceiling or laths to ceiling and no soffit to stair
- 8 Cracking over doorway to G53 and propped doorway

Poor condition. There is no plaster to walls. There is no ceiling plaster or laths and no soffit to the underside of the stair. Openings blocked up with concrete blocks. Brickwork has been repaired with cement mortar. Bricks are broken or missing, particularly to reveals of the window. There is a large crack in the wall over the doorway into G53 with missing and loose bricks and mortar. The door opening between G53 and G54 is supported on props.

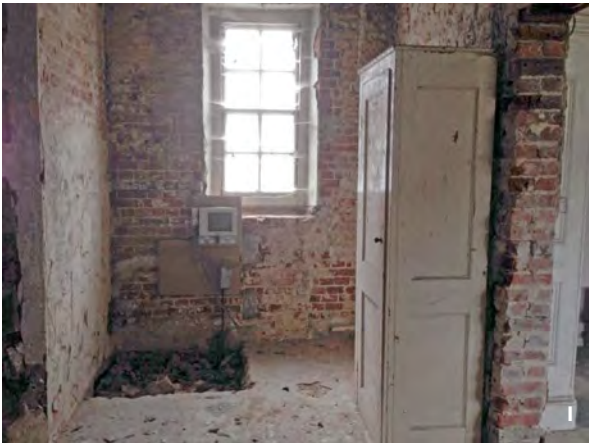
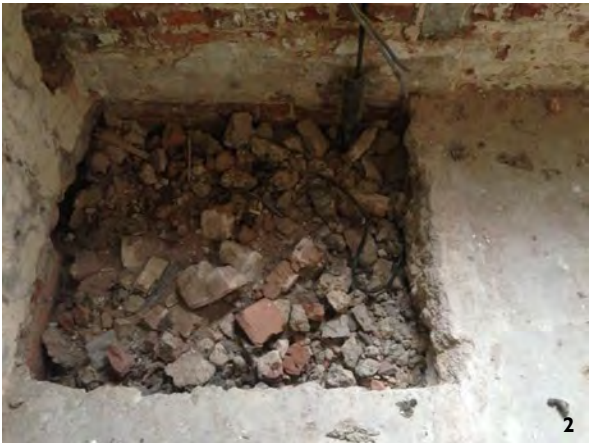
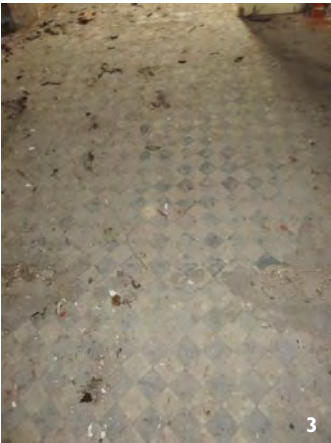
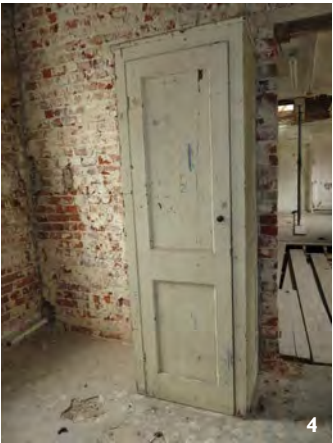
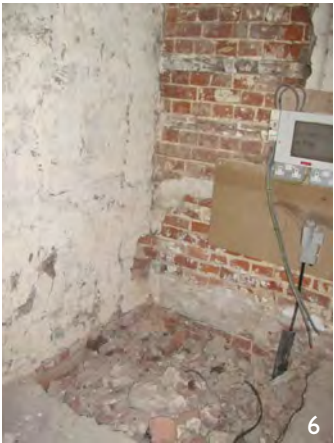
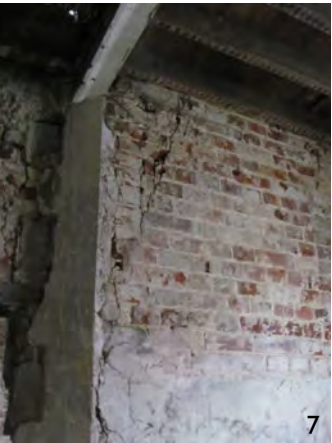
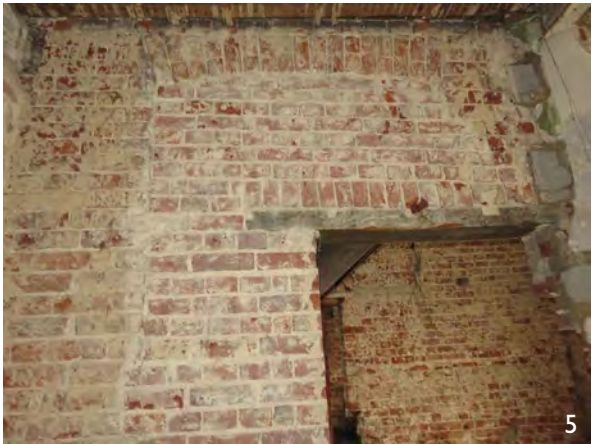
INTERNAL - GROUND FLOOR: G55, EASTERN CELL RANGE

- 1 G55 looking north
- 2 Concrete floor
- 3 Black and white tile floor
- 4 Cupboard
- 5 Blocked window in west wall

- 6 Hole in the floor against the north wall
- 7 Large crack in west wall

Poor condition. There is no plaster to the walls. There is no ceiling plaster or laths. Openings are blocked up with concrete blocks. Brickwork has been repaired with cement mortar. Bricks are broken or missing, particularly to reveals of window. There is a hole in the concrete floor against the north wall. There is a large crack to the west wall extending from the joists the full height of the wall with missing bricks and mortar. There are holes in the brickwork where services are/were.
