BETHEL HOSPITAL, NORWICH
GAZETTEER
ISSUE 3
NOVEMBER 2016

This Gazetteer has been written to accompany the Conservation Management Plan (CMP) for Bethel Hospital. It is a room by room assessment of most of the site with the occupied flats generally having a single entry. The Gazetteer is intended as a reference guide to allow the status of a particular structure or interior to be checked if a change or conservation works are proposed. A location plan and photographs are included for each entry.

The Gazetteer has been prepared by the authors of this document based on a site visit to each area in late January and early February 2016.

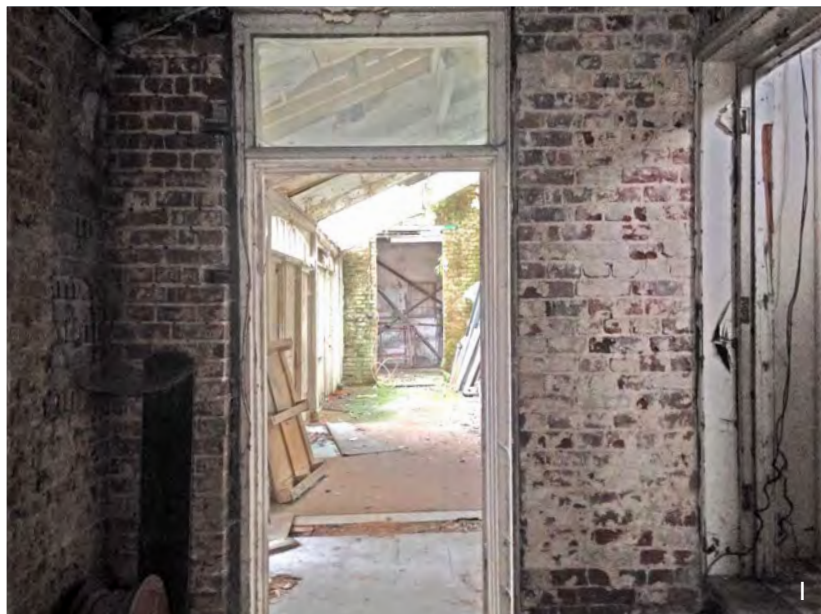
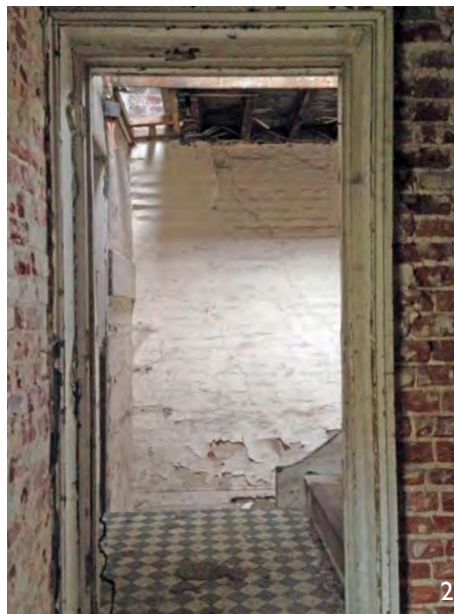
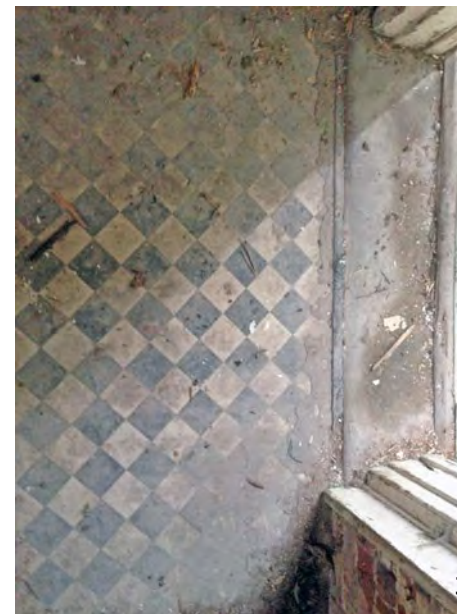
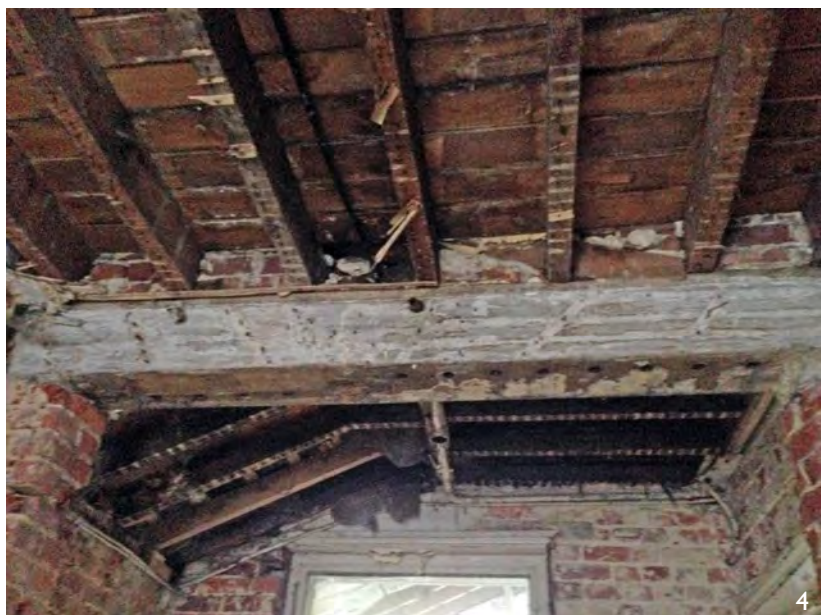
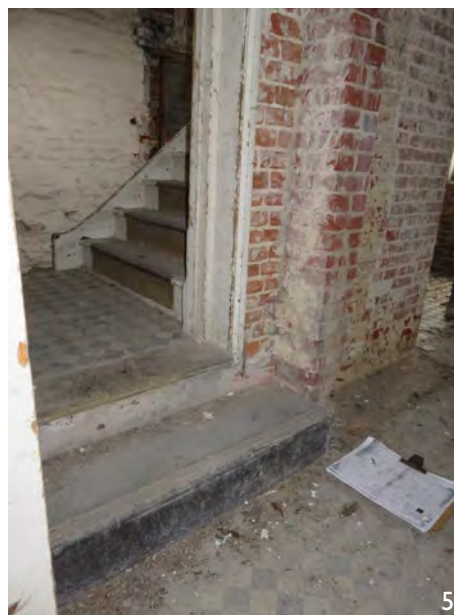
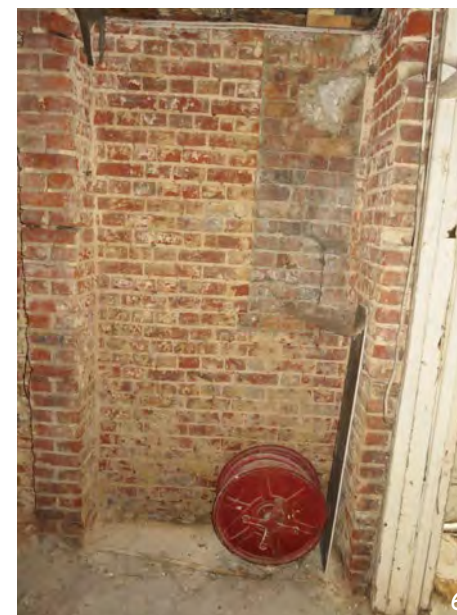
INTERNAL - GROUND FLOOR: G56, EASTERN CELL RANGE

- 1 South wall
- 2 Architrave to doorway in west wall
- 3 Marble floor
- 4 Timber lintel between G55 and G56
- 5 Steps in G54
- 6 East wall with evidence of blocked window

Poor condition. There is no plaster to the walls. There is no ceiling plaster or laths. Brickwork has been repaired with cement mortar. Bricks are broken or missing. The door is missing and the door frame is in poor condition.

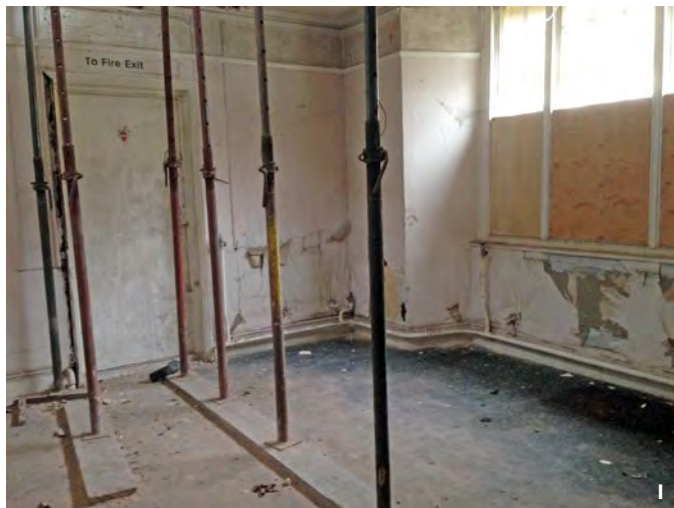
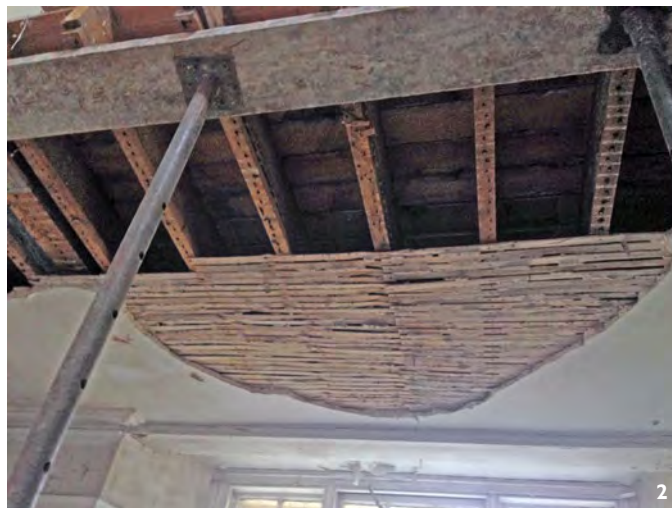
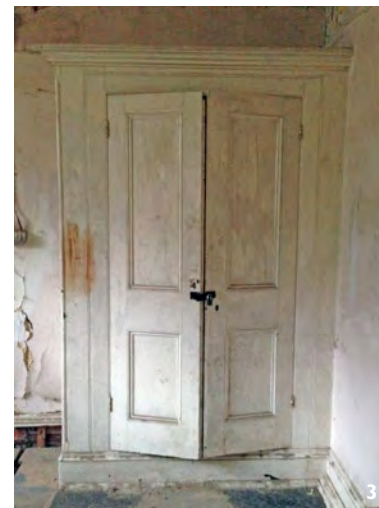
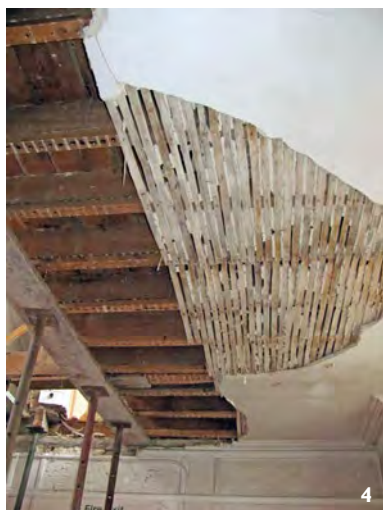
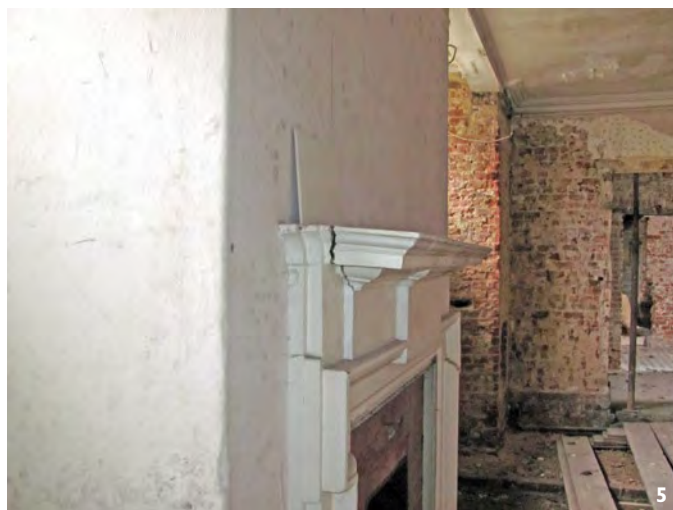
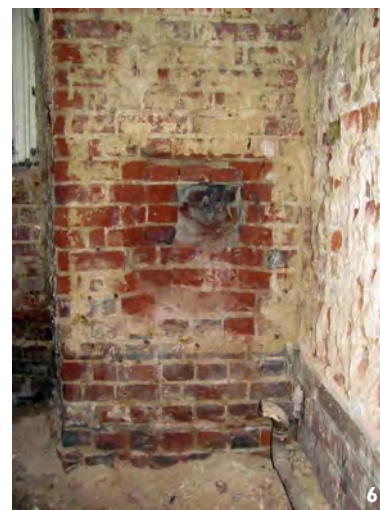
INTERNAL - GROUND FLOOR: G57, EASTERN CELL RANGE

- 1 G57 looking east
- 2 Exposed section of lath and plaster ceiling
- 3 Historic cupboard
- 4 Hole in ceiling, missing ceiling laths and plaster

- 5 Mantelpiece breaking away from wall
- 6 Brickwork and hole adjacent to door

Poor condition. There is no plaster, laths or joists to the ceiling at the east end of the room and this area is supported on props. The rest of the ceiling is in a poor condition with missing plaster, missing laths and a number of cracks with potentially blown plaster. The walls are also in a poor condition with no plaster to the walls at the south west end of the room. The plaster to the other walls has blown in many places and many areas are damp and showing mould growth, particularly to the north wall and under the east window. The visible brickwork has many spalled bricks and poor pointing. There are two large holes in the south wall, one under the window and one adjacent to this by the door. The south west end of the room has no floor due to dry rot. There are areas of missing cornice and skirting throughout. The mantel is severely cracked and coming away from the wall.

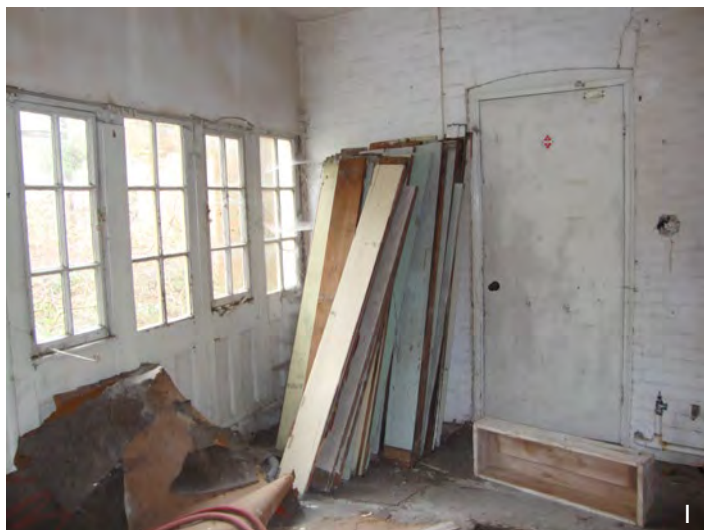
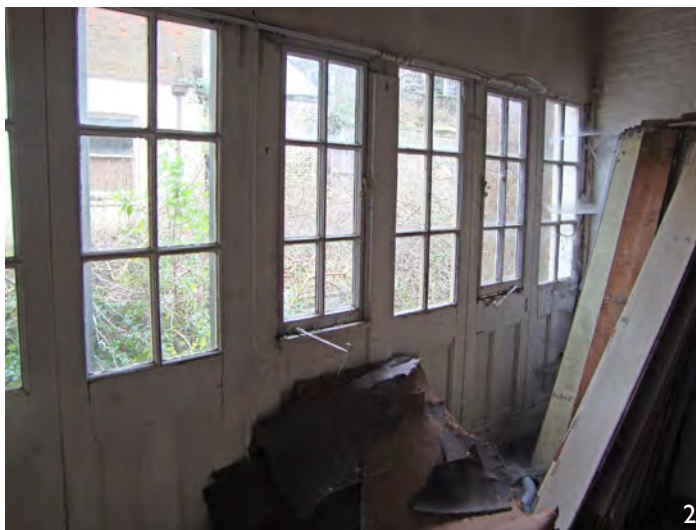
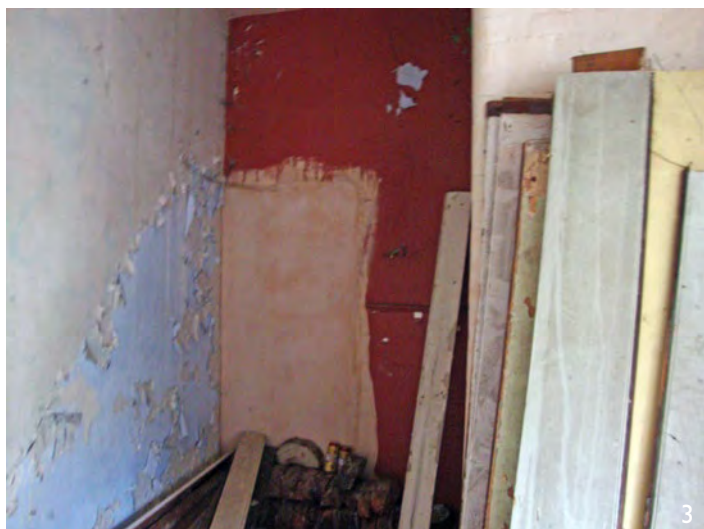
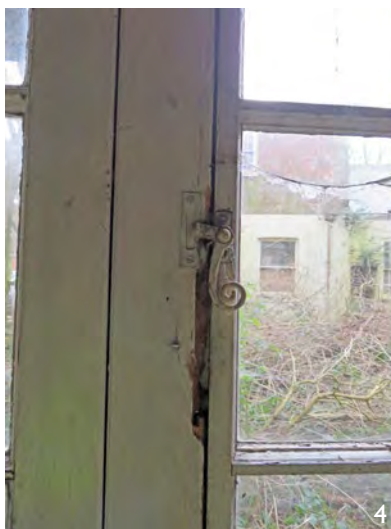
INTERNAL - GROUND FLOOR: G58, EASTERN CELL RANGE

- 1 G58 looking south-west
- 2 Timber panelled wall
- 3 Former stairwell
- 4 Detail of ironmongery

Adequate condition. Existing main water intake in manhole. Hole in wall adjacent to door. External door, internal door and windows in poor condition. No floor finish. Peeling paint to wall and poor plaster in areas.

NB External fire escape no33 not inspected but in poor and unsafe condition. Prevent access and remove.

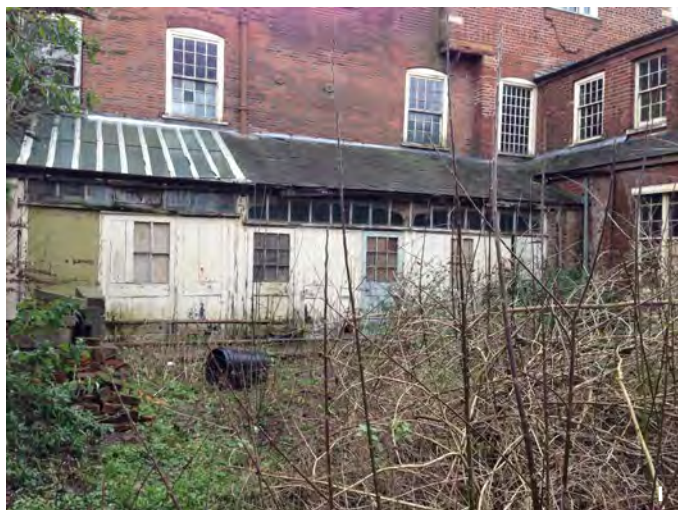
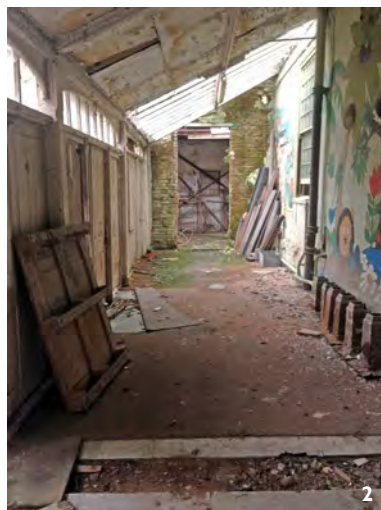
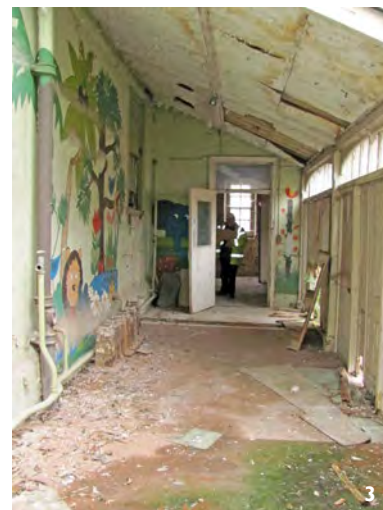
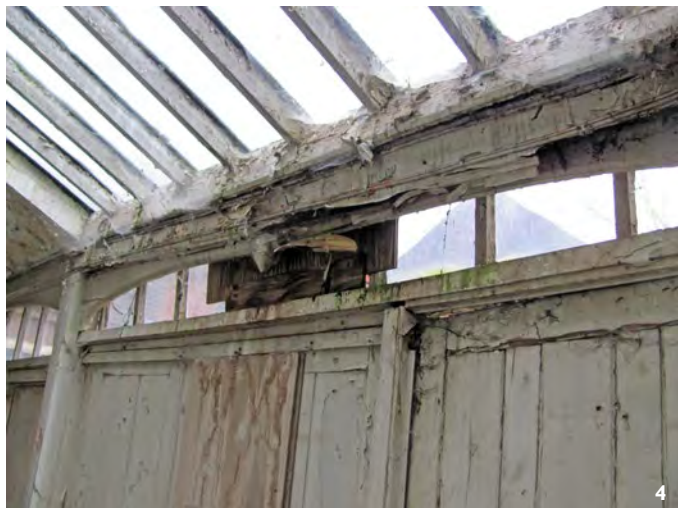
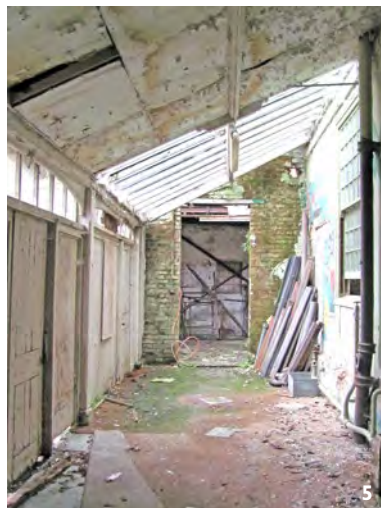
INTERNAL - GROUND FLOOR: G59, 1713 EASTERN RANGE LEAN-TO

- 1 The timber panelled exterior
- 2 G59 looking south
- 3 G59 looking north
- 4 Rotten timber panelling and boarded up glazing
- 5 View of passage way looking south

Very poor. The ceiling is missing in areas and very damp with mould growth. The glazed roof is also in poor condition with rotten timbers. The timber panelling, doors and fanlight are in poor condition with areas of timber rotten, missing and very damp with mould growth. The glazed panels are boarded up and broken. The wall at the south end is very green with considerable moss growth to this, the threshold and the floor. The west wall is also in poor condition being damp with cracked plaster and mould growth. The floor at the north end of the room is missing in areas.

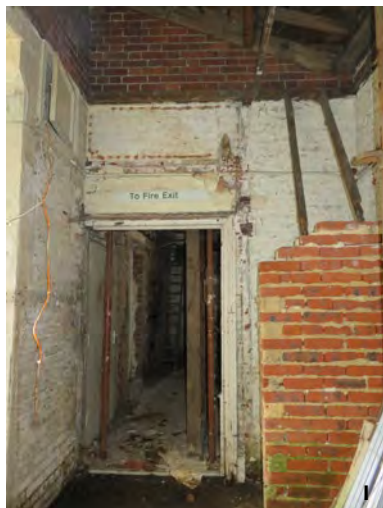
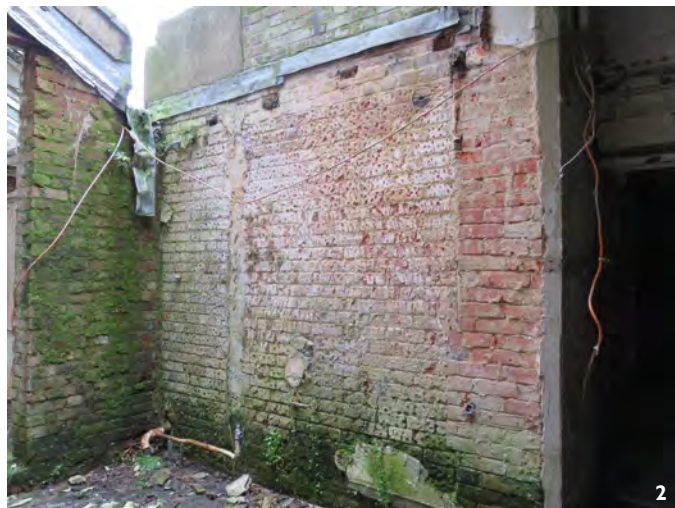
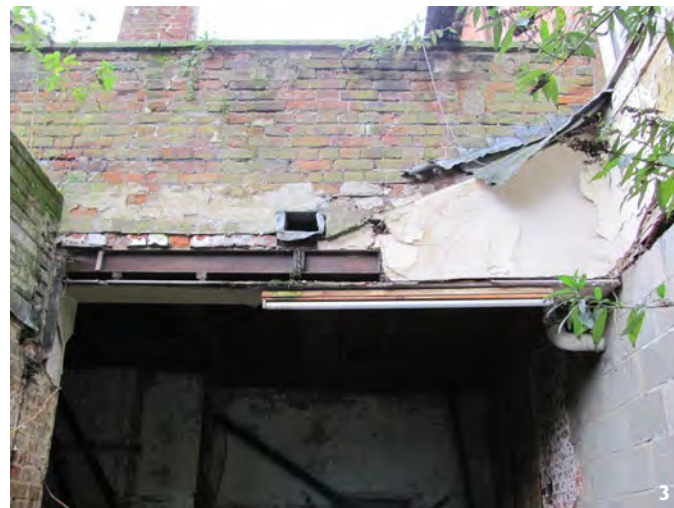
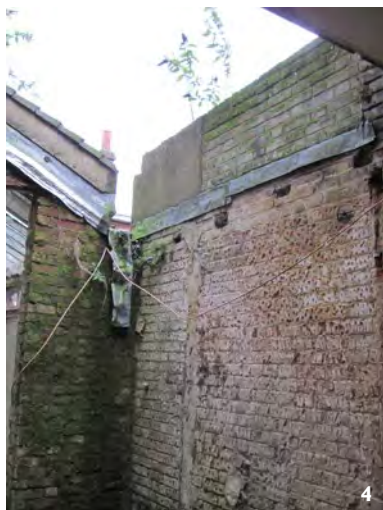
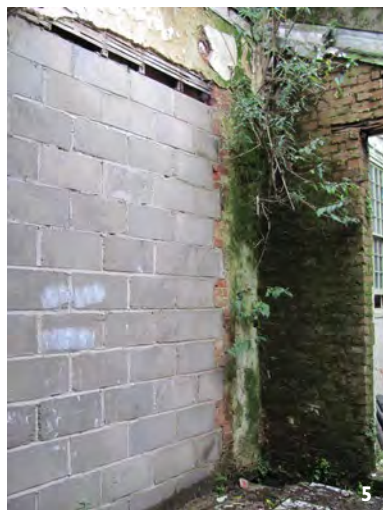
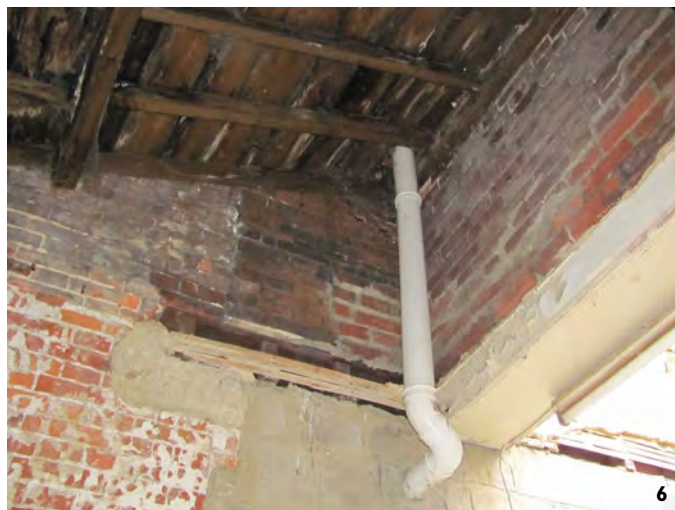
INTERNAL - GROUND FLOOR: G60, SOUTH-EAST RANGE

- 1 G60 looking east
- 2 G60 looking north-east
- 3 Rusted lintel
- 4 No roof to north end
- 5 Vegetation growth and blockwork and cement mortar to fill openings
- 6 Rot to timber floor structure above

Very poor. No roof to north end of room, adjacent to G59. Metal beam exposed is badly rusted. The walls to the north end are very wet with considerable moss and vegetation growth throughout. The previous opening in the west wall has been blocked up with concrete blocks. The timber lintel over the door to G59 is rotten. The floor in the north end is very wet and muddy with moss and vegetation growth.

There is no ceiling plaster or laths to the remaining space and the exposed timbers and joists are very damp with dry rot evident. The structure is being supported on a prop. The walls are very damp in the south end of the room with green brickwork and peeling paint. There is drainage pipe extending through the roof and returning into the west wall. Openings in the west wall have also been blocked with plywood boards. The previous internal brick walls and are now at door head height.

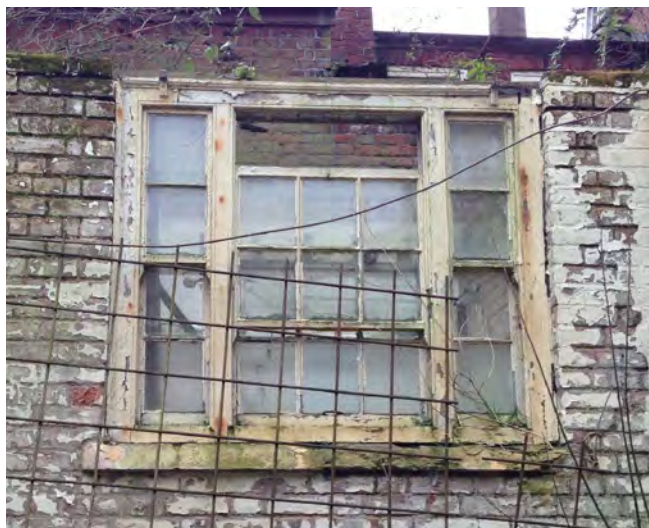
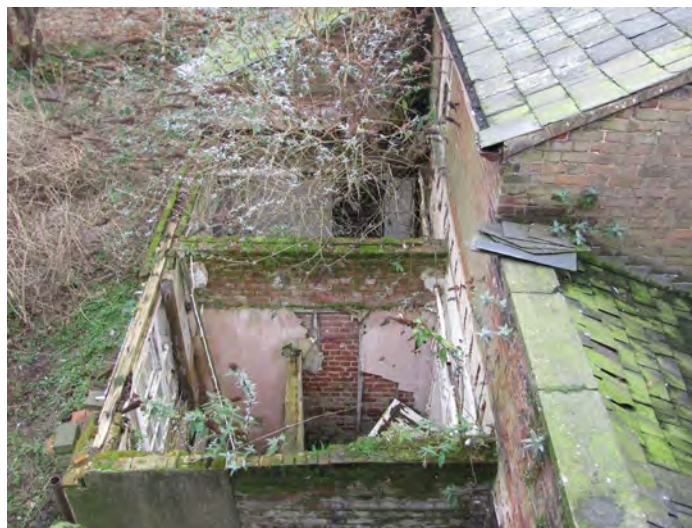
INTERNAL - GROUND FLOOR: G61 AND G62, SOUTH-EAST RANGE

Very Poor. The roof to these rooms is missing and the rooms are very wet. There is considerable moss and vegetation growth to the walls. No access for further inspection.

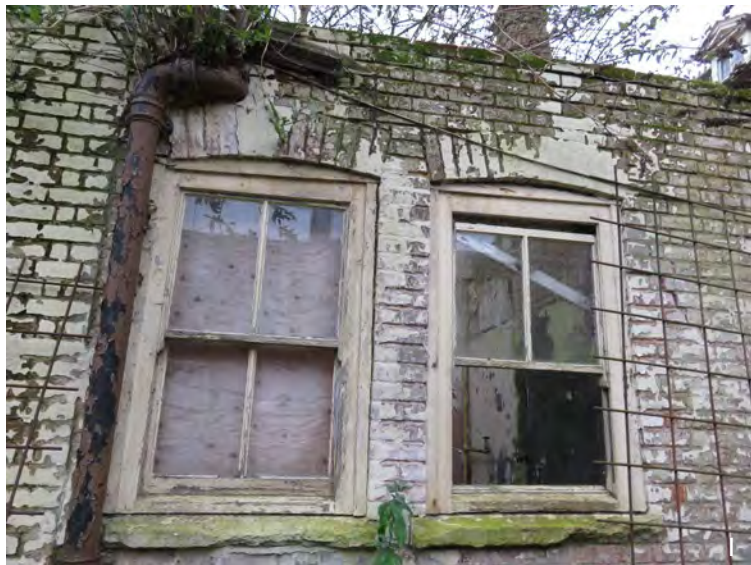
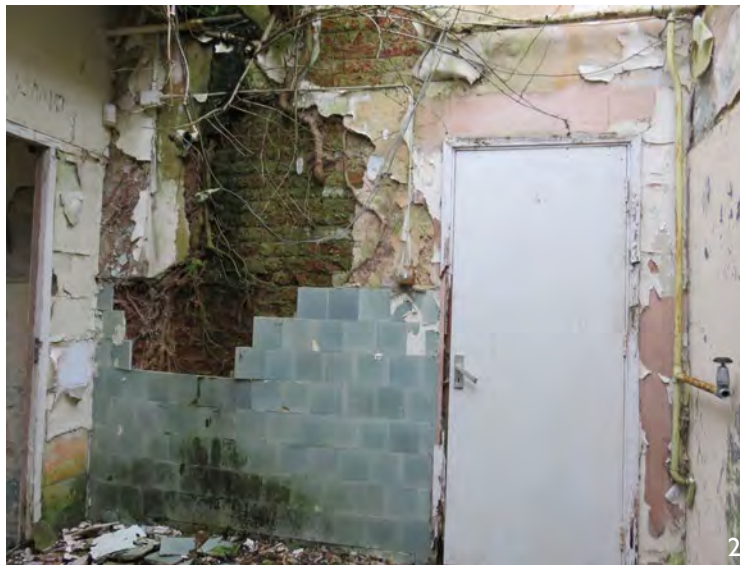
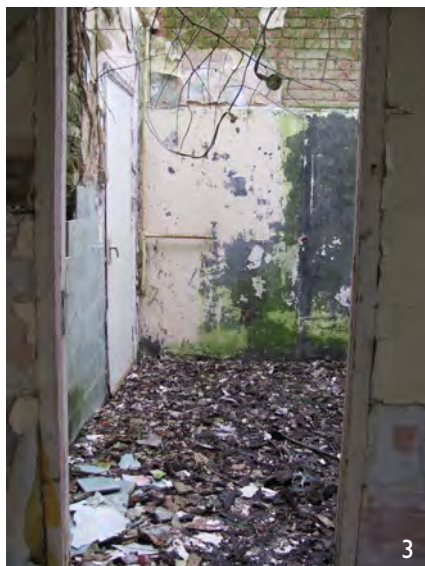
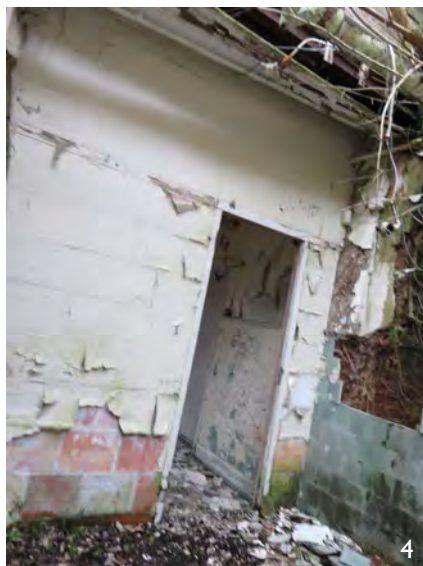
INTERNAL - GROUND FLOOR: G63, SOUTH-EAST RANGE

- 1 Windows (external)
- 2 South wall
- 3 View through to G63 towards west well
- 4 East wall

Very Poor. The roof to these rooms is missing and the rooms are very wet. There is considerable moss and vegetation growth to the walls. No access for further inspection.

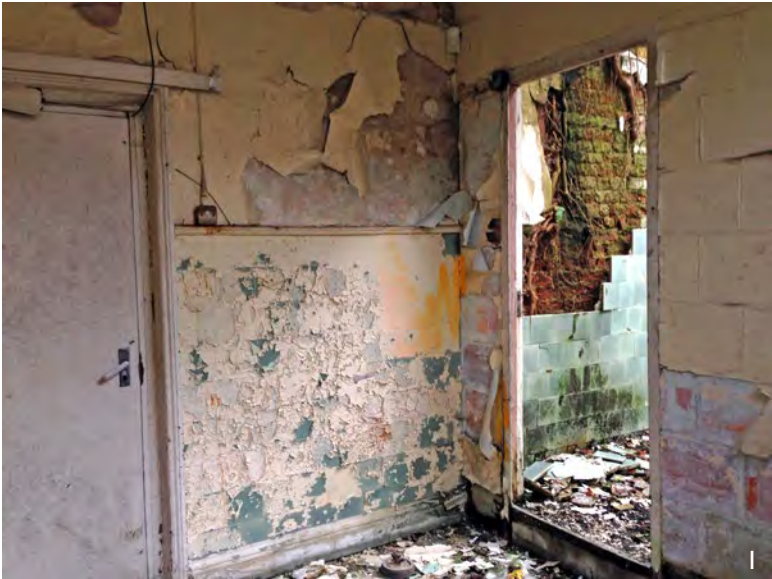
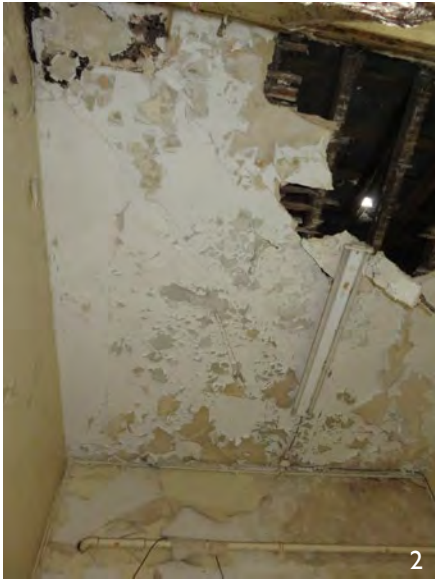
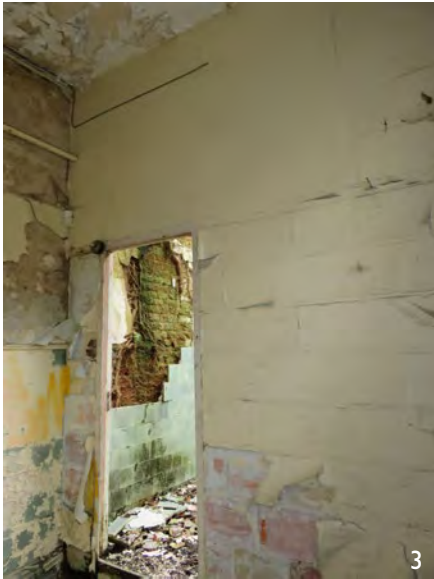
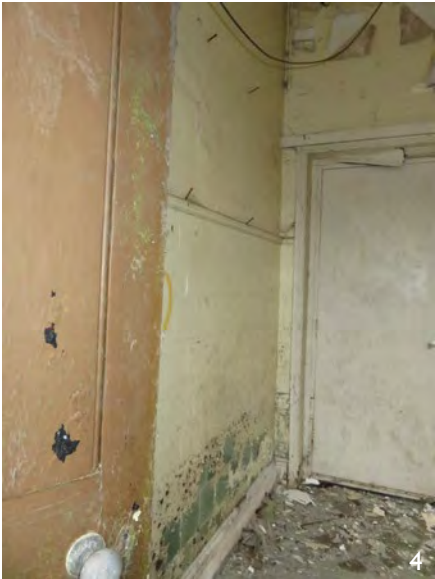
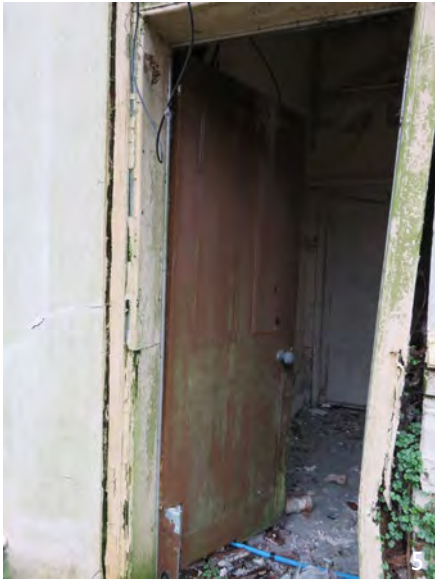
INTERNAL - GROUND FLOOR: G64, SOUTH-EAST RANGE

- 1 G64 looking south-west
- 2 Ceiling
- 3 West wall
- 4 East wall
- 5 External door

Very Poor. The roof to these rooms is missing and the rooms are very wet. There is considerable moss and vegetation growth to the walls. No access for further inspection.

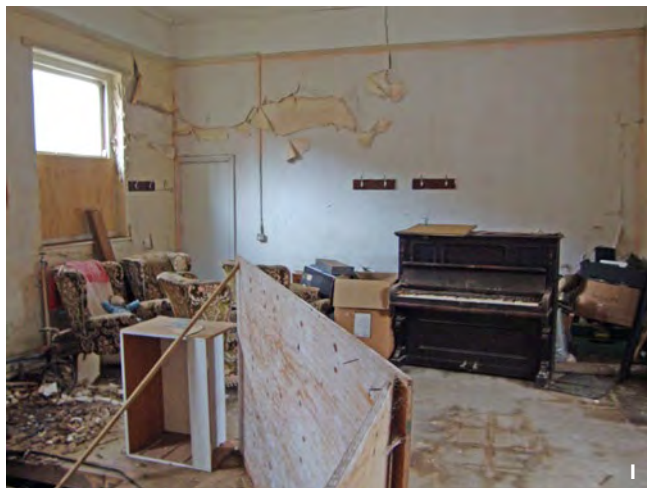
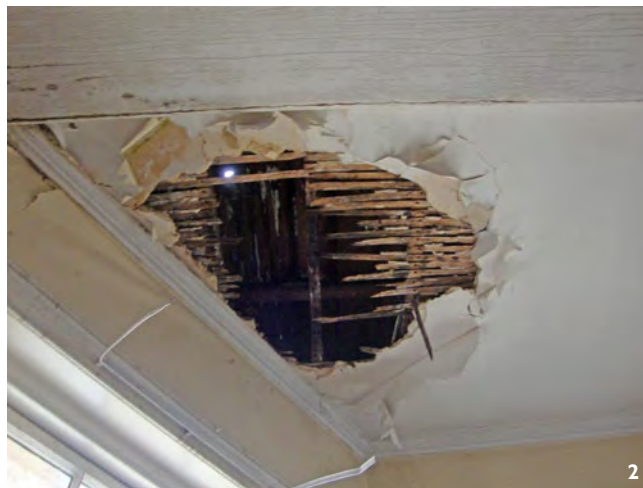
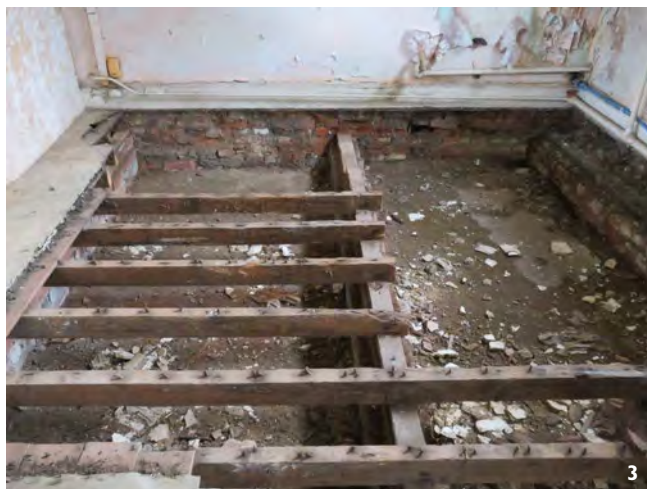
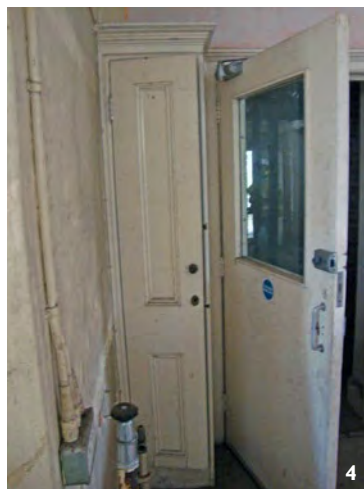
INTERNAL - GROUND FLOOR: G65, SOUTH-EAST RANGE

- 1 G65 looking east
- 2 Hole in lath and plaster ceiling
- 3 Section of removed floor
- 4 West door and historic cupboard

Large well-lit room with canted bay that has retained many of its historic features though it is in poor condition. Large section of floor and part of ceiling missing.

Poor condition. Parts of the floor structure and finishes are missing due to previous dry rot which has been treated. The ceiling is badly cracked and needs propping. The wall plaster is badly cracked and the room is damp with areas of mould growth. There are areas of ceiling plaster missing and holes in the lath. The visible laths look very damp and dry rot is evident to the timbers visible. The access door to services cupboard is badly rusted.

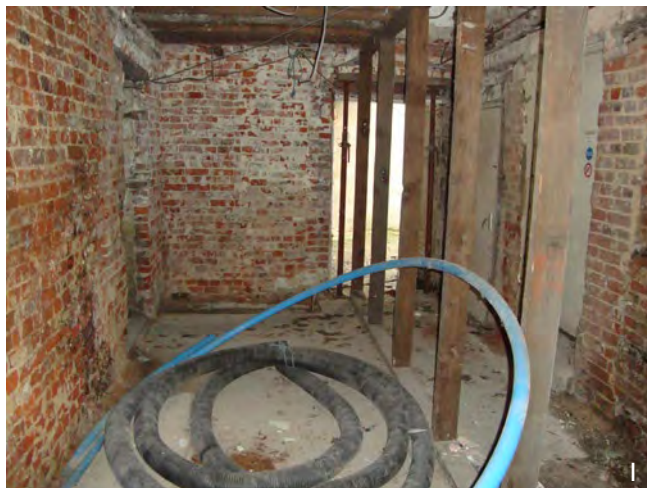
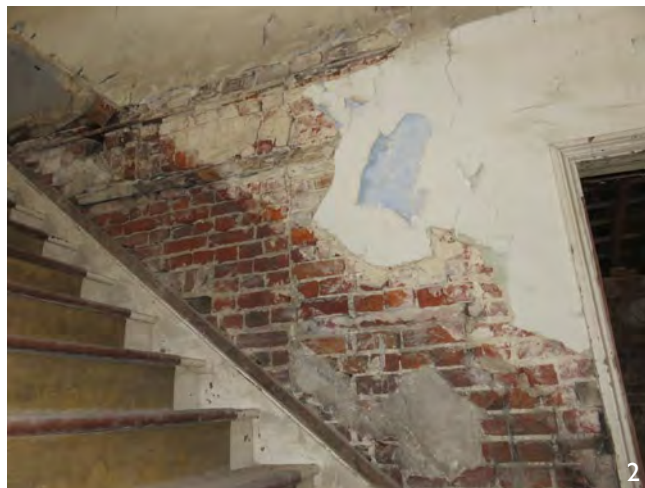
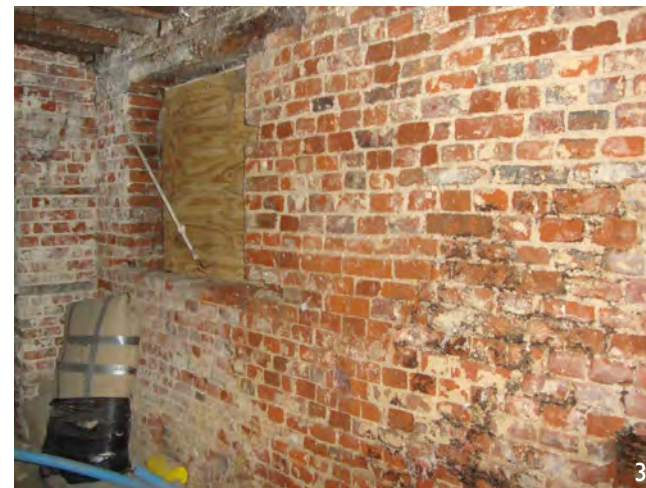
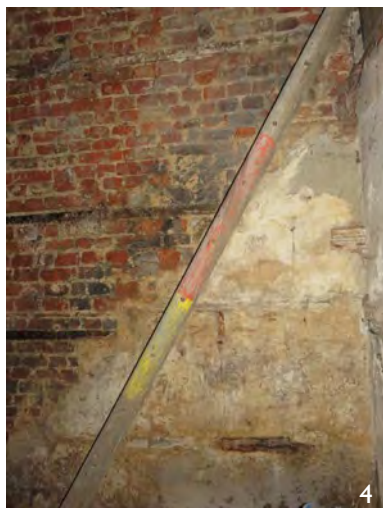
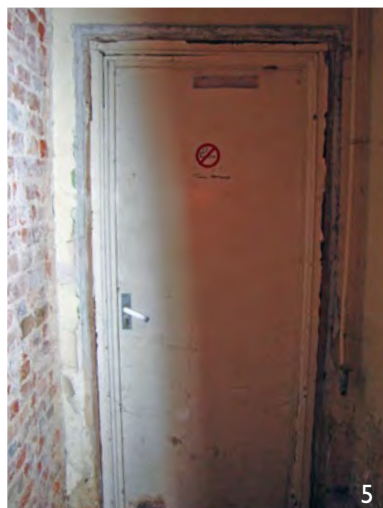
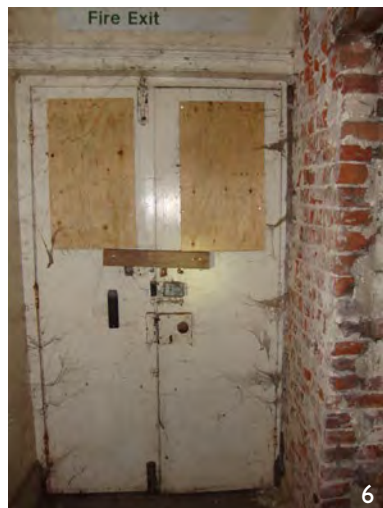
INTERNAL - GROUND FLOOR: G66 AND G67, SOUTH-EAST RANGE

- 1 G67 looking east
- 2 G67 looking west
- 3 South wall of G67
- 4 North wall of G67
- 5 Door to G64
- 6 External door

Poor condition. There is no ceiling plaster or laths. There is no plaster on the walls and some of the bricks are spalled or missing. The window opening in the south wall is blocked up and there is no window sill or frame. The stairs have been removed or collapsed. There are no doors into adjoining rooms nor door frames.

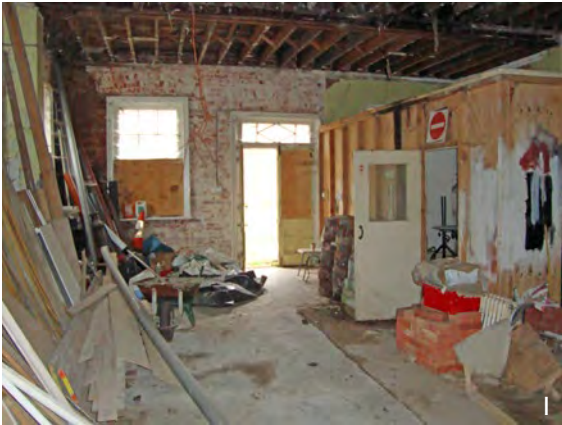
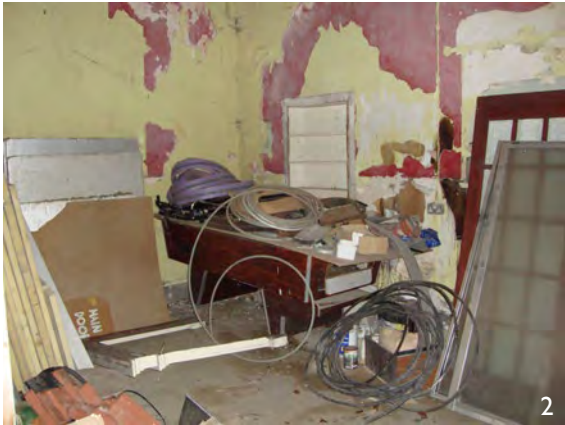
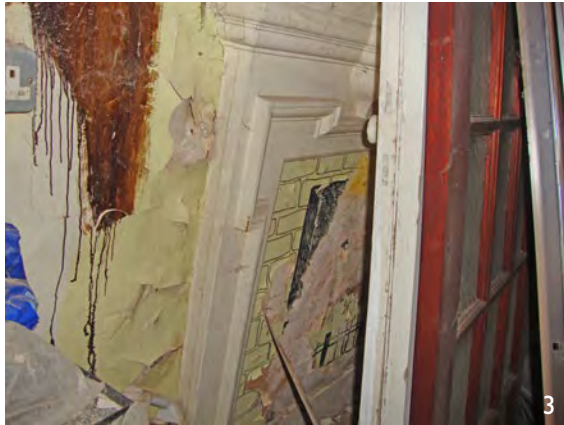
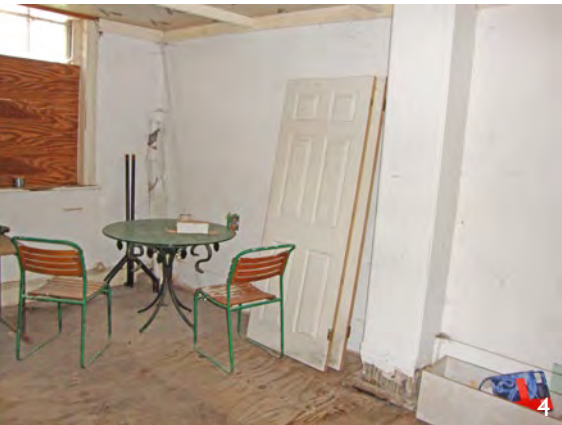
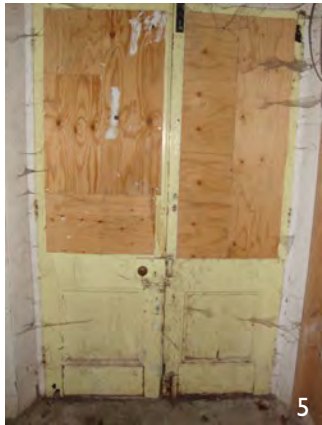
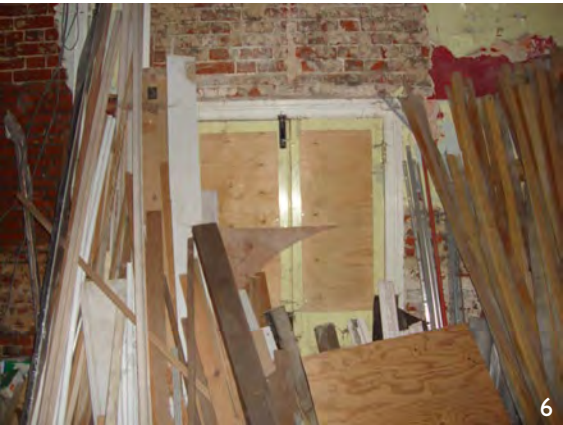
INTERNAL - GROUND FLOOR: G68 AND G69, SOUTH-EAST RANGE

- 1 G68 looking south
- 2 G68 looking north-west
- 3 Fireplace
- 4 G69 looking south-west
- 5 Detail of door
- 6 East door
- 7 Floor timbers and beams above showing significant rot
- 8 Cracking over window at south end of east wall
- 9 View of doorway to G67

Poor condition. There is no plaster to walls. There is no ceiling plaster or laths and the exposed timbers and joists are very damp with dry rot evident to the joist ends. The metal beams are badly rusted. Bricks are missing or broken, particularly around the door opening to G67. There is a large crack in the south east corner of the room extending down from the ceiling and this area of the rooms appears damp. The windows and external door are in a poor condition with broken and missing glazing to the door. The partition to G68/69 is temporary and should be removed. The floor in the north east corner by the door into G67 is bowing due to the weight of items stored here.

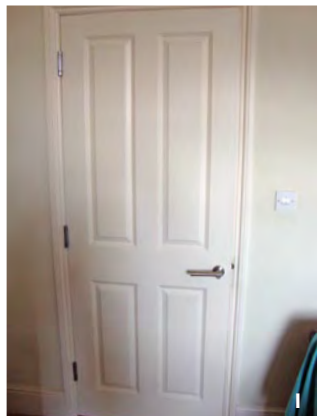
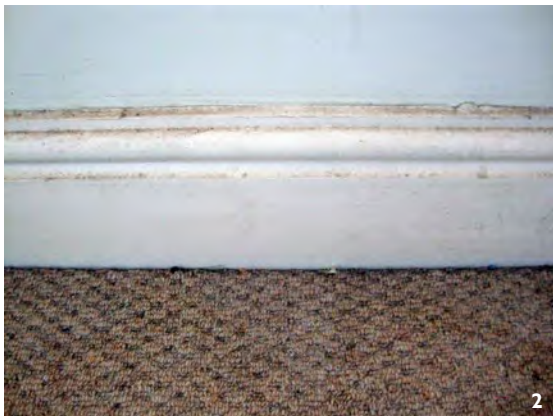
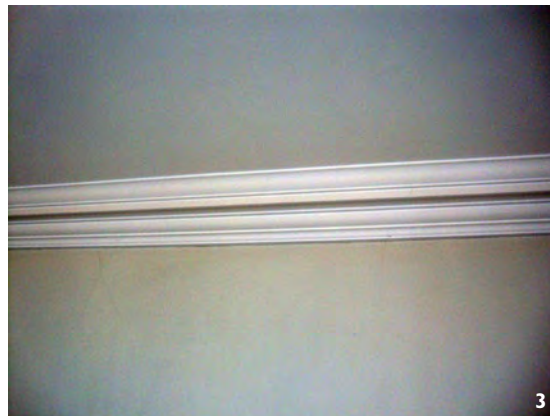
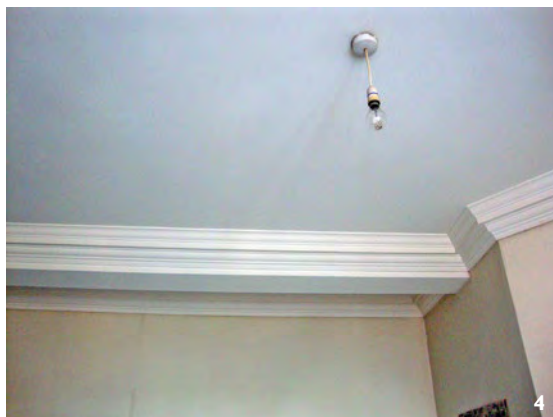
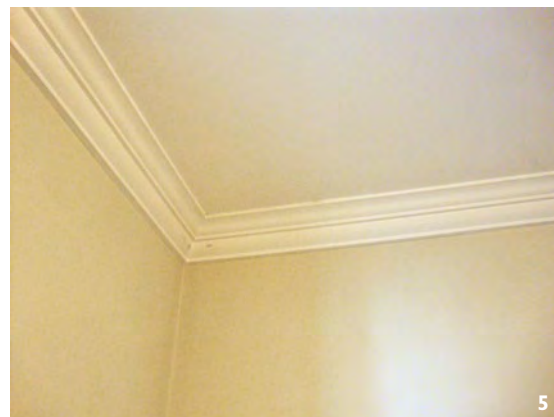
INTERNAL - FIRST FLOOR: F23 TO F30, BOARDMAN RANGE (39A BETHEL STREET)

Generally good although severe condensation and mould growth to northern windows. Some hairline cracking to cornices.

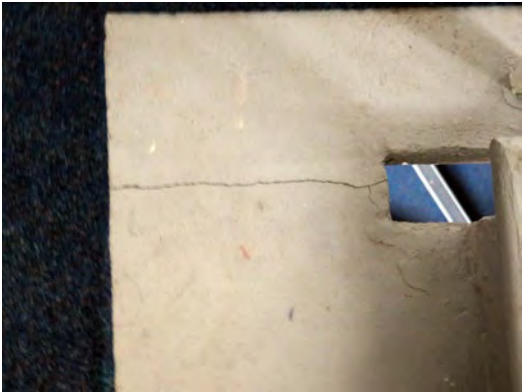
Crack in concrete landing

Good generally. Cracks to concrete landing possibly relating to cracking at ground floor level caused by water ingress in basement.

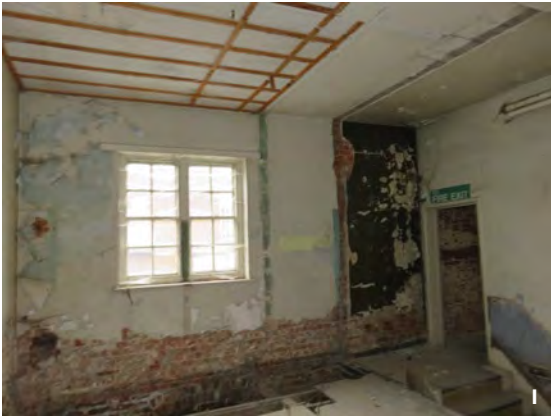
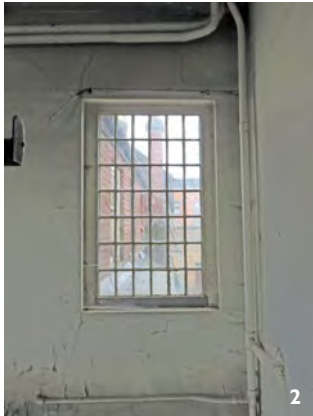
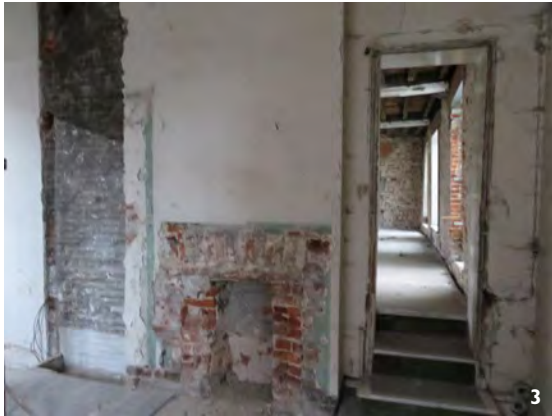
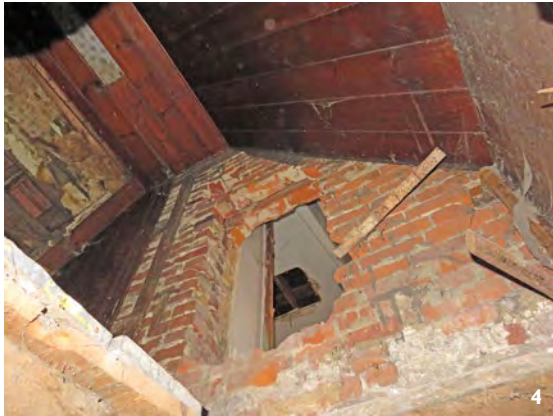
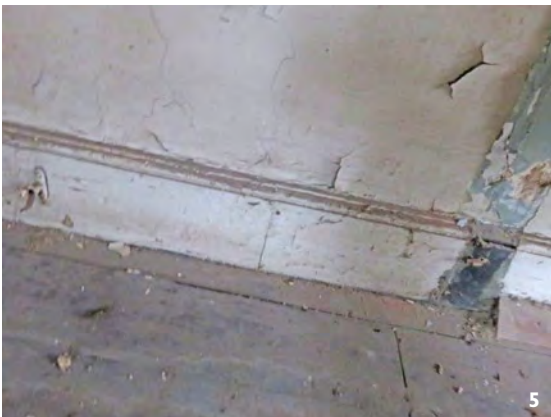
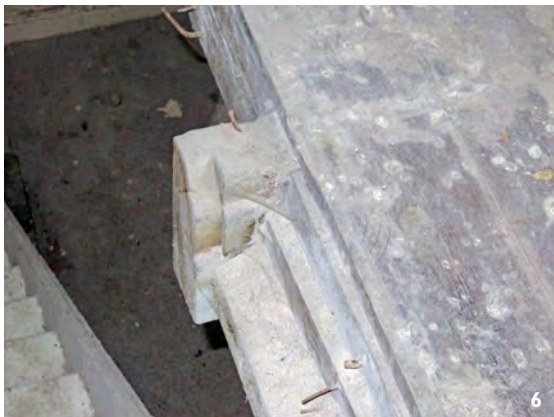
INTERNAL - FIRST FLOOR: F32, NORTHERN EXTENSION TO 1713 EASTERN RANGE

- 1 North Wall
- 2 Window in east wall
- 3 South wall with chimney breast and brick fireplace. Brickwork painted black was on external wall
- 4 East Wall
- 5 Skirting
- 6 Moulded timber protruding into stair opening possibly indicating the stair was originally oriented east to west as recorded in the western northern extension on the 1893 plan

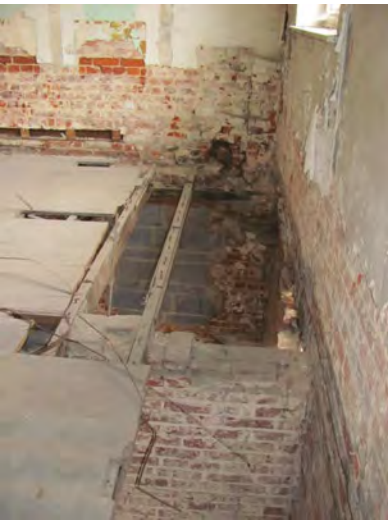
Hole in floor in north-west corner

Poor condition. Areas of cracked and missing plaster. There are areas of all walls without plaster and remaining plaster is cracked and breaking off the masonry walls. The brickwork visible is spalled and there are areas of missing and broken brickwork, particularly around the fire place. The floor is not safe. There is a large unguarded hole in the north west corner of the room and the staircase is unguarded.

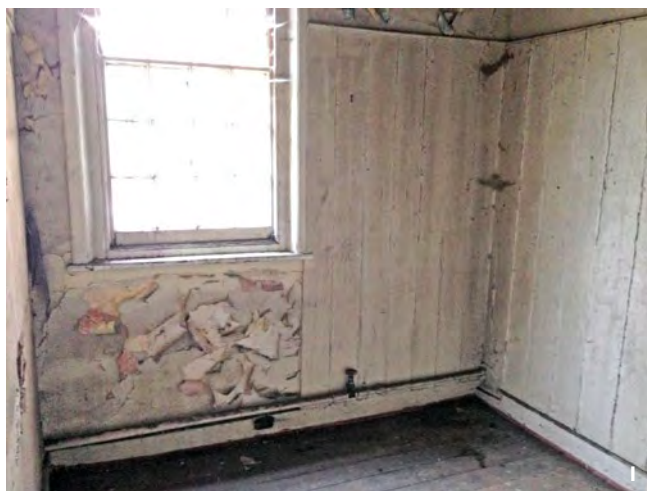
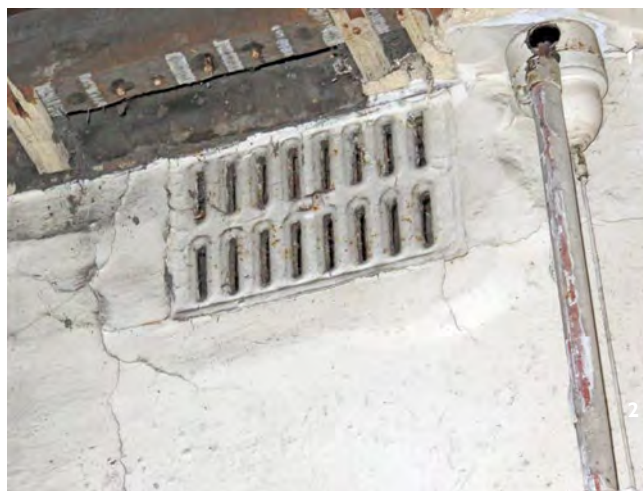
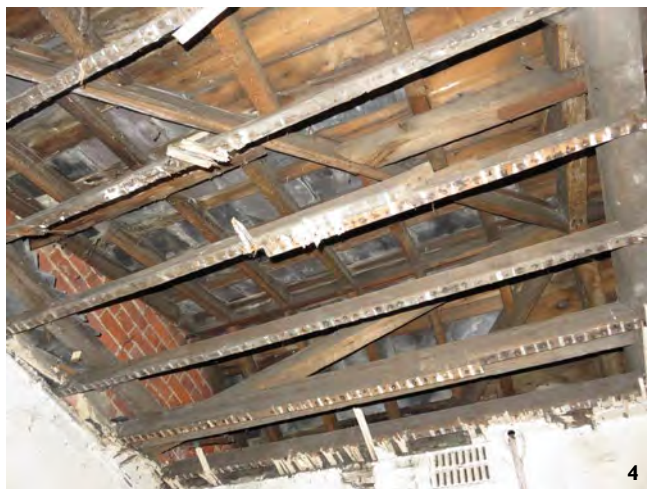
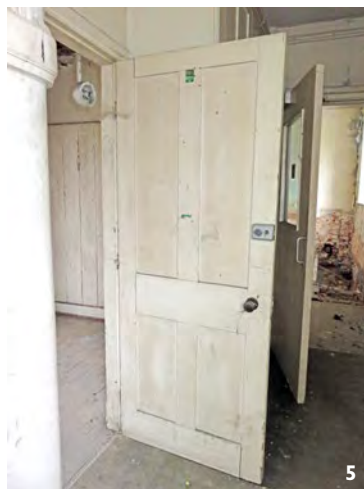
INTERNAL - FIRST FLOOR: F33, EASTERN CELL RANGE

- 1 Interior of cell
- 2 Ceiling and ventilation grille
- 3 Mould growth throughout
- 4 Removed ceiling reveals the roof was hipped and probably altered in 1899
- 5 Door

Poor. There is no ceiling plaster or laths. This room is very damp with mould growth throughout. The window is in poor condition with mould growth and peeling paint.
