BETHEL HOSPITAL, NORWICH
GAZETTEER
ISSUE 3
NOVEMBER 2016

This Gazetteer has been written to accompany the Conservation Management Plan (CMP) for Bethel Hospital. It is a room by room assessment of most of the site with the occupied flats generally having a single entry. The Gazetteer is intended as a reference guide to allow the status of a particular structure or interior to be checked if a change or conservation works are proposed. A location plan and photographs are included for each entry.

The Gazetteer has been prepared by the authors of this document based on a site visit to each area in late January and early February 2016.

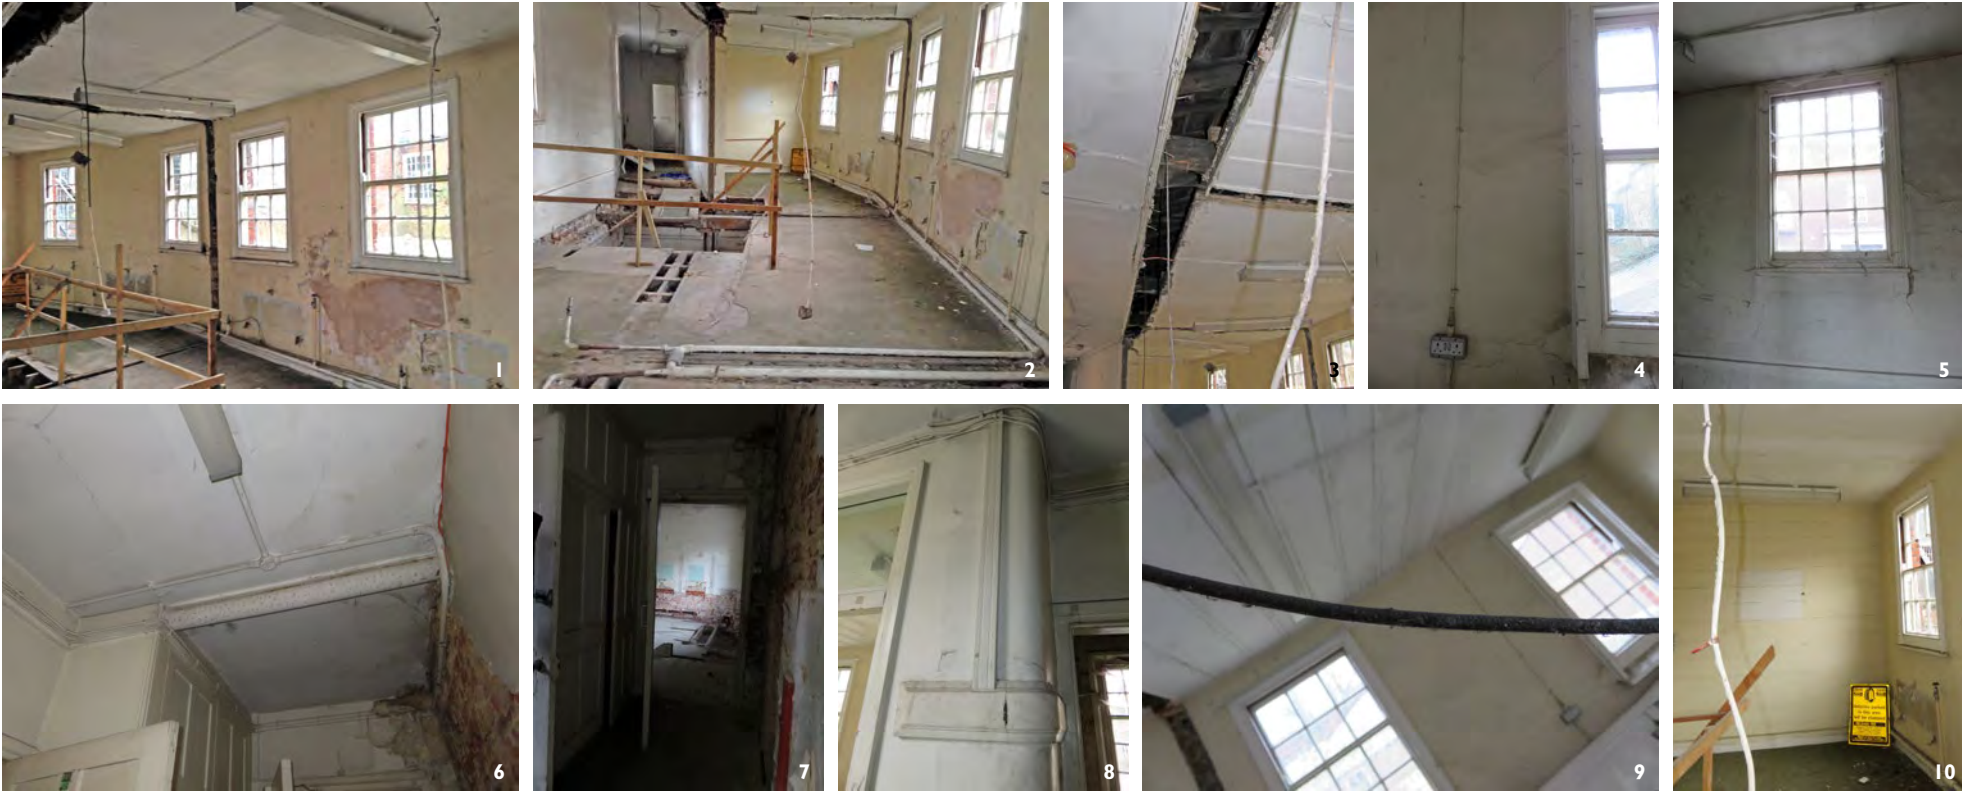
INTERNAL - FIRST FLOOR: F34, EASTERN CELL RANGE

- 1 Sash windows along the south wall
- 2 Looking from west to east
- 3 Ceiling hole where partition removed
- 4 Evidence of removed window bars
- 5 North wall window
- 6 Ventilation pipe from F33
- 7 Cupboard at west end
- 8 Early electrical conduit
- 9 Early electrical cable with ribbed ceiling panelling behind
- 10 Timber panelling on east wall

Poor condition. Partitions have been removed leaving holes in the floor, ceiling and wall finishes. The ceiling appears to be sagging towards the central hole. Ceiling and wall plaster and ceiling laths damaged. There is no floor structure at the east end of the room. The windows are in poor condition with rotten frames and glazing panes that have come out of the frames.

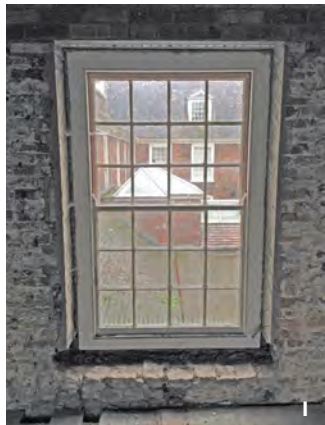
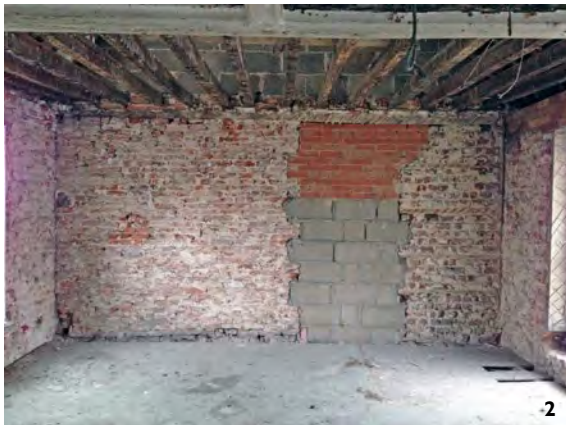
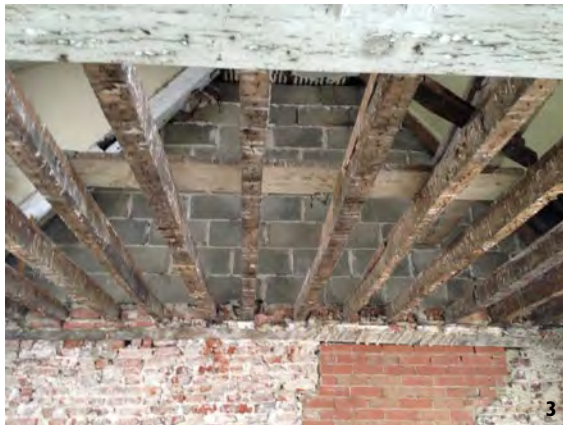
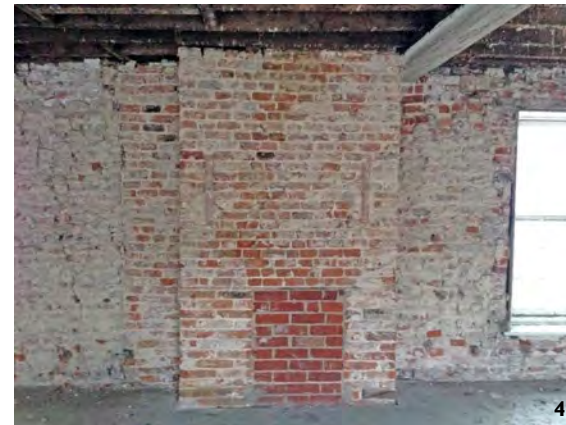
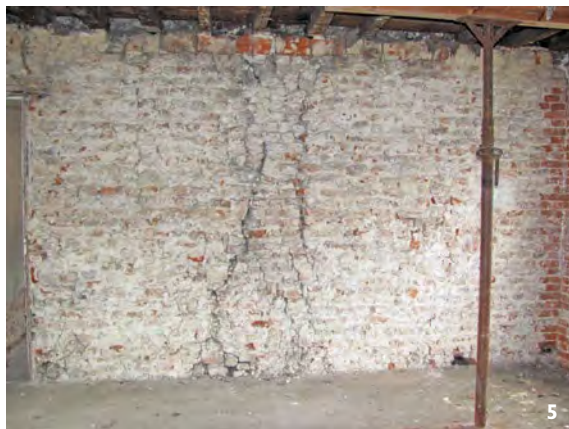
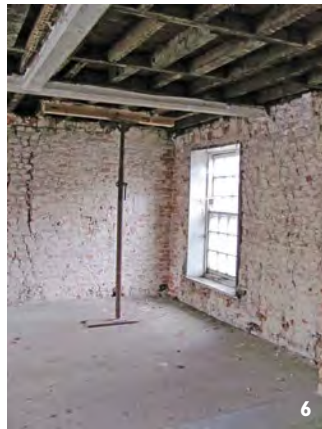
INTERNAL - FIRST FLOOR: F38, 1713 SOUTH-EAST WING

- 1 Sash window (12 over 12)
- 2 South wall with blocked entrance
- 3 Section of removed ceiling
- 4 Chimney breast with blocked fireplace
- 5 Cracking in north wall
- 6 Cracking in east wall and propping

Poor condition. There is no plaster to walls. There is no ceiling plaster or laths, nor boards over the joists. Previous doorways are blocked up with concrete blocks. Brickwork has been badly repaired and repointed with cement mortar. Bricks are missing or broken, particularly to window reveals and sills. There are severe cracks in the north and east walls and the north end of the room is supported on a prop.

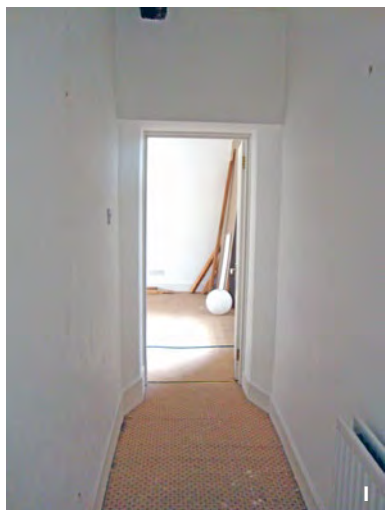
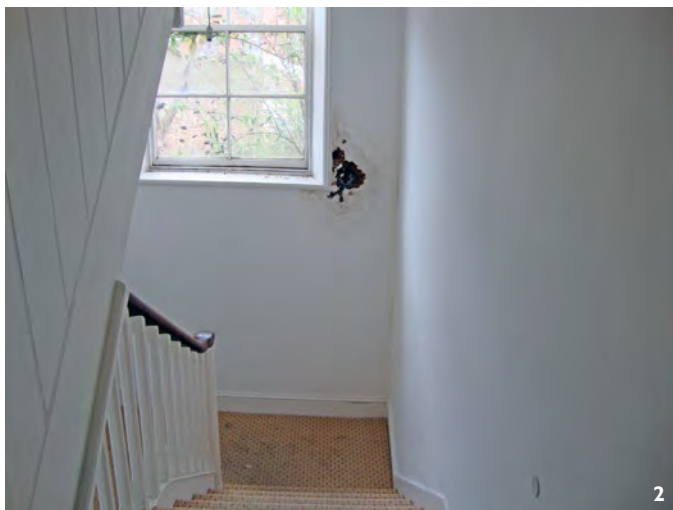
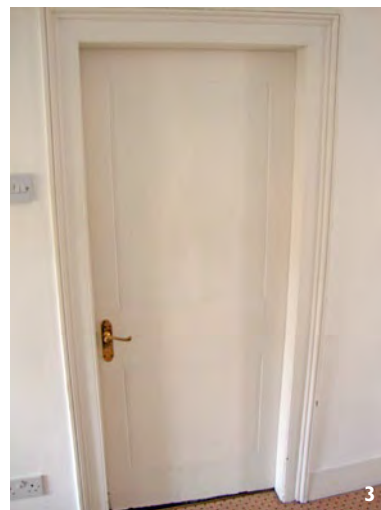
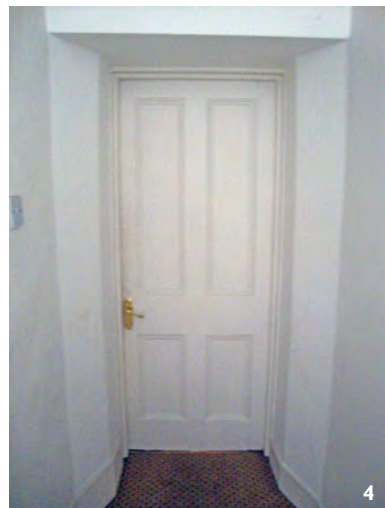
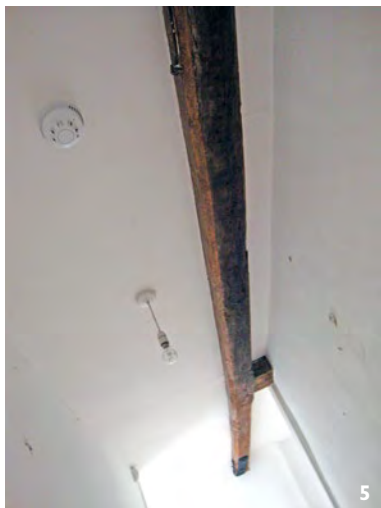
INTERNAL - FIRST FLOOR: F39 AND F40, 1713 CENTRAL RANGE

- 1 Corridor
- 2 Looking down staircase
- 3 Door to F44
- 4 Door to F46
- 5 Chamfered and stopped beam running north to south

Good, with the exception of an area of mould and decay due to water penetration, to the east wall adjacent to the window on the half lading.

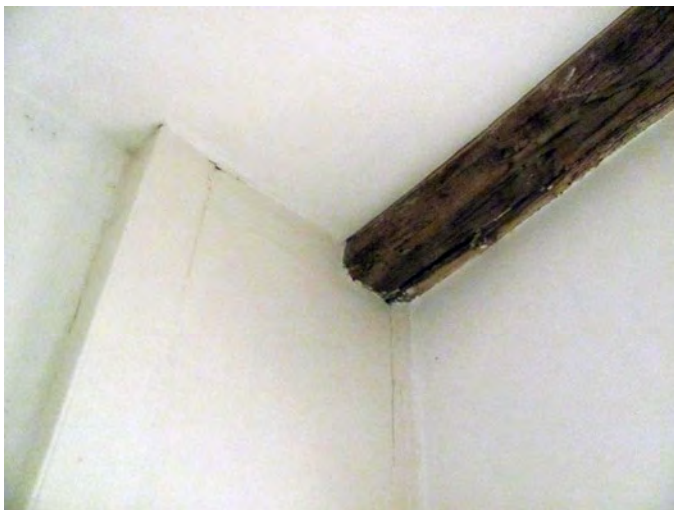
Damp to the east end of corridor

Good condition with the exception of damp areas to ceiling at east end of corridor due to water ingress.

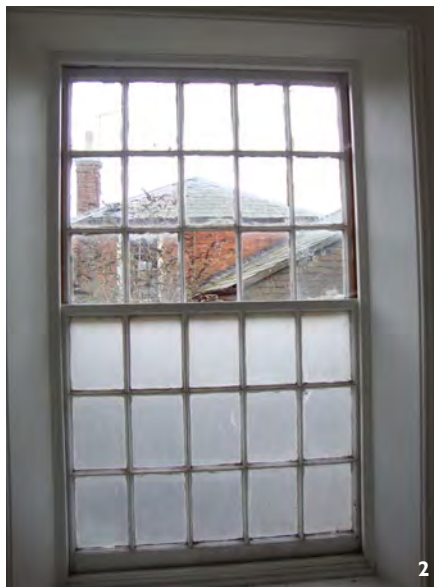
- 1 Peeling paint to casement window reveal
- 2 Missing glass pane in sash window
- 3 Quirk
- 4 Door

Good although some peeling paintwork around small casement window. Area to be investigated for damp/water ingress.

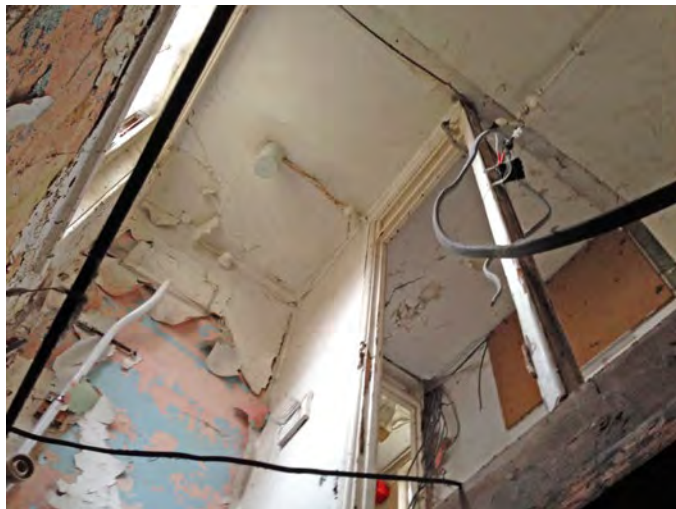
Partition between F52 and F51

No access but part visible from safe area. Looks in poor condition throughout with holes in floor and damaged wall plaster.

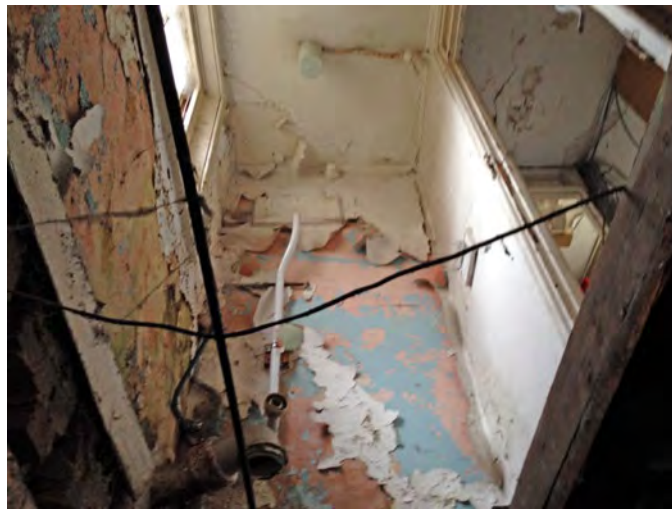
FLOOR • Floor to F52 missing

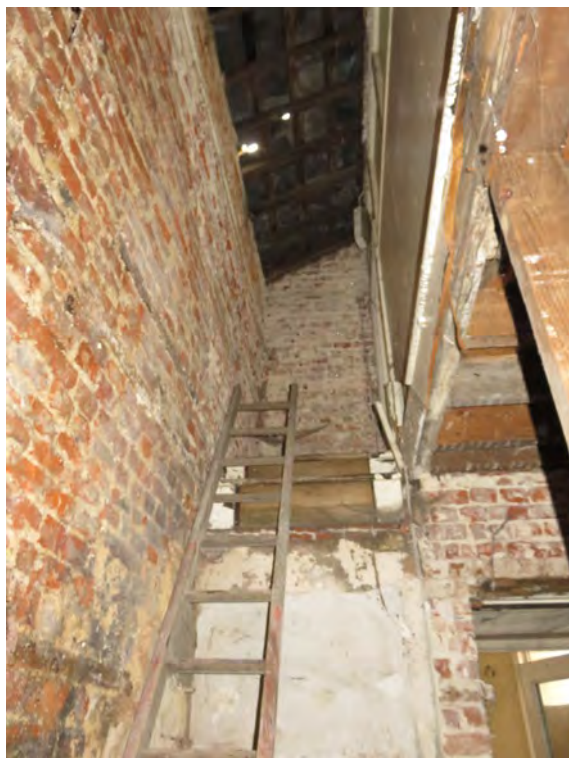
INTERNAL - FIRST FLOOR: F54, SOUTH-EAST RANGE

View from below

No staircase remains except for the top two treads. No ceiling plaster or laths. No plaster to the north wall.

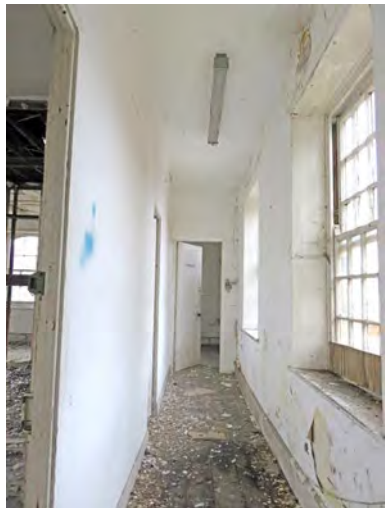
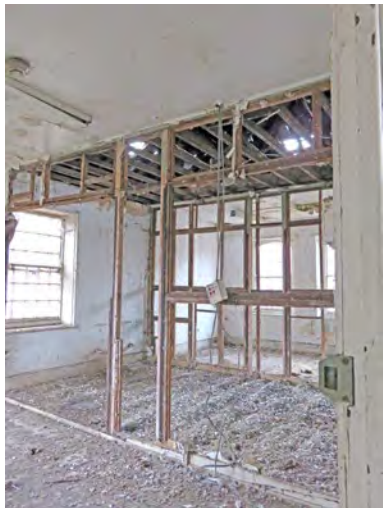
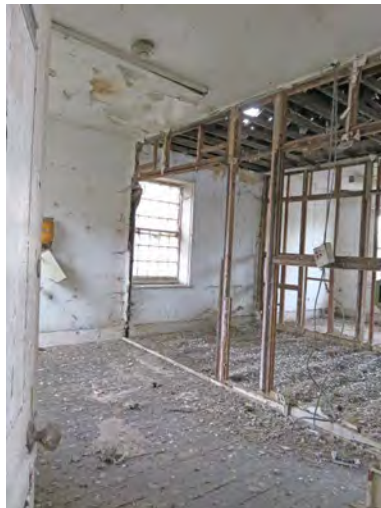
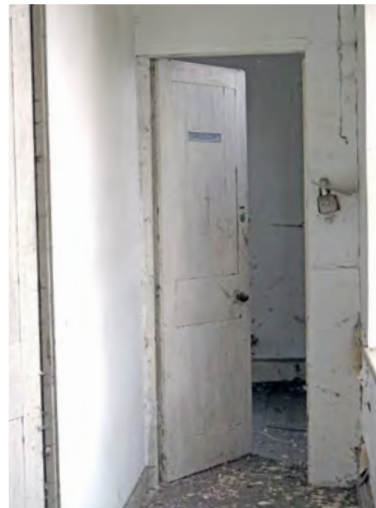
INTERNAL - FIRST FLOOR: F55 TO F58, SOUTH-EAST RANGE

No access but part visible from safe area. Significant pigeon guano present. Looks in poor condition throughout with no ceiling plaster or laths and damage to wall plaster and floors.

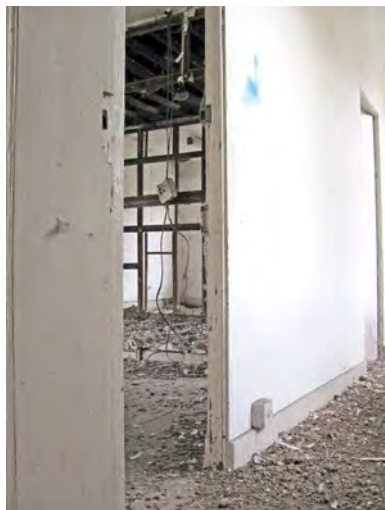
Pigeon guano

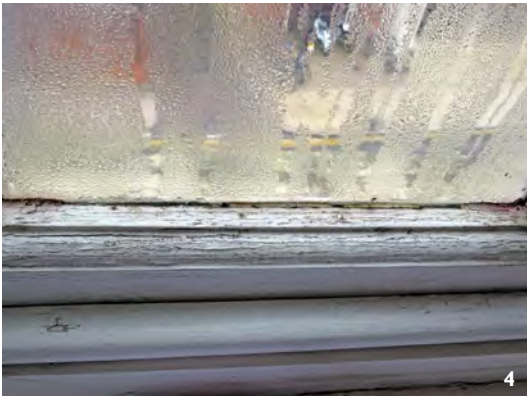
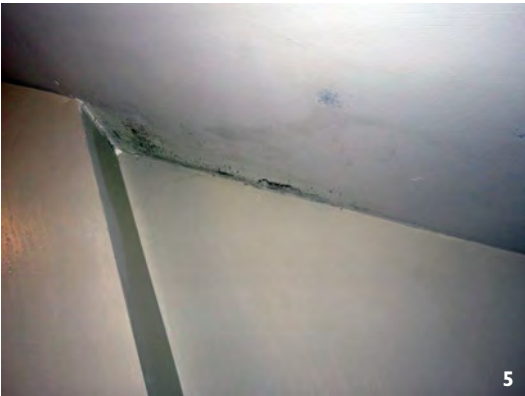
- 4 Detail of condensation on window in S26
- 5 Mould on ceiling of S27

Generally good condition but severe condensation and mould growth to all windows, severe condensation to window in S24 and S26 and mould to ceiling of S23 and S27.

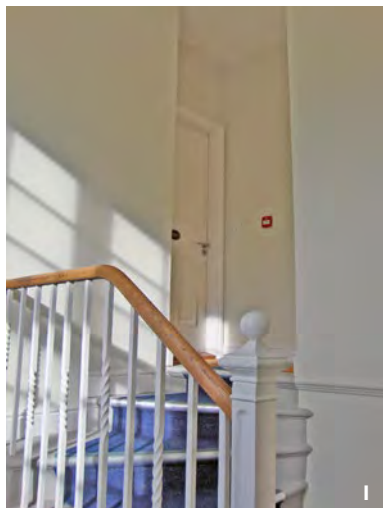
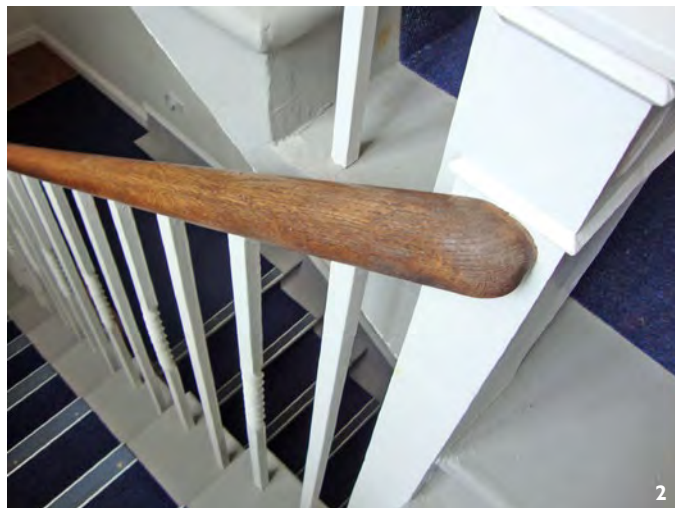
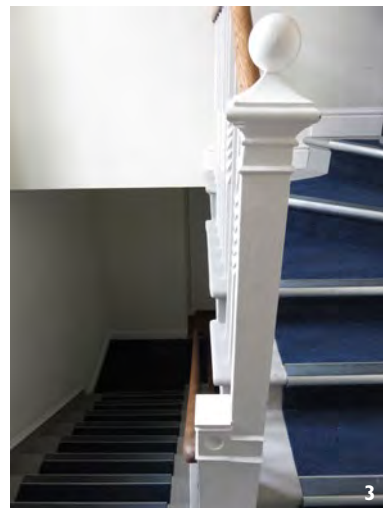
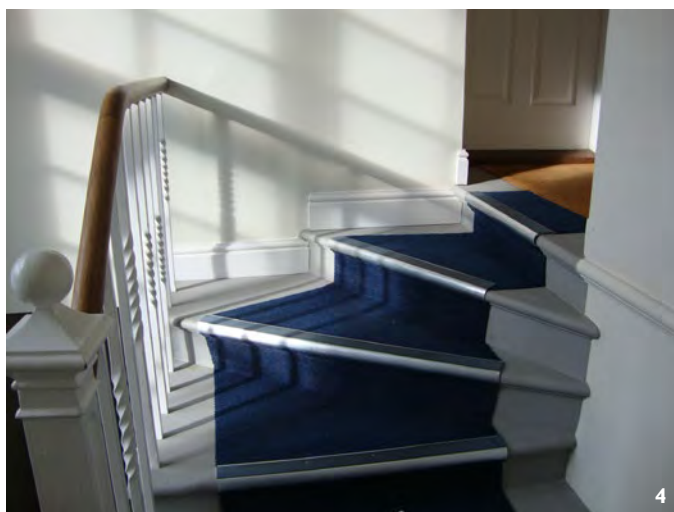
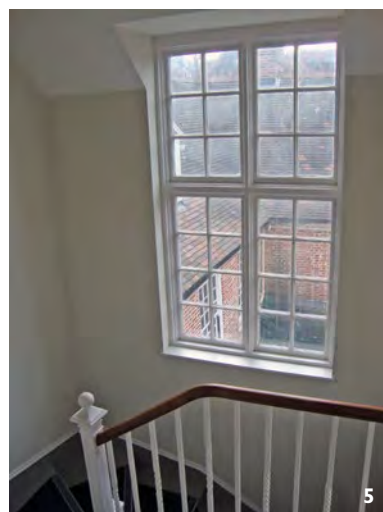
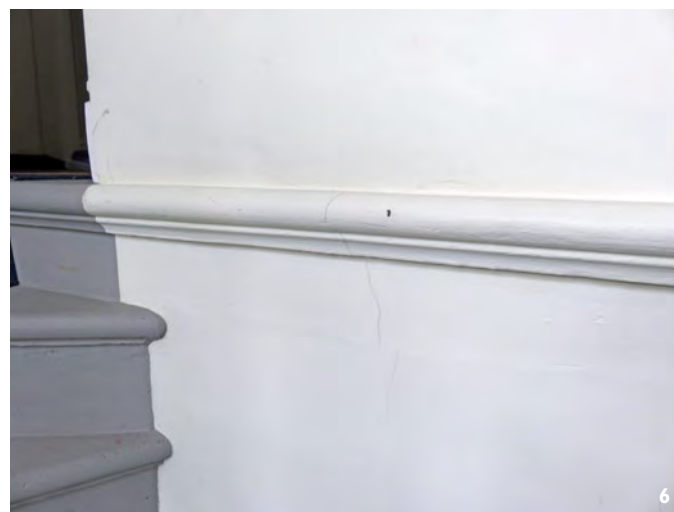
INTERNAL - SECOND FLOOR: S28 AND S29, BOARDMAN RANGE

Good - some hairline cracks to concrete stair and cement wall moulding.

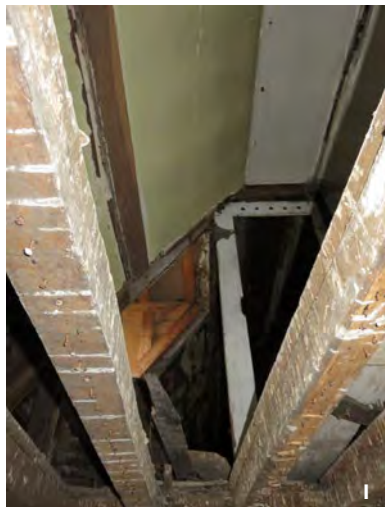
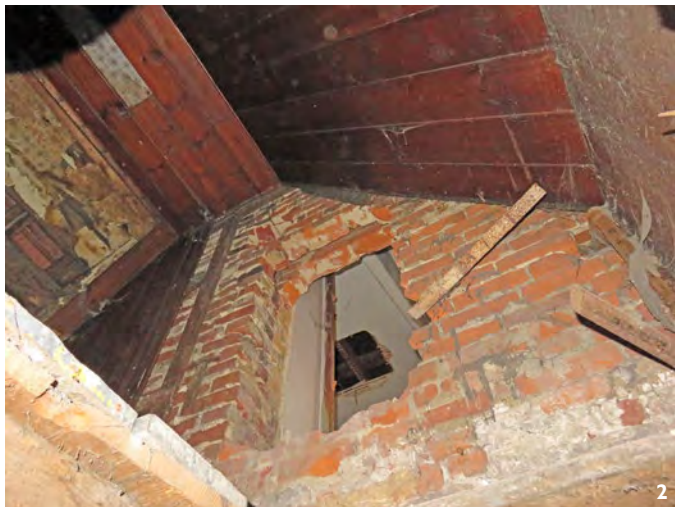
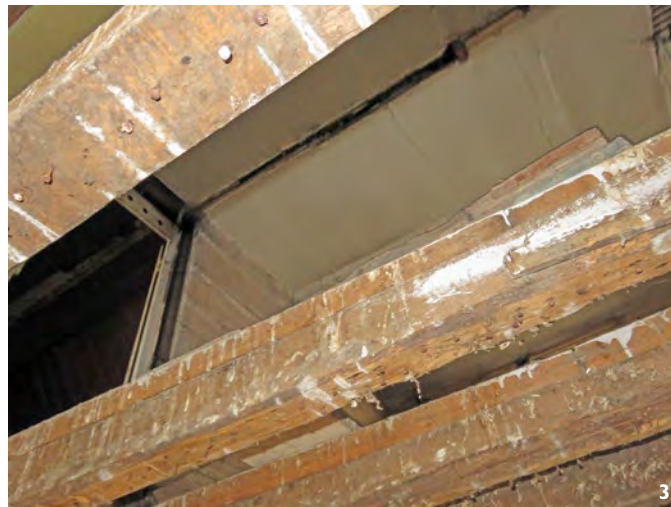
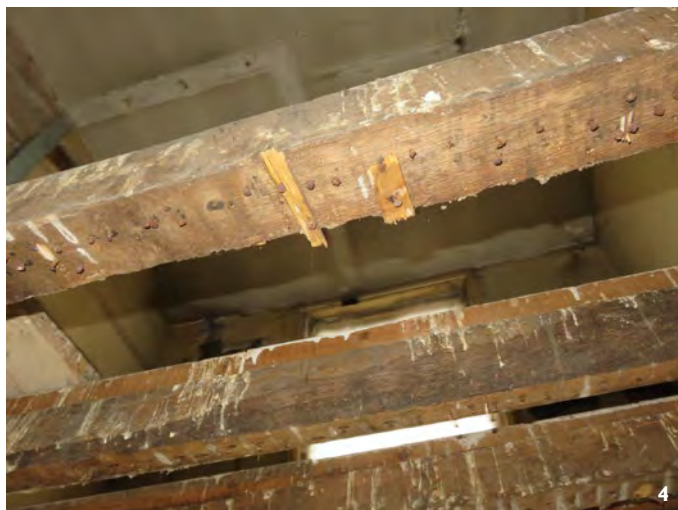
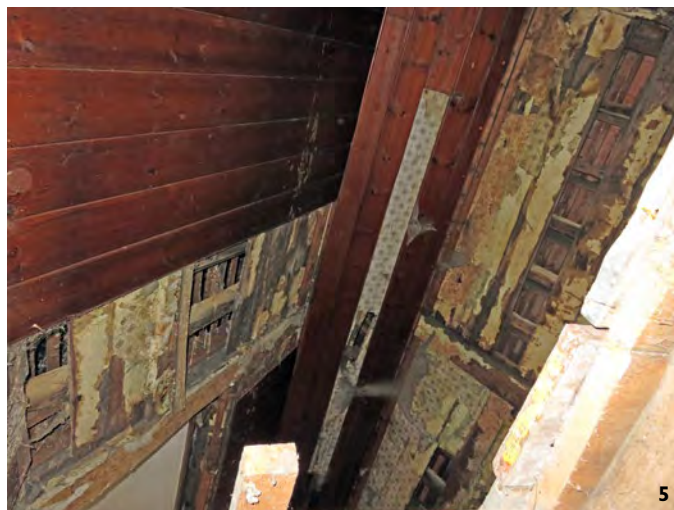
INTERNAL - SECOND FLOOR: S30 TO S32, 1713 EASTERN RANGE

No access for inspection. Looking through exposed, condition looks reasonable.

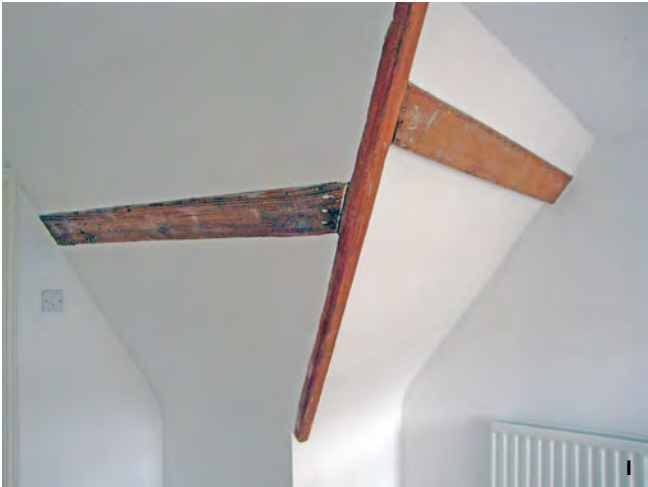
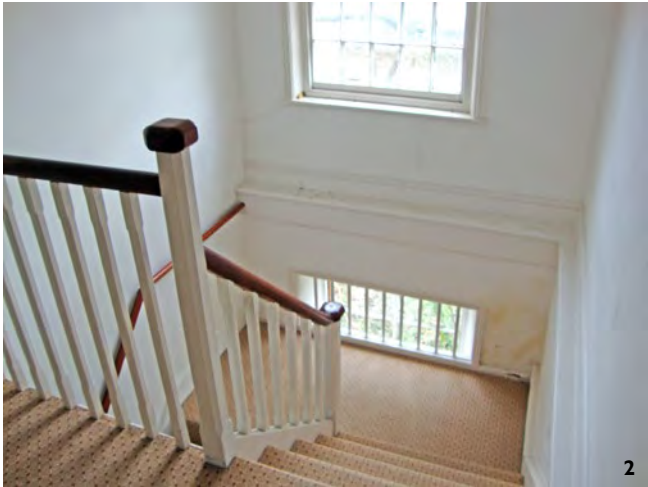
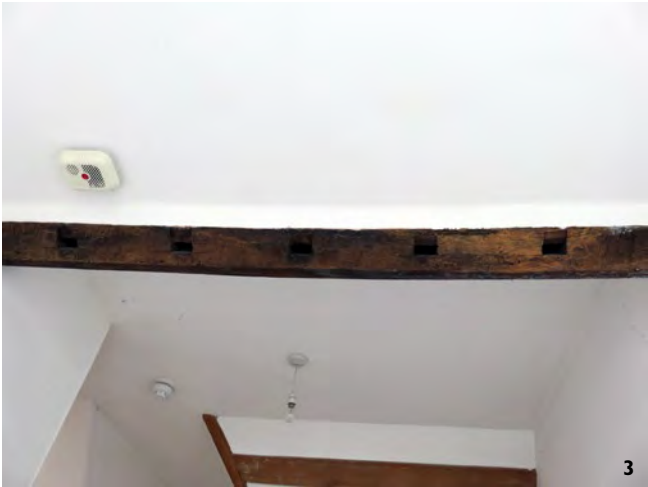
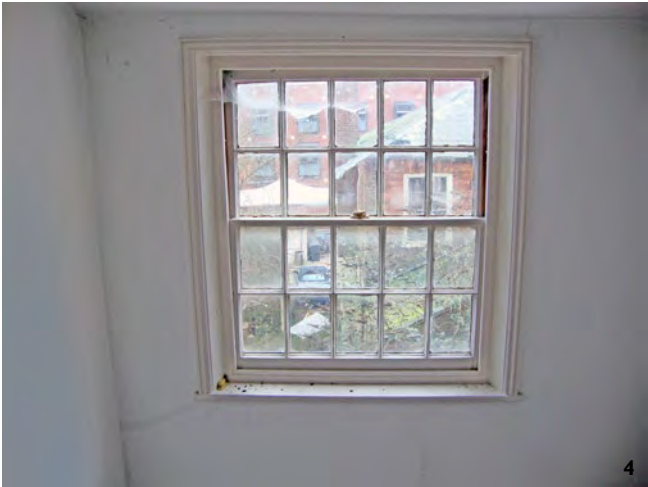
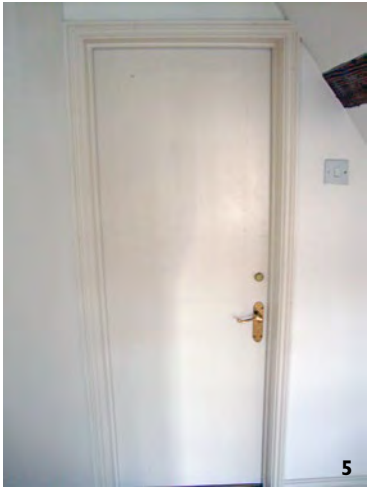
INTERNAL - SECOND FLOOR: S33, 1713 CENTRAL RANGE

Good, with the exception of an area of mould and decay due to water penetration, to the east wall adjacent to the window on the half landing.

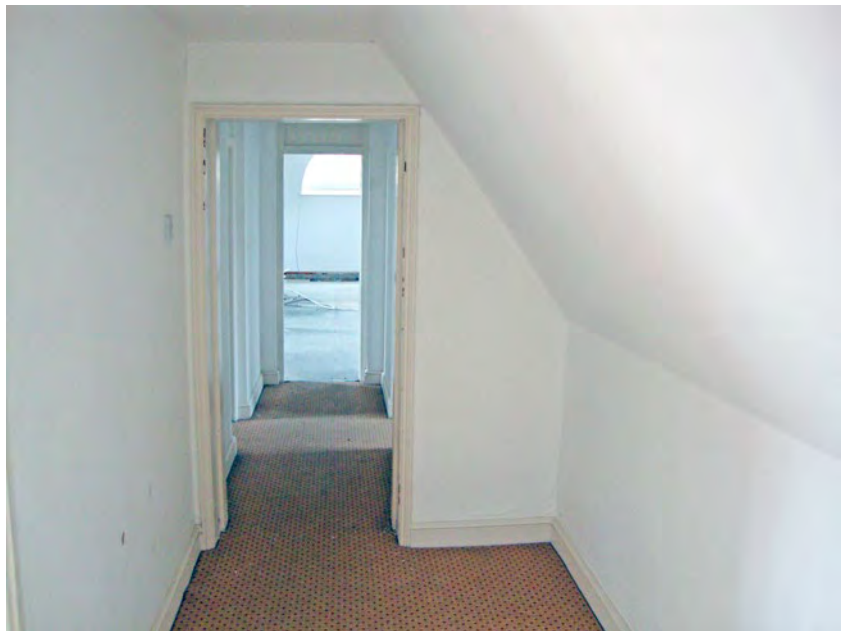
S34 looking south through to S39

Good

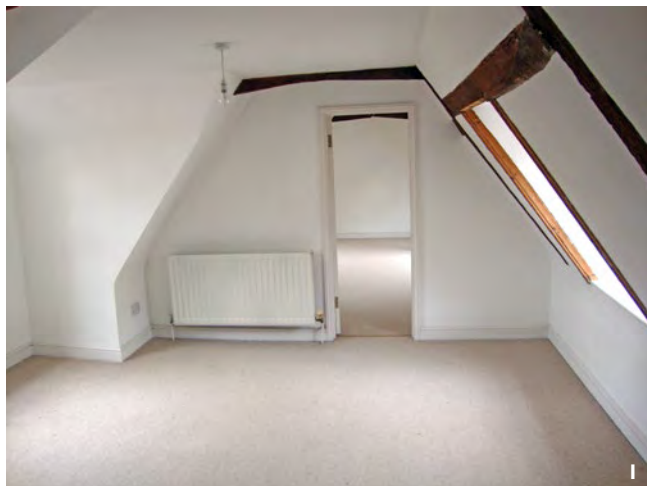
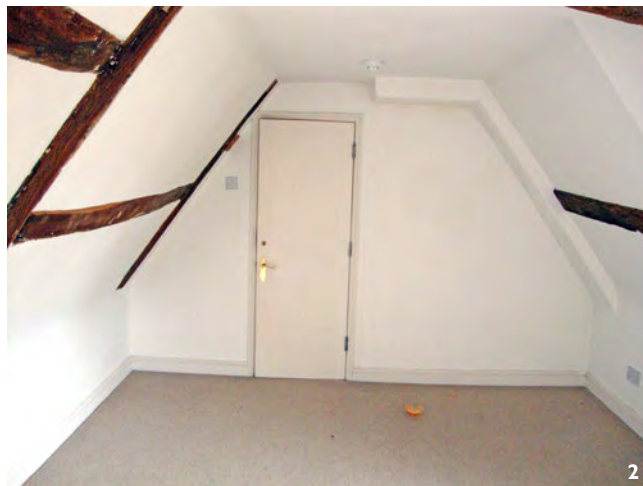
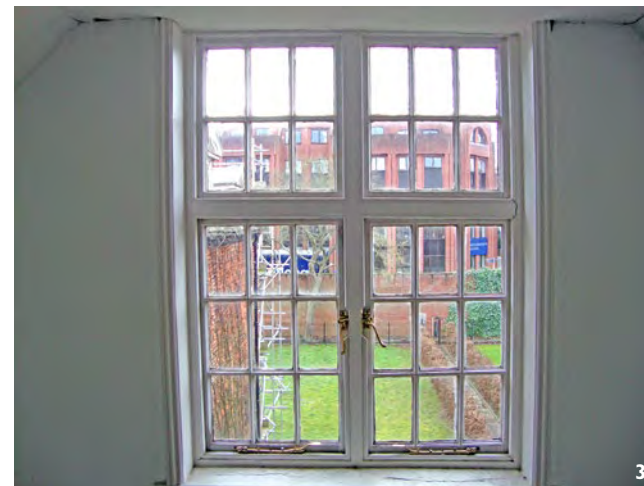
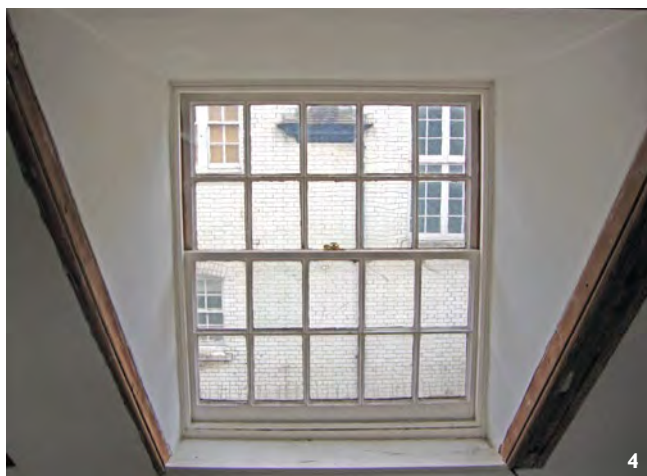
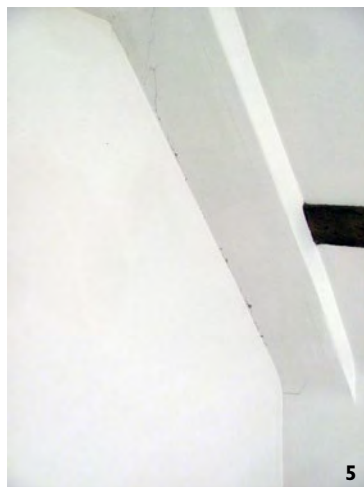
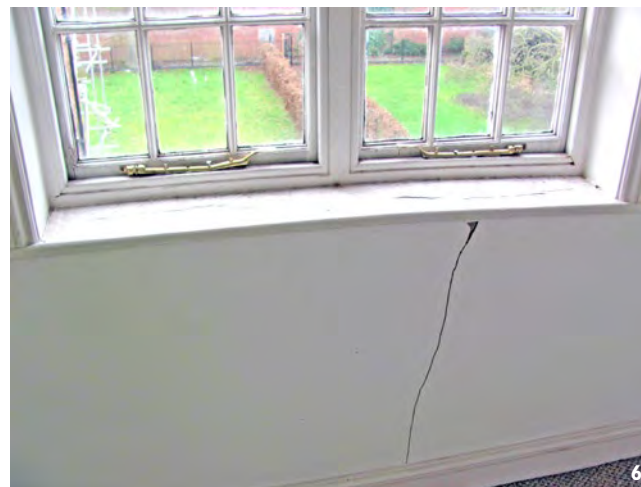
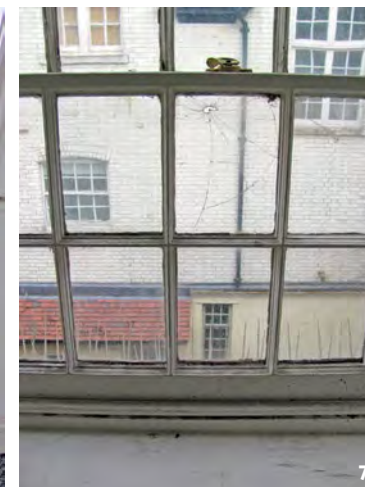
INTERNAL - SECOND FLOOR: S35, 1713 CENTRAL RANGE

- 1 S35 looking west
- 2 S35 looking east
- 3 Casement window in south wall
- 4 Sash window in north wall
- 5 Crack in south east corner
- 6 Crack under window in south wall
- 7 Broken window in north wall

Generally good, although there is a crack along the rafter line in the south east corner. There is also a large crack in the south wall directly under the window sill. The sill is cracked and bowing, possibly due to water ingress. The window in the north wall has two broken panes of glass and is partially covered in mould.

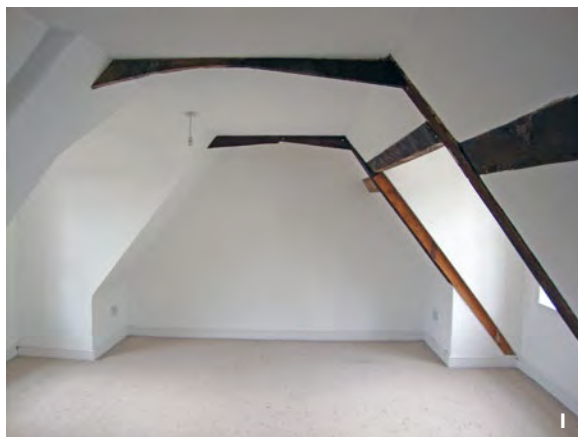
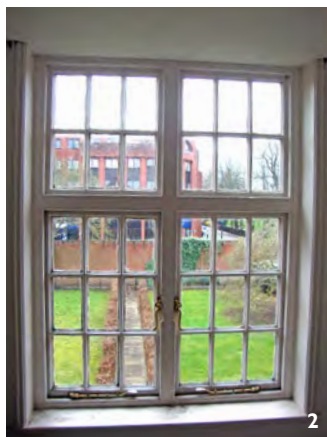
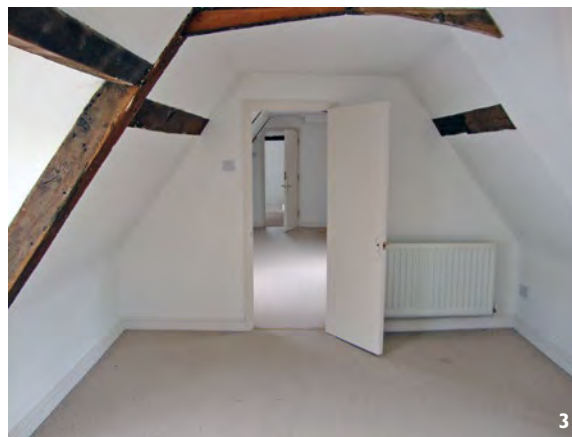
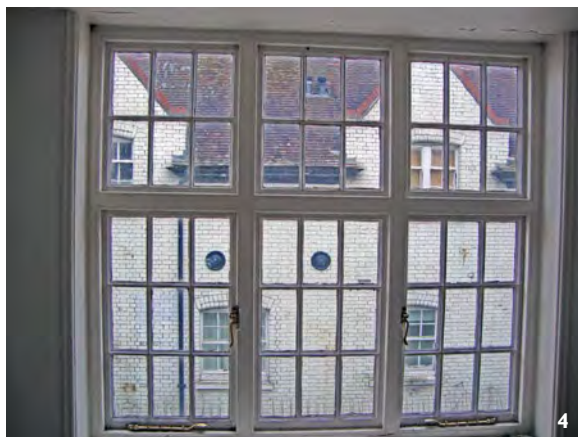
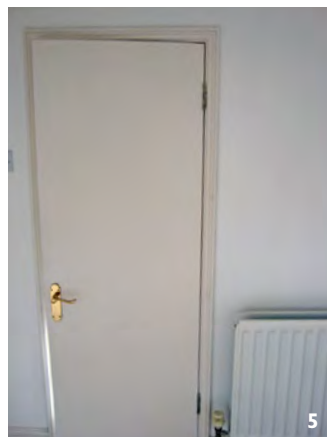
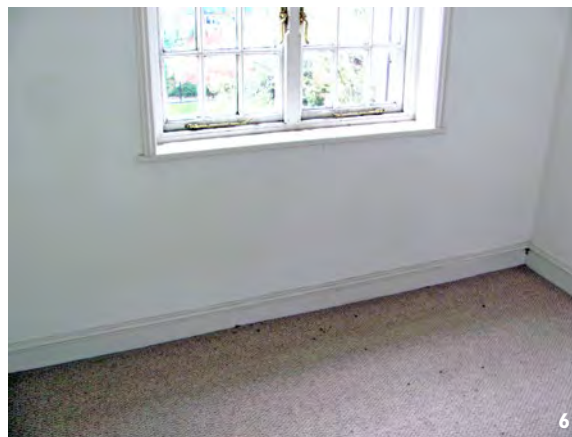
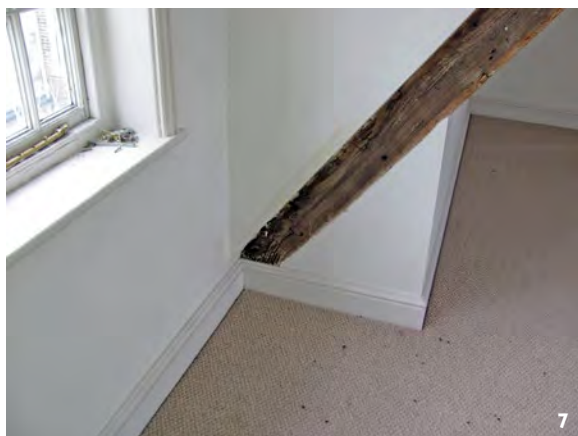
INTERNAL - SECOND FLOOR: S36, CENTRAL RANGE

- 1 S36 looking west
- 2 Casement window in south wall
- 3 S36 looking east
- 4 Window in north wall
- 5 Door
- 6 Crack under window in south wall
- 7 Damp areas adjacent to north wall

Generally good, although there is a crack along the rafter line in the south east corner. There is also a crack in the south wall directly under the window sill. The window sill is partially covered in mould. There are also some damp areas around the exposed rafters in the north wall. There is some cracking to the ceiling plaster on the north side of the room and over the window in the north wall.

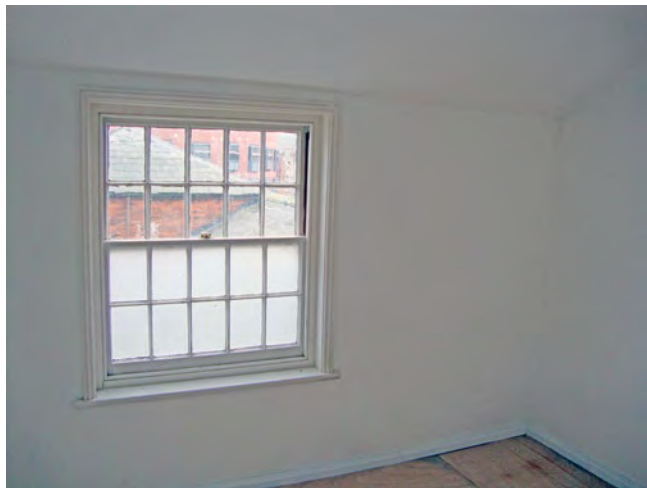
Window in east wall

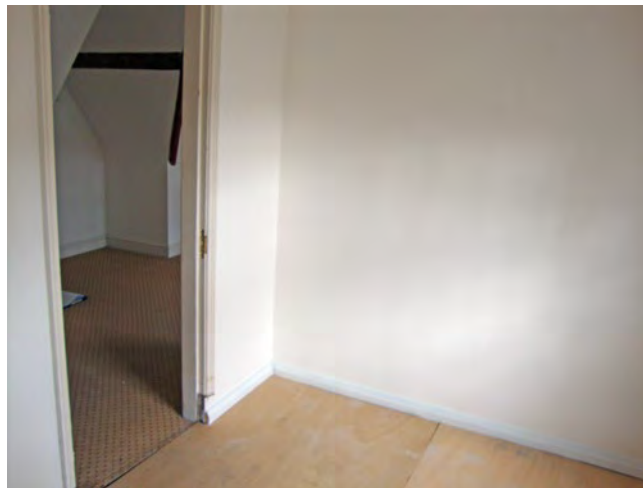
Door opening in west wall

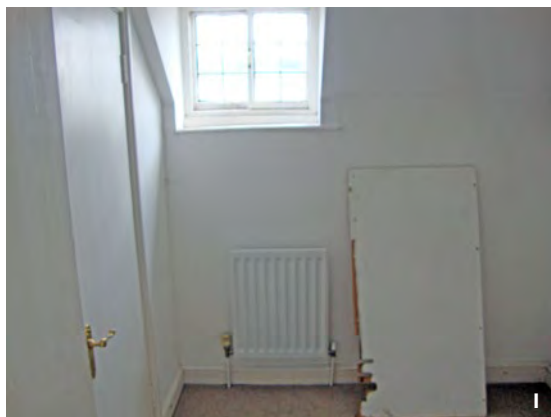
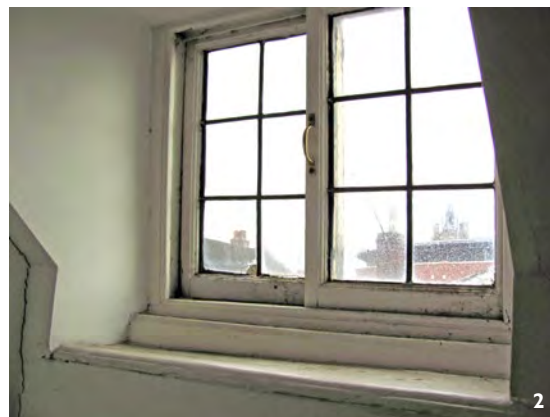
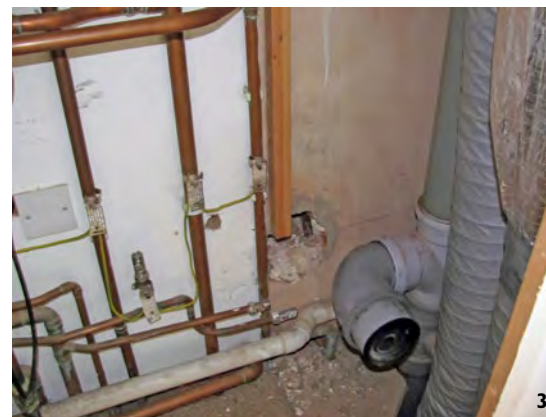
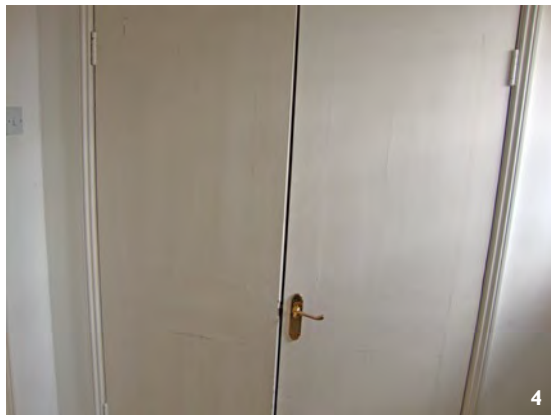
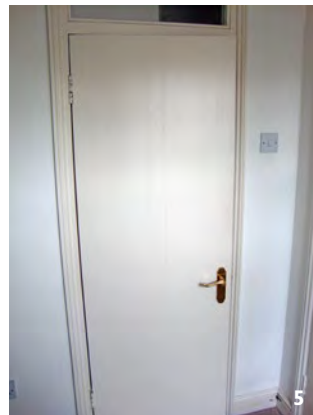
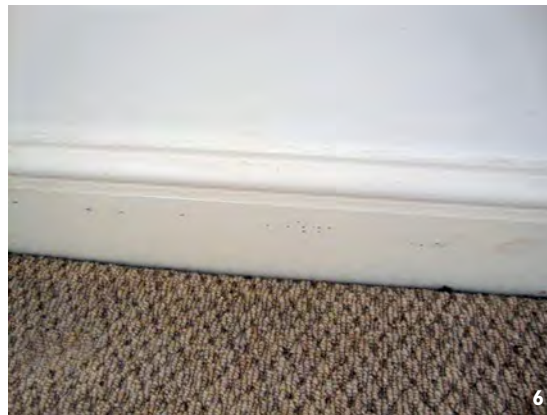
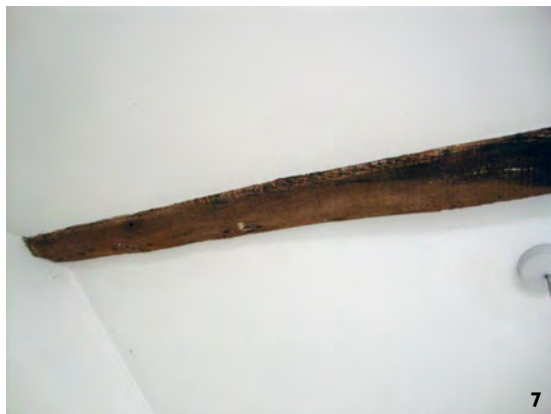
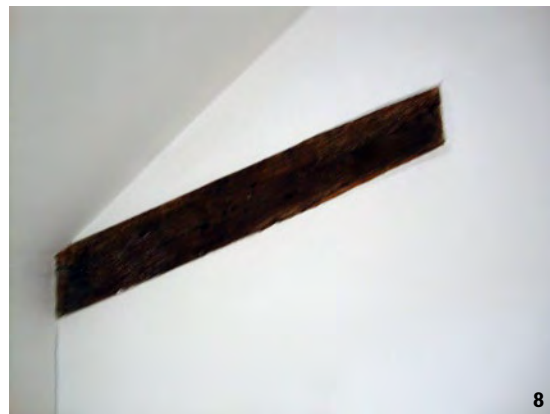
INTERNAL - SECOND FLOOR: S38, 1753 TO 1756 EASTERN RANGE

- 1 East wall
- 2 Casement window in east wall and adjacent crack
- 3 Services hole in north wall
- 4 Modern cupboard
- 5 Door
- 6 Skirting
- 7 Beam
- 8 Rafter in south wall

Adequate. The window is in poor condition with a hole in one of the panes and mould growth. There is a large crack in the east wall adjacent to the window and services holes in the north wall of the cupboard.

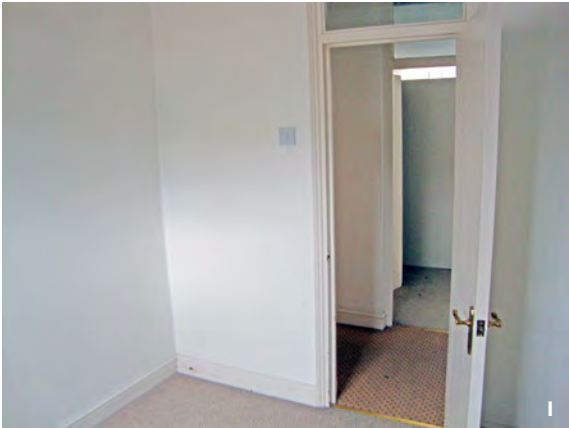
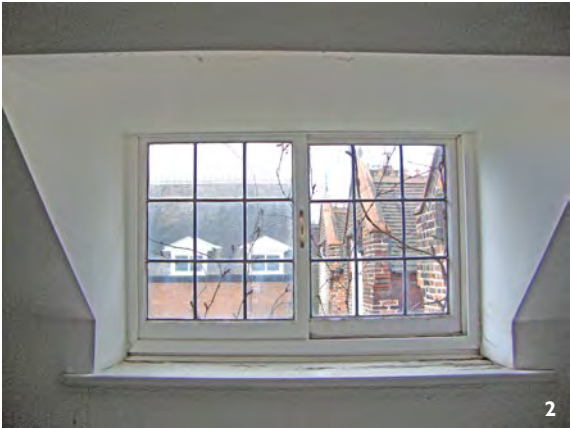
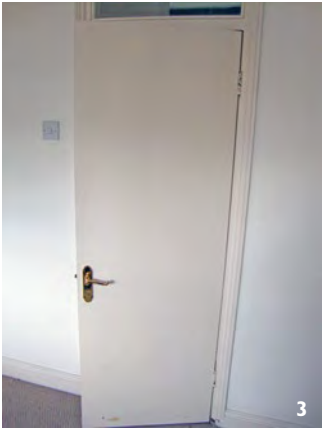
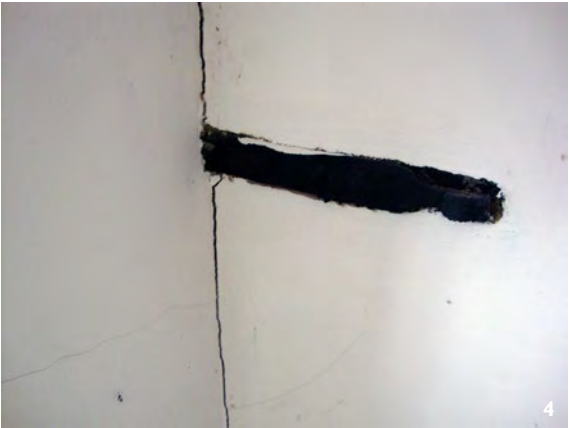
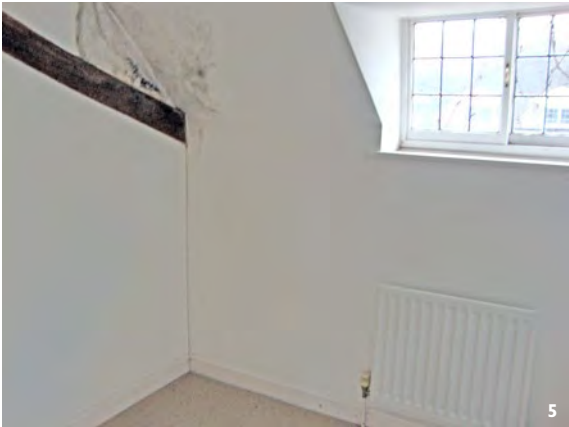
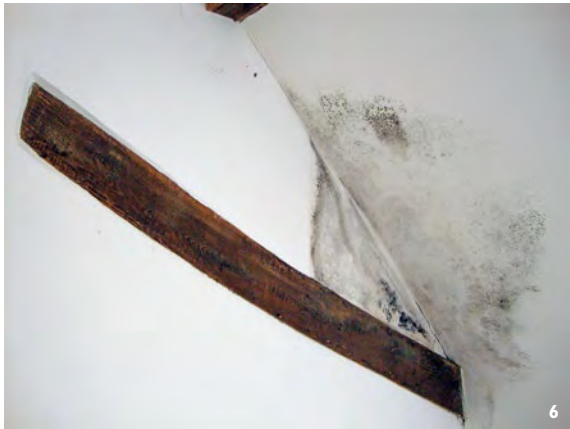
INTERNAL - SECOND FLOOR: S40, 1753 TO 1756 EASTERN RANGE

- 1 East wall
- 2 Window
- 3 Door
- 4 Iron tie
- 5 Looking south-west
- 6 Mould growth to south-west corner

Generally good, although there is a significant damp stain with mould growth in the south west corner of the room. The window sill is also cracking and bowed with peeling paint and the window has mould growth.
