BETHEL HOSPITAL, NORWICH
GAZETTEER
ISSUE 3
NOVEMBER 2016

This Gazetteer has been written to accompany the Conservation Management Plan (CMP) for Bethel Hospital. It is a room by room assessment of most of the site with the occupied flats generally having a single entry. The Gazetteer is intended as a reference guide to allow the status of a particular structure or interior to be checked if a change or conservation works are proposed. A location plan and photographs are included for each entry.

The Gazetteer has been prepared by the authors of this document based on a site visit to each area in late January and early February 2016.

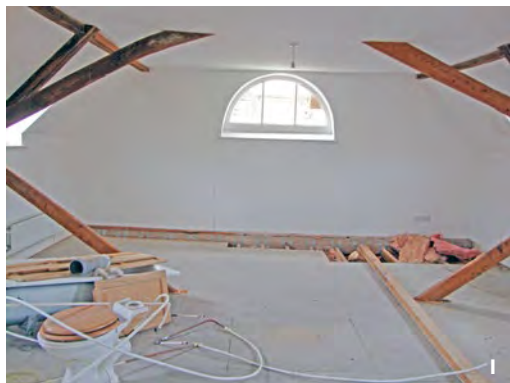
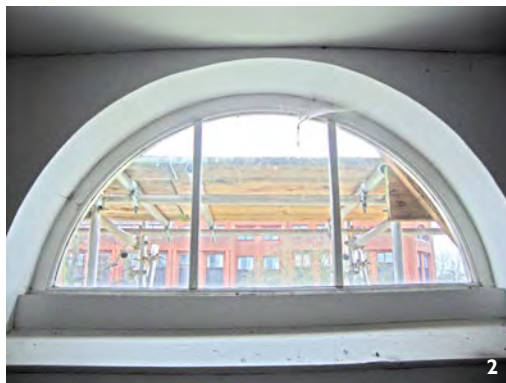
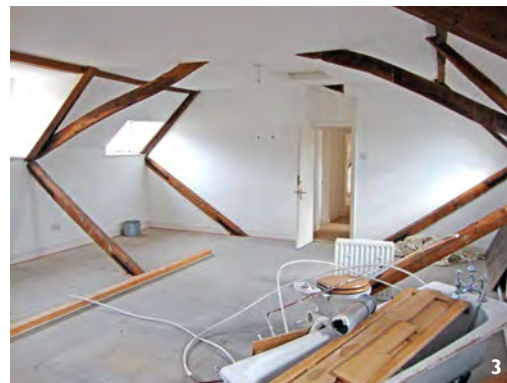
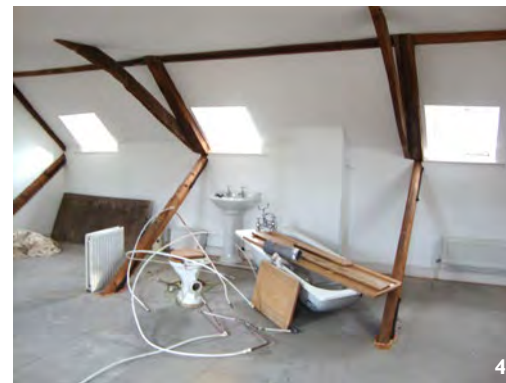
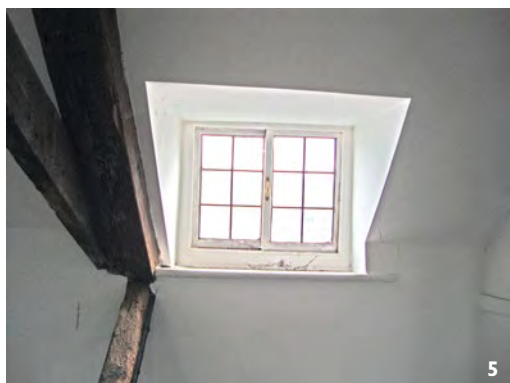
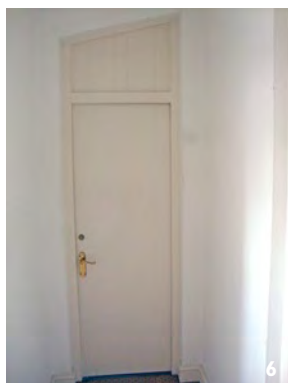
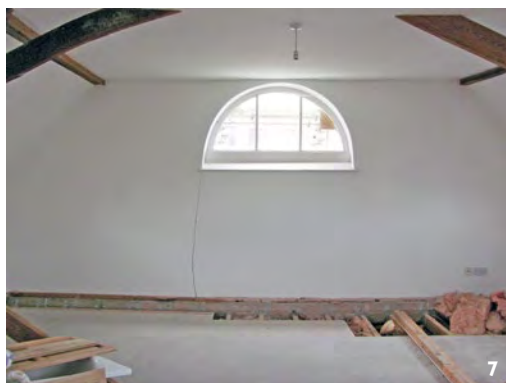
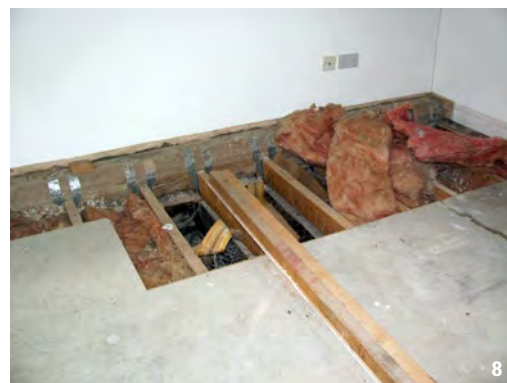
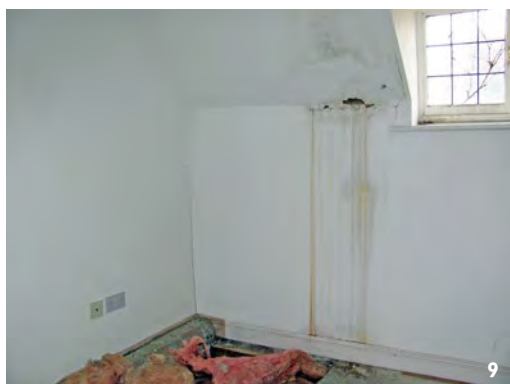
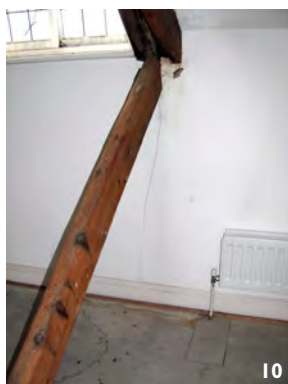
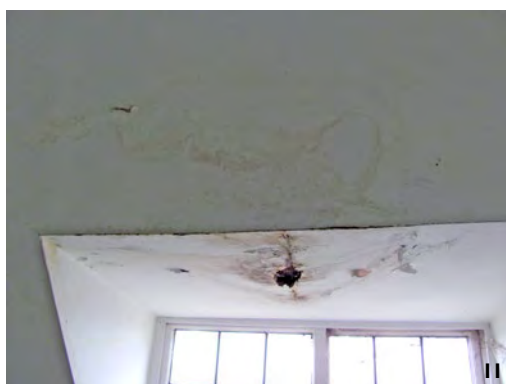
INTERNAL - SECOND FLOOR: S4I, 1753 TO 1756 EASTERN RANGE

- 1 Attic room
- 2 Lunette window
- 3 Attic room
- 4 West wall
- 5 Horizontal sliding sash window
- 6 Door with boarded fan light (viewed from S39)
- 7 Crack under window in south wall
- 8 No floor at south end of wall
- 9 Damp at south of west wall
- 10 Crack adjacent to beam in west wall and damp area
- 11 Damp over window at north end of west wall

Generally adequate although there is no floor at the south end of the room. There are cracks running adjacent to all timbers in the east and west walls. There is also a crack running from the sill to the floor at the east end of the window in the south wall. There is severe damp to the west wall and stains from water running down the wall at the south end of the west wall, as well as severe damage over window at the north end of the west wall.
